PRELIMINARY REPORT ON ACCIDENT AT TURØY, NEAR BERGEN, NORWAY ON 29 APRIL 2016, INVOLVING AIRBUS HELICOPTERS H225, LN-OJF OPERATED BY CHC HELIKOPTER SERVICE AS

- Type and reg.:	Airbus Helicopters H225, LN-OJF
Serial No.:	2721
Call sign:	HKS241
No. and Type of Engines:	2 x Turbomeca Makila 2A1 turboshaft engines
Date and time (local):	Friday 29 April 2016 at 11:55 hours
Year of Manufacture:	2009
Accident site:	Turøy, Hordaland county, Norway (Pos. 60,45234°N 004,93028°E) Radial/Distance from ENBR: 330°/13 NM
Weather conditions:	METAR ENBR 290950Z 20017KT 9999 SCT018 SCT023 07/03 Q1005 NOSIG RMK WIND 1200FT 19020KT=
Light conditions:	Daylight
Operator:	CHC Helikopter Service AS
Type of Operation:	Commercial Air Transport (CAT), Non-scheduled operations
Persons on board:	Crew - 2 (Fatal) Passengers – 11 (Fatal)
Nature of damage:	Helicopter destroyed
Information Source:	AIBN Field Investigation

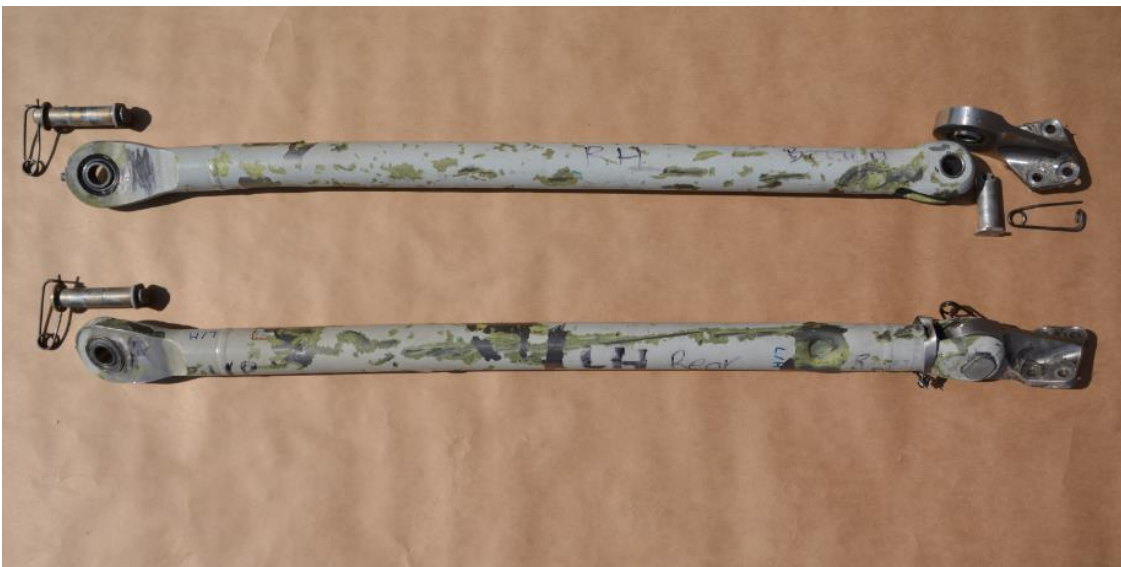
Figure 3: MGB Right and left hand aft suspension bars with attachment fittings. Photo: AIBN

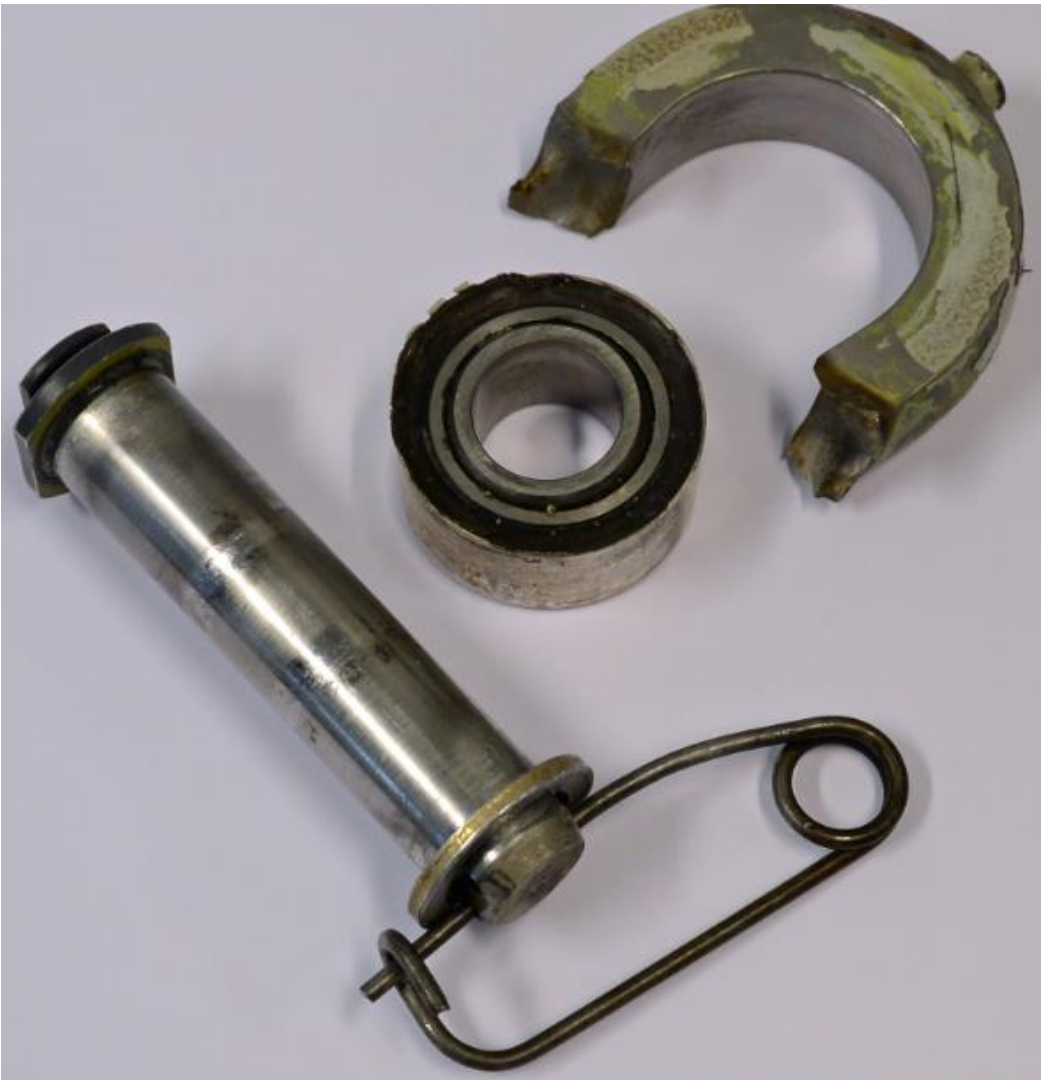
Figure 4: Upper forward suspension bar fitting. Photo: AIBN

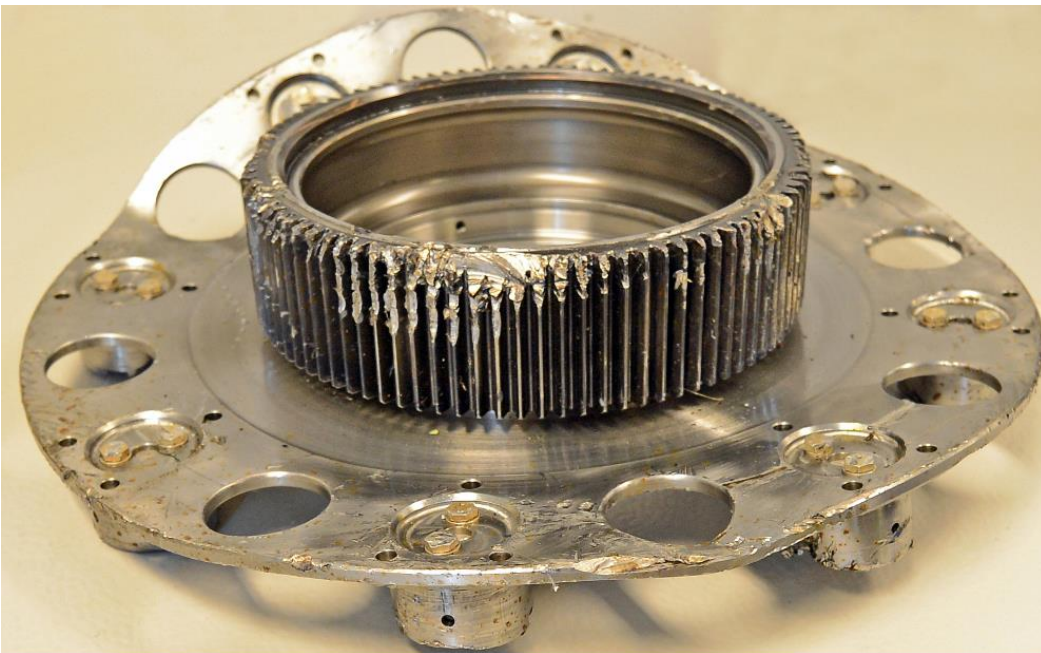
Figure 5: MGB first stage planetary gear carrier. Photo: AIBN

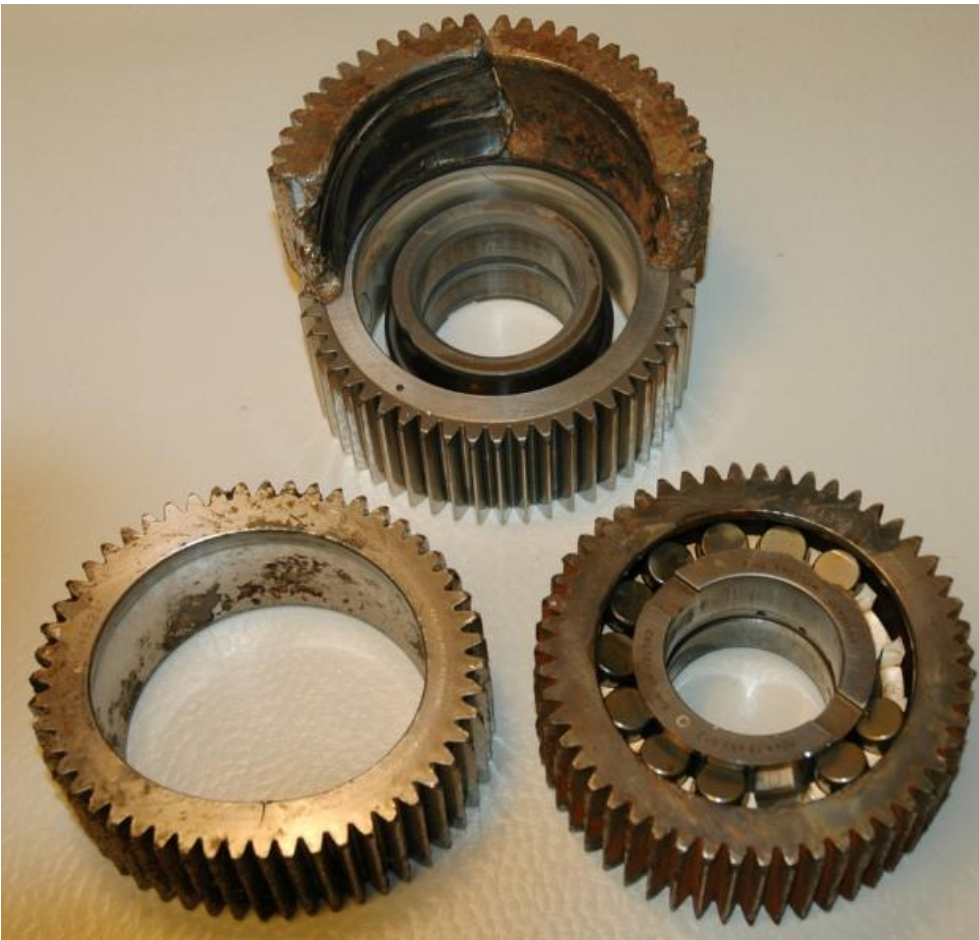
Figure 6: Parts from second stage planet gear. (The fractured gear is placed on top of a sample gear that was not involved in the accident.) Photo: AIBN
