PRELIMINARY REPORT 1 JUNE 2016

ACCIDENT AT TURØY, NEAR BERGEN, NORWAY ON 29 APRIL 2016, INVOLVING AIRBUS HELICOPTERS H225, LN-OJF OPERATED BY CHC HELIKOPTER SERVICE AS

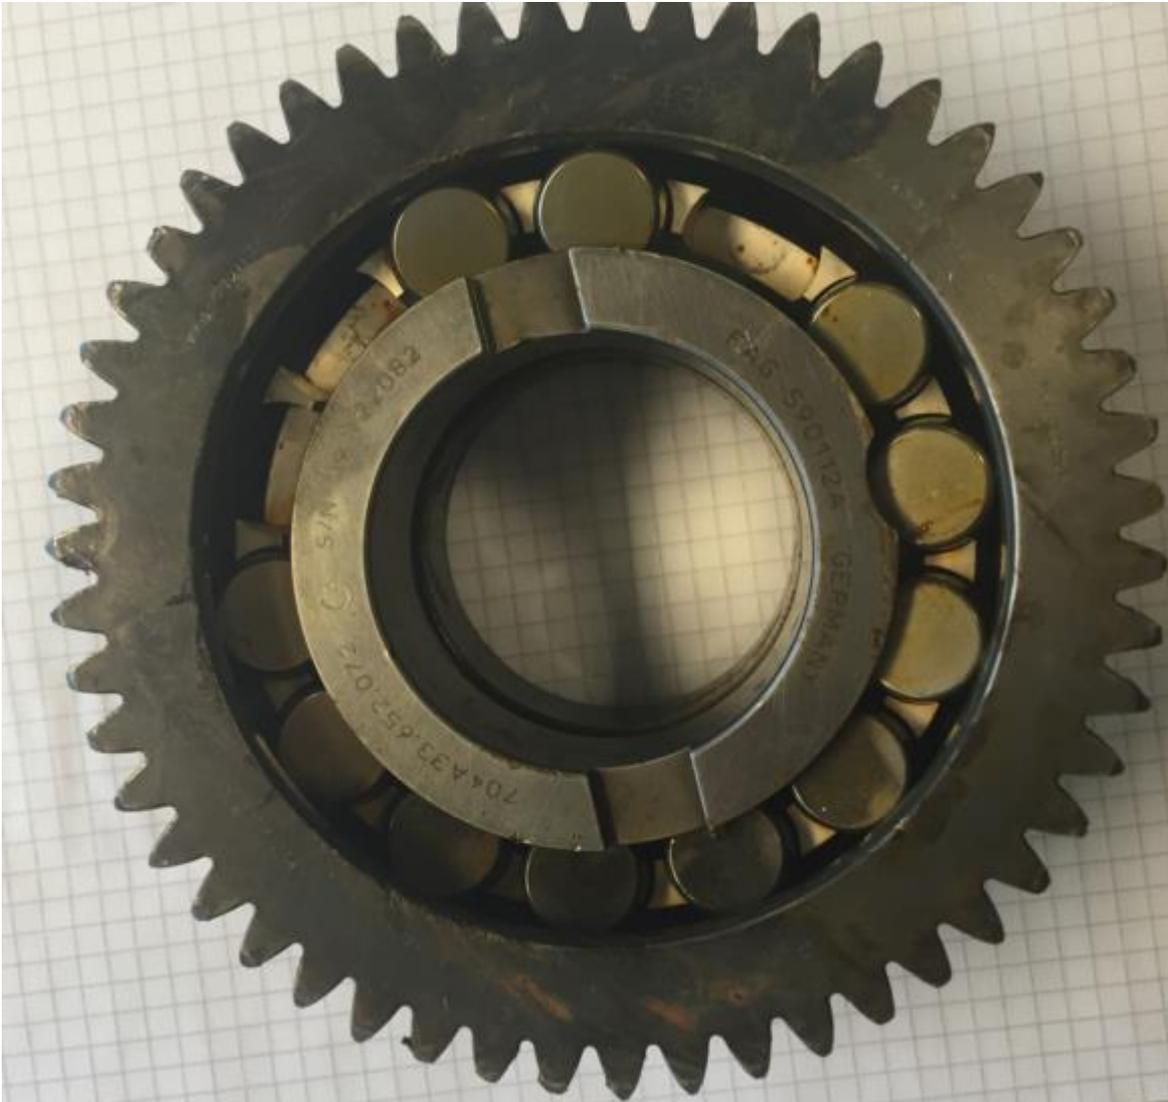
Figure 1: Second stage planet gear (as found with three rollers missing). Photo: AIBN

Planet gears have a double function, acting as a gear on the outside while at the same time functioning as the outer race of a roller bearing on the inside. In order to improve wear resistance it has been given a hard outer surface through a carburization process.

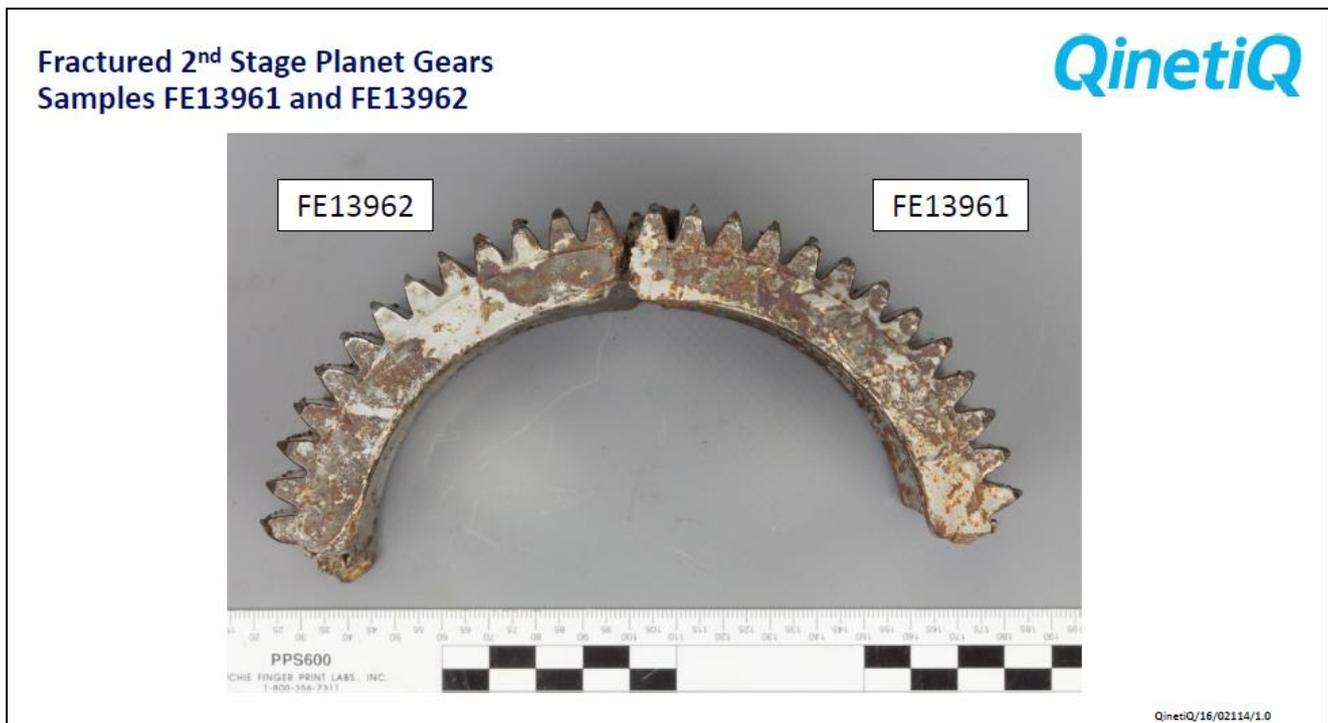
Among the recovered parts were two pieces which together form approximately half a second stage planet gear (ref. Figure 2). Examinations of these parts have revealed features strongly consistent with fatigue. The fatigue appears to have its origin in the outer race of the bearing (inside of the gear), propagating towards the web of the gear teeth. There is sign of spalling in front of the fracture surface.

Figure 2: The two pieces of the second stage planet gear prepared for metallurgical examinations.
Photo: QinetiQ

Recent metallurgical findings have revealed features strongly consistent with fatigue in the outer race of a second stage planet gear in the epicyclic module of the MGB. It cannot be ruled out that this signifies a possible safety issue that can affect other MGBs of the same type. The nature of the catastrophic failure of the LN-OJF main rotor system indicates that the current means to detect a failure in advance are not effective.

The AIBN therefore recommends that EASA take immediate action to ensure the safety of the Airbus Helicopters H225 Main Gear Box.
