PRELIMINARY REPORT 28 JUNE 2016

ACCIDENT AT TURØY, NEAR BERGEN, NORWAY ON 29 APRIL 2016, INVOLVING AIRBUS HELICOPTERS H225, LN-OJF OPERATED BY CHC HELIKOPTER SERVICE AS

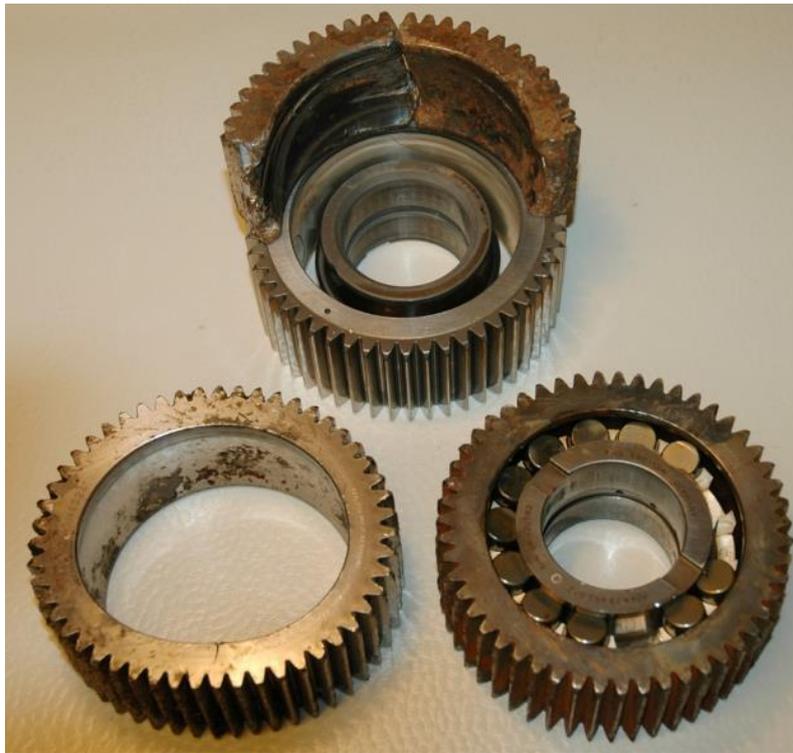
Figure 2: Planet gear parts from second stage epicyclic reduction gear module. (The fractured gear is on top of a sample gear that was not involved in the accident.) Photo: AIBN

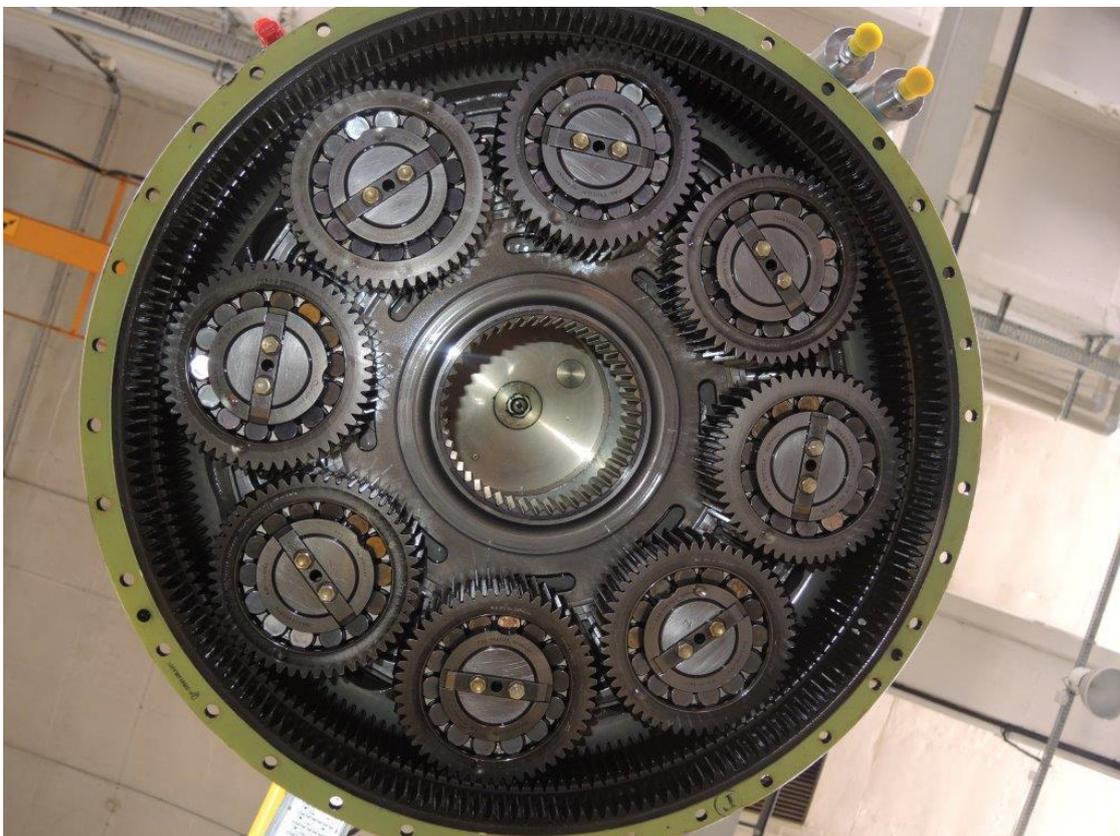
Figure 3: Eight second stage planet gears as fitted on the carrier inside the ring gear, seen from below (first stage gears and carrier is not shown). Photo: AIBN

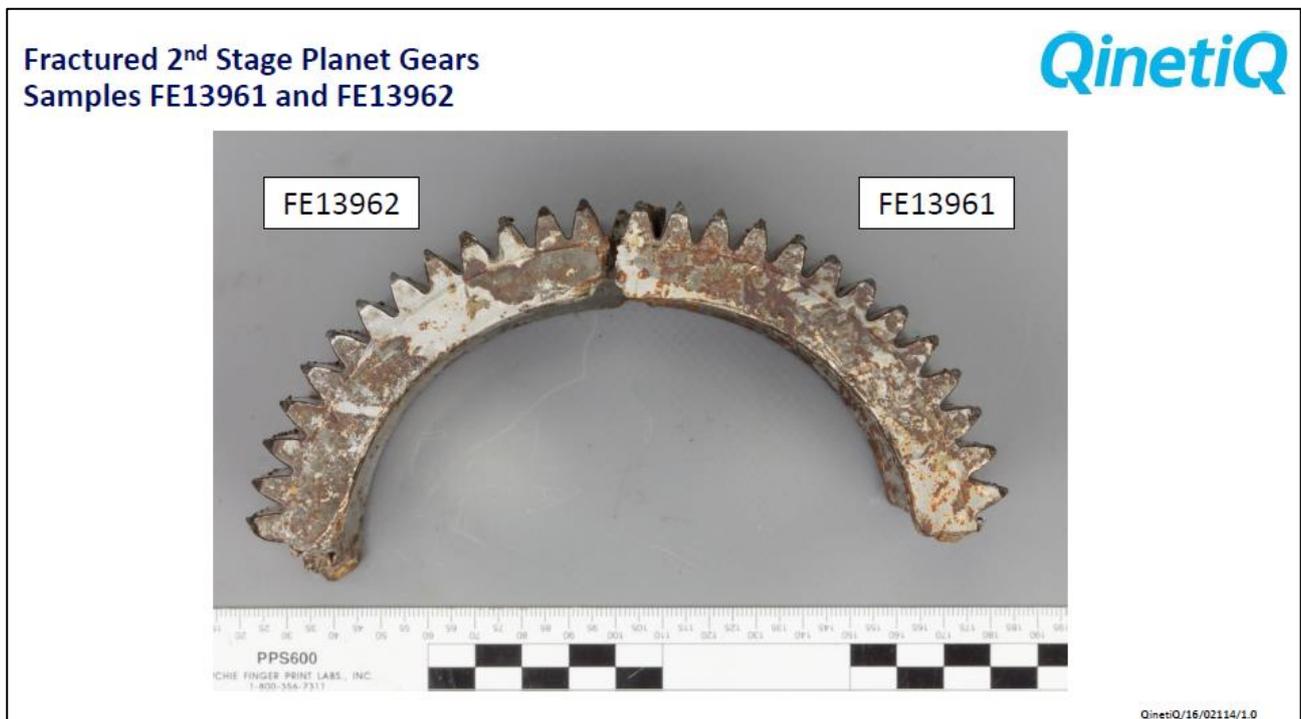
Two pieces of the recovered parts have been of particular interest. Together they make up approximately half of a second stage planet gear P/N 332A32.3335.07, S/N 10-1292 (ref. Figure 4). Examinations of these parts show that one of the fracture surfaces can be described as being close to 100% fatigue (ref. Figure 5).

Figure 4: The two pieces of the second stage planet gear prepared for metallurgical examinations. The fracture surface with fatigue is to the right in the figure. Photo: QinetiQ

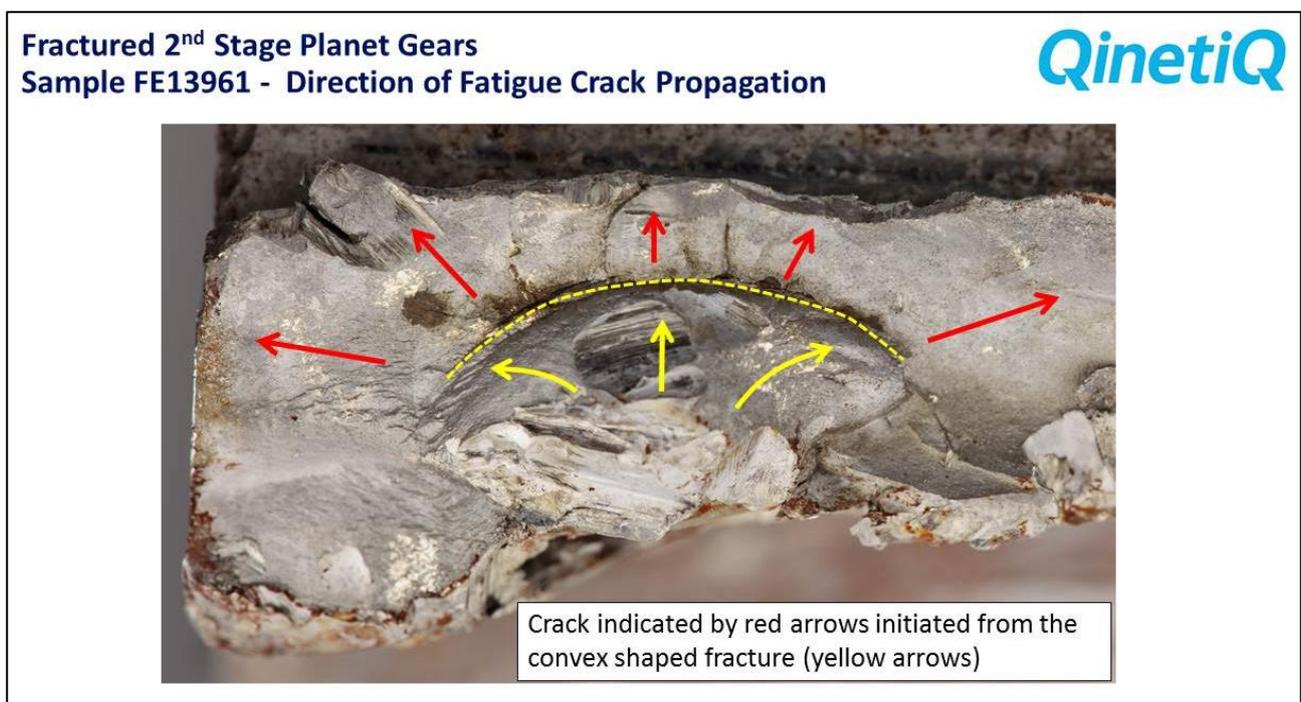
Figure 5: Close-up of the fracture surface initiated on the inner surface (outer race). Multiple cracks propagating from major crack around convex fracture surface. Photo: QinetiQ

The fatigue appears to have its origin in the outer race of the bearing (inside of the gear), propagating towards the web of the gear teeth. In order to examine the fatigued part before performing any destructive testing, the piece was inspected using x-ray computed tomography (CT)

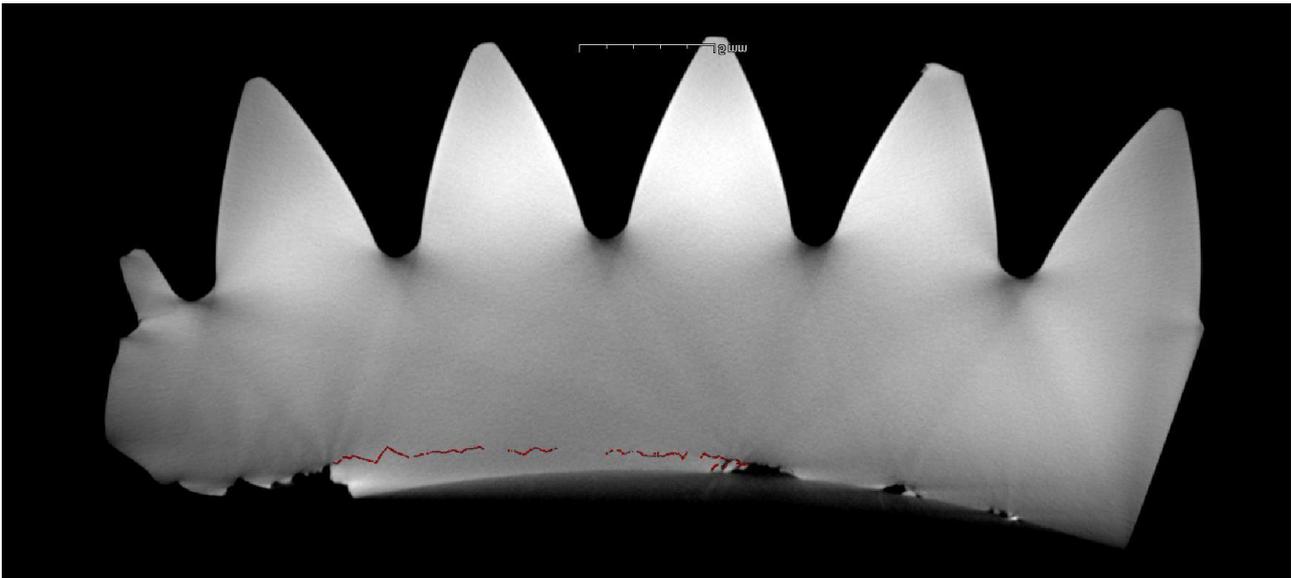
scans. The scans showed several cracks below the surface of the outer race. One crack runs below the surface between areas of surface damage (spalling) (ref. Figure 6).

Figure 6: An example from the CT scan showing a subsurface crack propagating from the right hand spalling all the way to the left. The red colour is a frame-by-frame mapping performed by hand to highlight the crack. Photo: University of Southampton
