# REPORT

SL 2013/16

## REPORT ON AIR ACCIDENT NEAR SØVATNET LAKE IN BJUGN IN SØR-TRØNDELAG COUNTY, NORWAY ON 10 AUGUST 2012 - CESSNA 172RG, D-EIYL

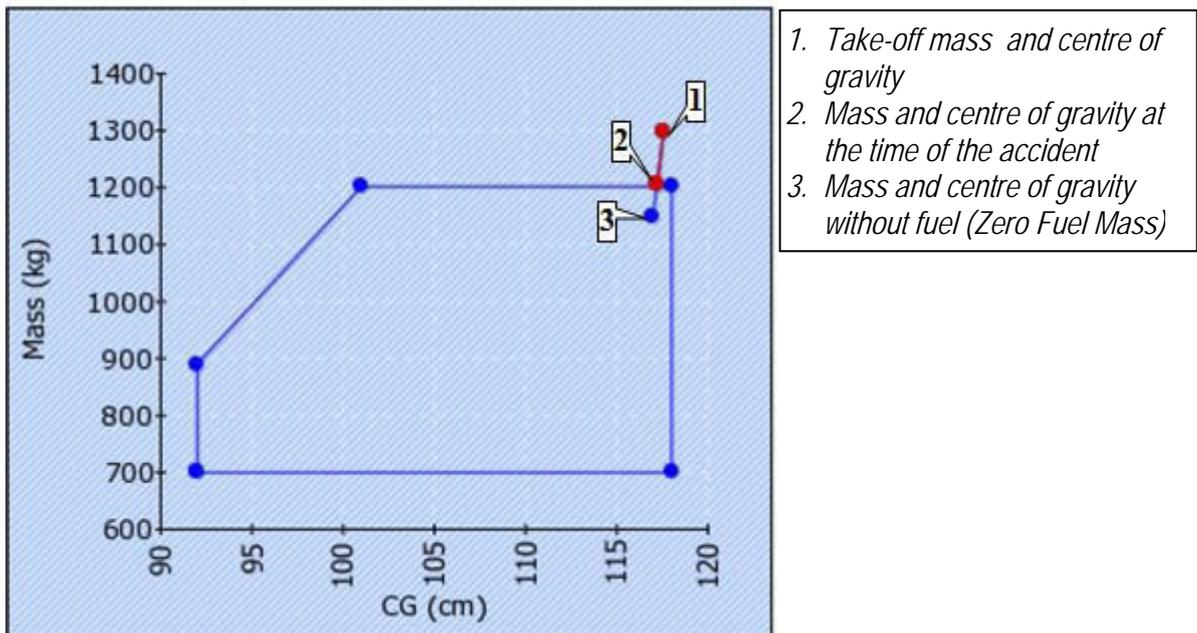
ITEM	MASS (kg)	ARM (Cm)	MOM (Cm.kg*100)	Max.Limits (kg)
Basic Empty Mass	785.00	99.00	777.15	
Crew	167.00	94.00	156.98	
Row 1	118.00	185.00	218.30	
Row 2	0.00	0.00	0.00	
Row 3	0.00	0.00	0.00	
Row 4	0.00	0.00	0.00	
Baggage	80.00	241.00	192.80	
=Zero Fuel Mass	1150.00	116.98	1345.23	
+Fuel Loading	155.00	122.00	189.10	
=Ramp Mass	1305.00	117.57	1534.33	MRM: 1202.00
-Taxi Fuel	5.00	122.00	6.10	
=Take Off Mass	1300.00	117.56	1528.23	MTOM: 1198.00
-Destination Fuel	93.26	122.00	113.78	
=Landing Mass	1206.74	117.21	1414.45	MLM: 1198.00

Figure 5: Mass and balance calculation, D-EIYL. For the accident flight, the limits were exceeded.

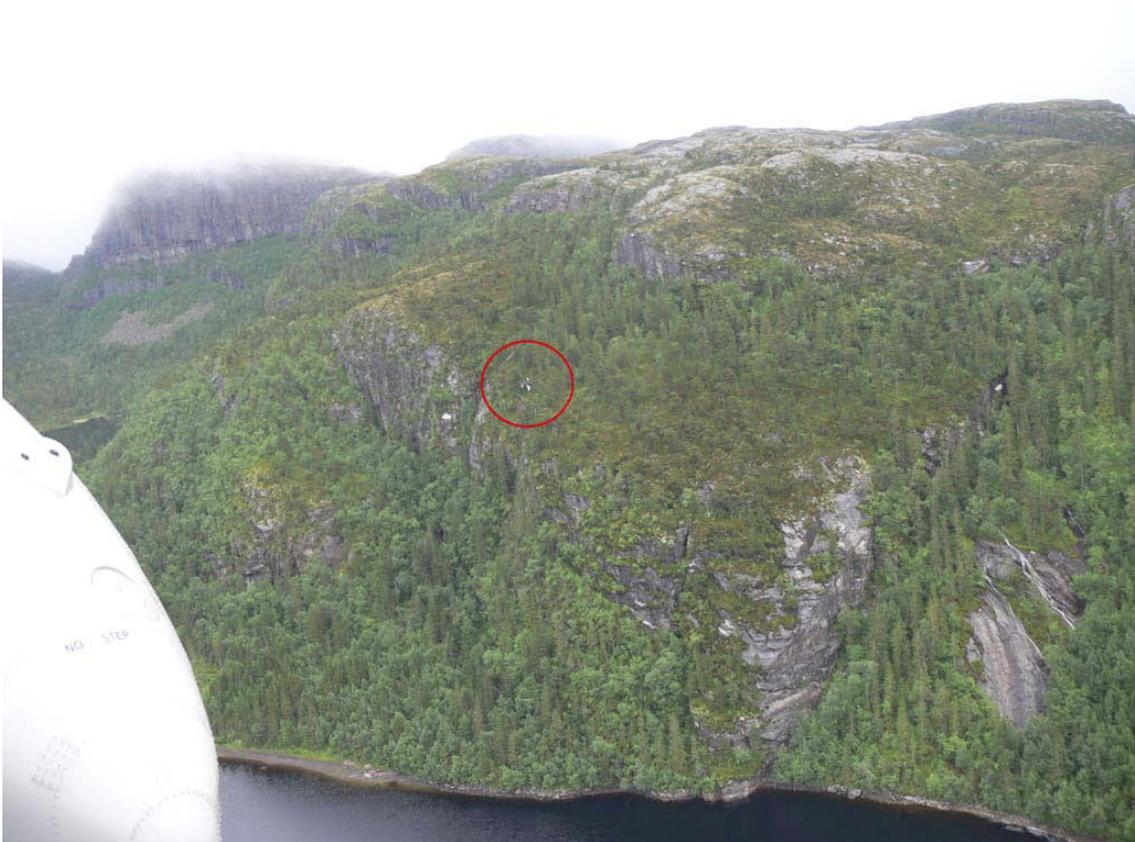
approx. 85 metres (280 ft) above the lake. The terrain where the wreckage came to rest slopes approx. 30° in the north-south direction. There are several peaks of more than 200 metres in the area, see the photo in Figure 8 and the map in Figure 4.

*Figure 8: The terrain at the southern end of Søvatnet lake. The red ring marks the accident site, with the wreckage at the centre. The prominent peak that is partly obscured by fog in the background to the left in the photo is the 379 m (1 240 ft) high Keipen. (Photo: 330 Squadron – taken from the north looking south a few hours after the accident.)*

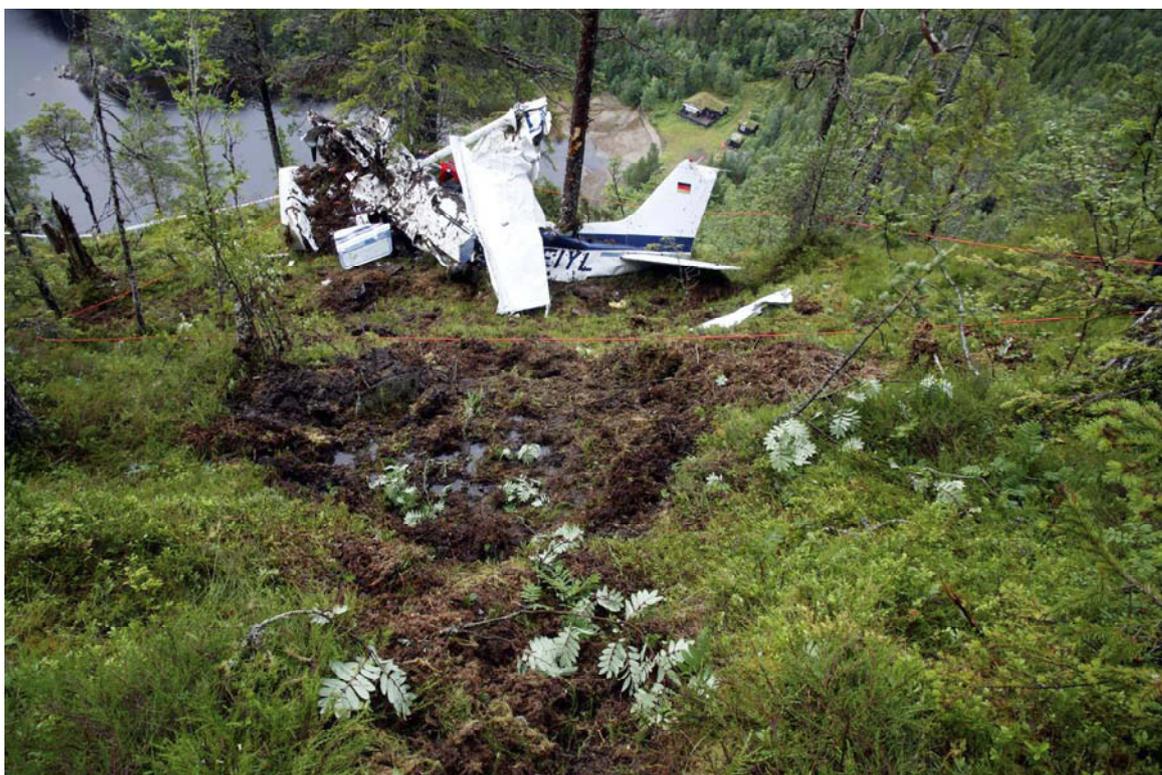
- 1.12.1.2 The impact zone showed a clear crater with a diameter of just over two metres in which heather and moss was mixed with wet earth. A 4.8 m long groove/elongated mark led from the crater up towards an approx. 18 m tall pine tree that had had its crown broken and a few branches torn off. The left wing tip cover and various fragments of glass and small parts were scattered around the area. The whole aircraft wreckage was otherwise found in one place further down the hill (ref. Figure 9). There were no other clear marks or trees with visible damage in the area of the accident site.

- 1.12.2 The aircraft wreckage
  - 1.12.2.1 The aircraft wreckage came to rest located approx. five metres from the impact site (ref. Figure 9 and Figure 10), up against some solid tree trunks. The fuselage had split in the transition between the cabin and tail section. The cockpit and cabin section was heavily deformed and partly compressed. All important parts of the aircraft were found on the accident site.

*Figure 9: The accident site viewed in a north-easterly direction. The cabin by the lake where the eye witness was located is visible in the background. The groove created by the left wing and the crater left by the engine are visible in front of the wreckage. (Photo: AIBN)*

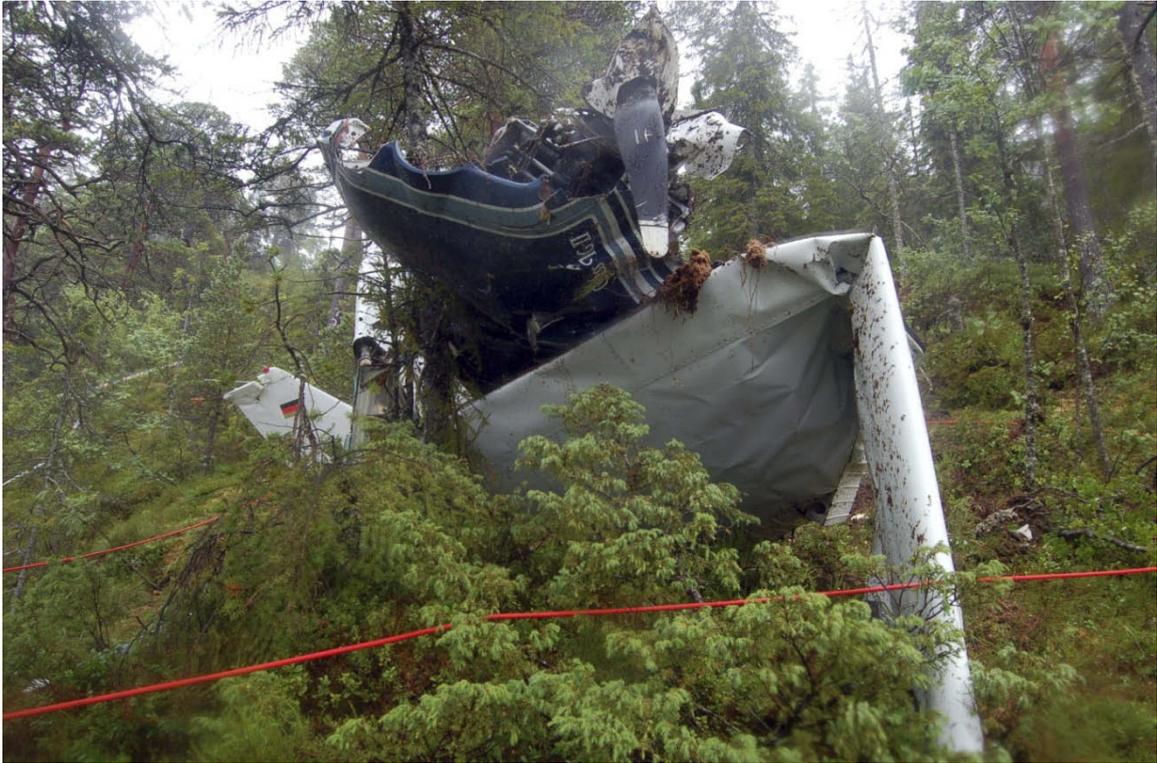
- 1.12.2.4 The left wing was broken at the wing strut, and most of the leading edge had been pushed in from below. The left wing tip cover was knocked off and was found lying on the ground further up, between the pine tree and the elongated mark. The right wing was broken and partly folded up underneath the wreckage.

- 1.12.2.5 The cowling was severely deformed, but the engine was still attached to the fuselage. The spinner was severely deformed, and both propeller blades were bent backwards. One of the blades had scratches resulting from rotation, and the propeller shaft was bent. The landing gear and flaps had not been extended.

Figure 10: The front of the wreckage. The engine lies on top of the folded-up right wing. (Photo: AIBN)
