# REPORT

SL 2017/01

## REPORT ON AIR ACCIDENT NEAR VANGSNES IN SOGN OG FJORDANE COUNTY ON 14 JUNE 2016 INVOLVING A ROBINSON HELICOPTER COMPANY R22 BETA D-HTIK

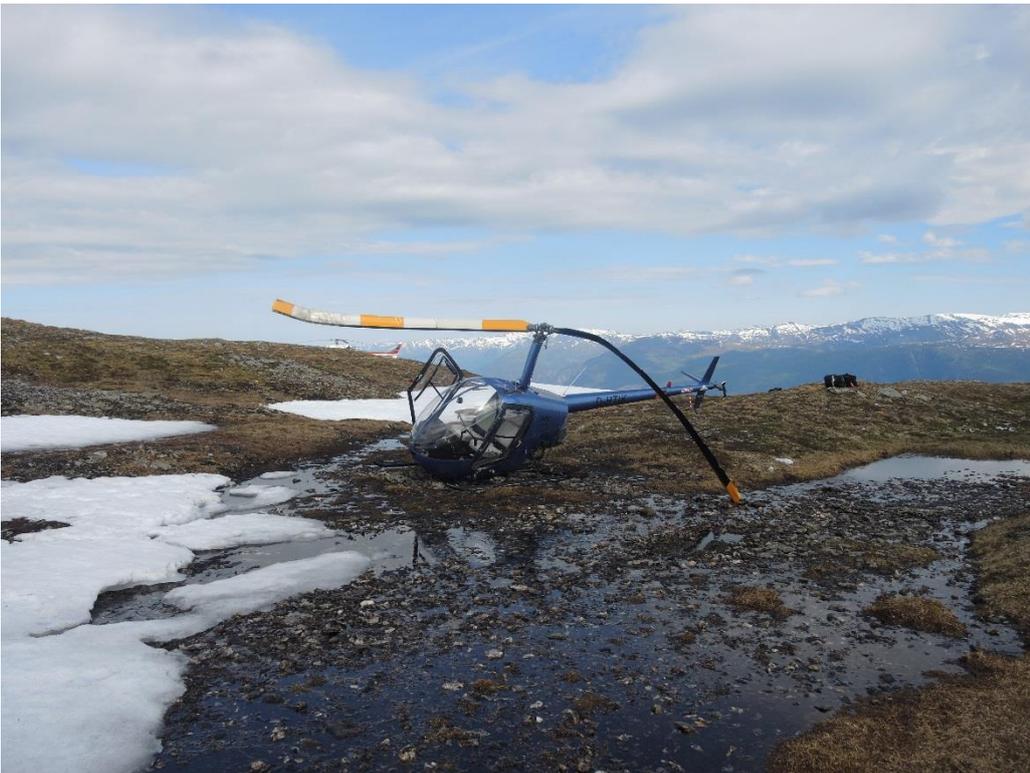
Broken left landing gear, broken main rotor mast, bent main rotor blades, damage to the main frame, tail boom and tail rotor.

The local terrain sloped slightly towards the north with some flat areas. One of these areas was chosen for the landing. Due to the reduced engine power, the landing was hard. The left landing gear broke, and the helicopter capsized towards the left. The rotor hit the ground, and the helicopter sustained major damage.

Figure 2: The accident site. This picture was taken after the helicopter had been straightened up. Photo: AIBN

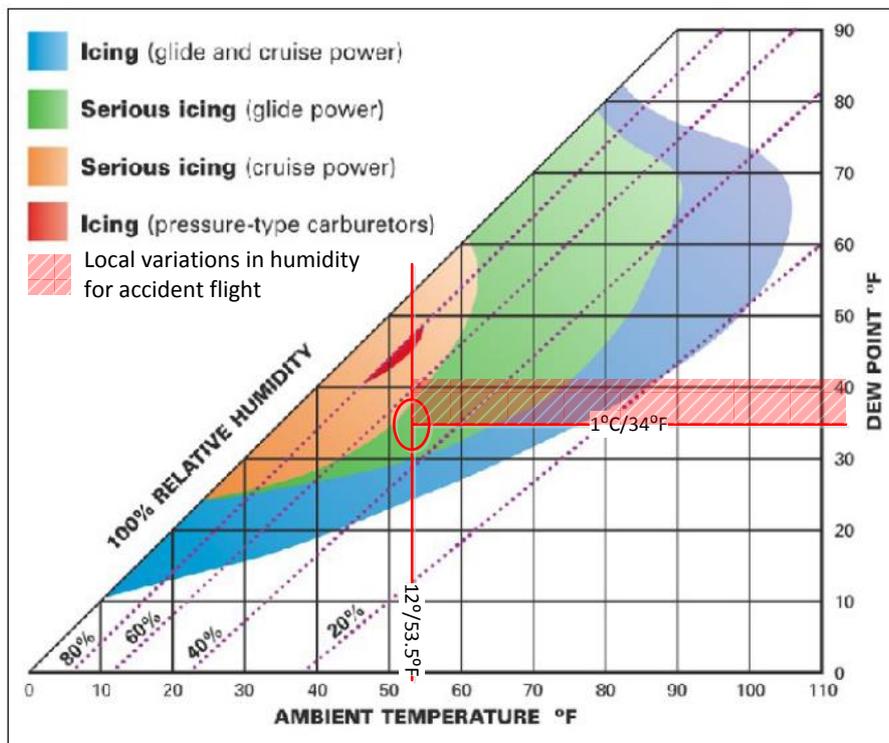
Figure 3: Diagram for air humidity and risk of carburetor ice. The prevailing local conditions at the time of the accident have been entered as red markings and a shaded field. Source: FAA

By plotting in the air temperature and dew point temperature stated in the Meteorological Institute report in a diagram included in FAA’s Special Airworthiness Information Bulletin (SAIB) CE-09-35 “Carburetor Icing Prevention”, we find that the risk of carburetor icing was present, see Figure 3. The engine’s lack of response to increased input from the collective after a period of flying at the same altitude without carburetor heating supports the theory that carburetor icing caused this accident.

- Carburetor heating was not used.
- AIBN is of the opinion that the observed loss of engine power most probably was caused by carburetor icing. No faults have been found in either the engine or the ignition system.
- The altitude selected above the terrain exposed the helicopter to water evaporation from snow patches that increased the risk of carburetor icing.
- In this case, it may also appear that the intended flightpath gave the commander very few options but to perform an emergency landing before the loss of rotor speed led to control problems.
