PRELIMINARY REPORT ON ACCIDENT AT TURØY, NEAR BERGEN, NORWAY ON 29 APRIL 2016, INVOLVING AIRBUS HELICOPTERS H225, LN-OJF OPERATED BY CHC HELIKOPTER SERVICE AS

Aircraft:	
- Type and reg.:	Airbus Helicopters H225, LN-OJF
Serial No.:	2721
Call sign:	HKS241
No. and Type of Engines:	2 x Turbomeca Makila 2A1 turboshaft engines
Date and time (local):	Friday 29 April 2016 at 11:55 hours
Year of Manufacture:	2009
Accident site:	Turøy, Hordaland county, Norway (Pos. 60,45234°N 004,93028°E) Radial/Distance from ENBR: 330°/13 NM
Weather conditions:	METAR ENBR 290950Z 20017KT 9999 SCT018 SCT023 07/03 Q1005 NOSIG RMK WIND 1200FT 19020KT=
Light conditions:	Daylight
Operator:	CHC Helikopter Service AS
Type of Operation:	Commercial Air Transport (CAT), Non-scheduled operations
Persons on board:	Crew - 2 (Fatal) Passengers – 11 (Fatal)
Nature of damage:	Helicopter destroyed
Information Source:	AIBN Field Investigation

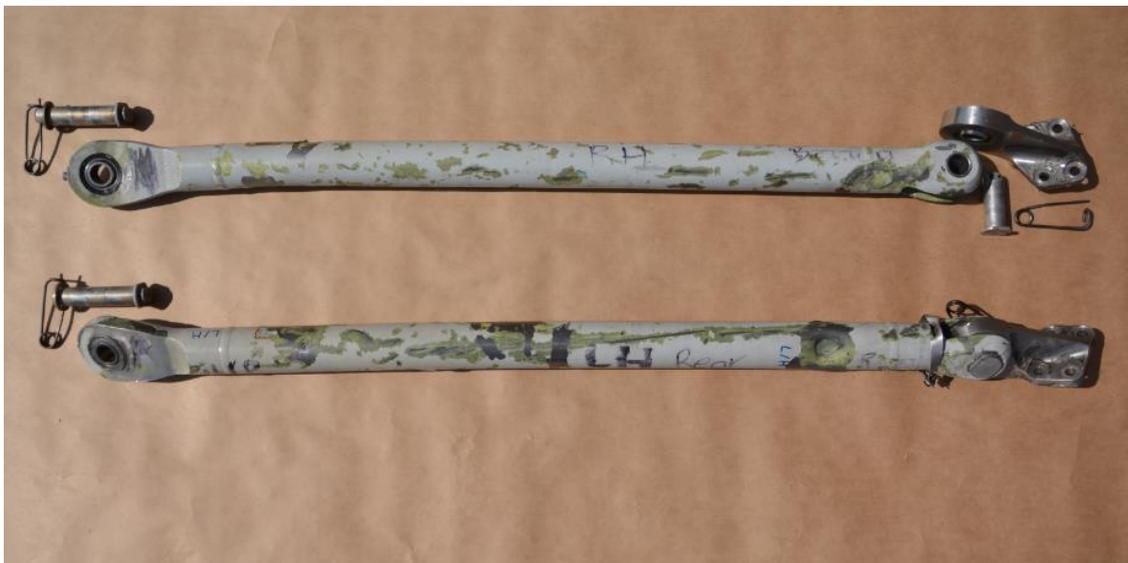
Figure 3: MGB Right and left hand aft suspension bars with attachment fittings. Photo: AIBN

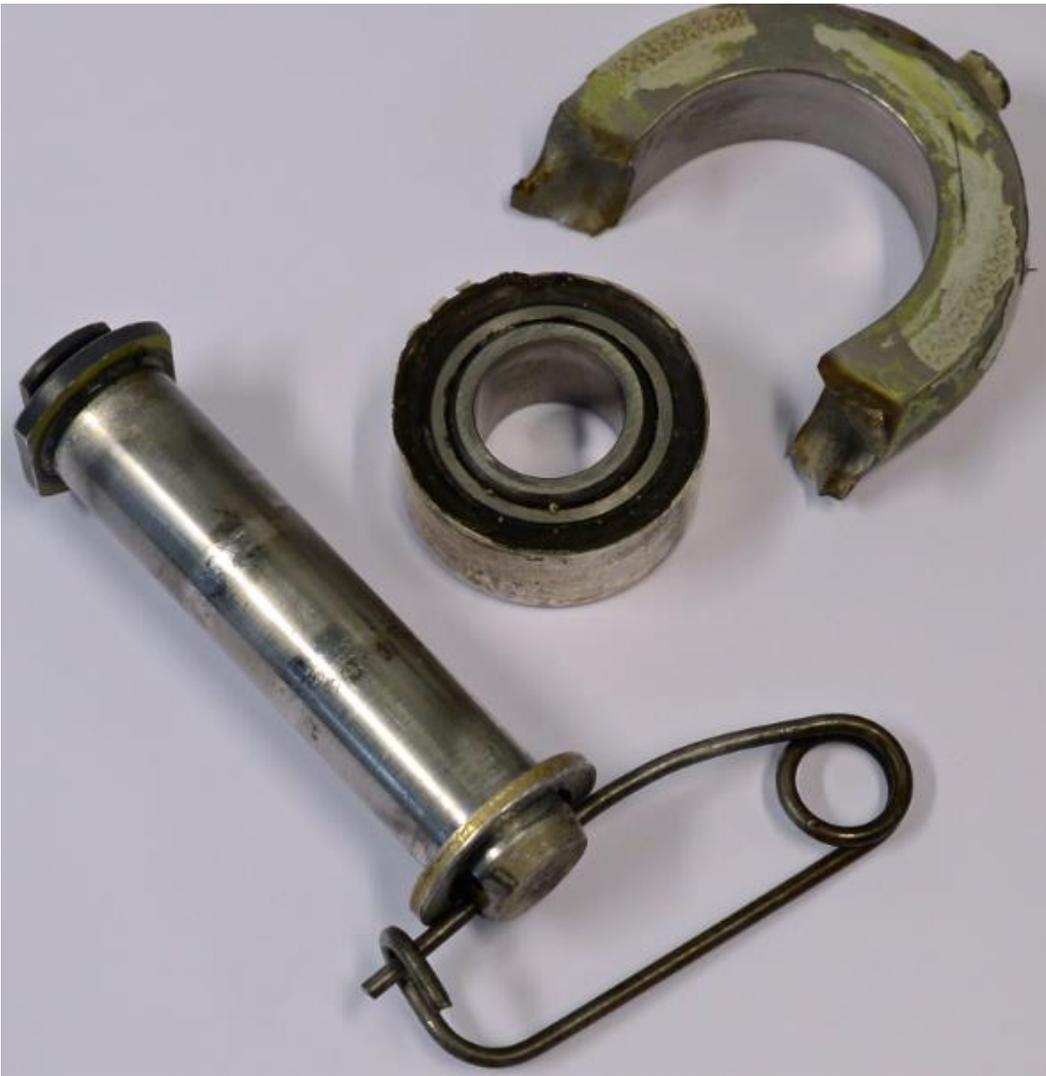
Figure 4: Upper forward suspension bar fitting. Photo: AIBN

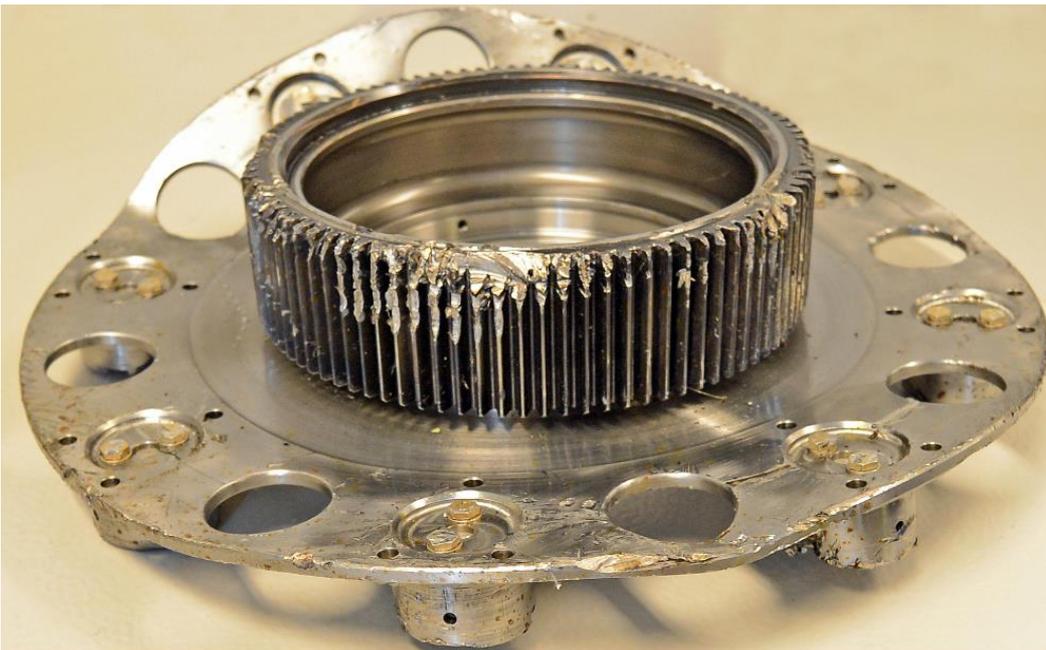
Figure 5: MGB first stage planetary gear carrier. Photo: AIBN

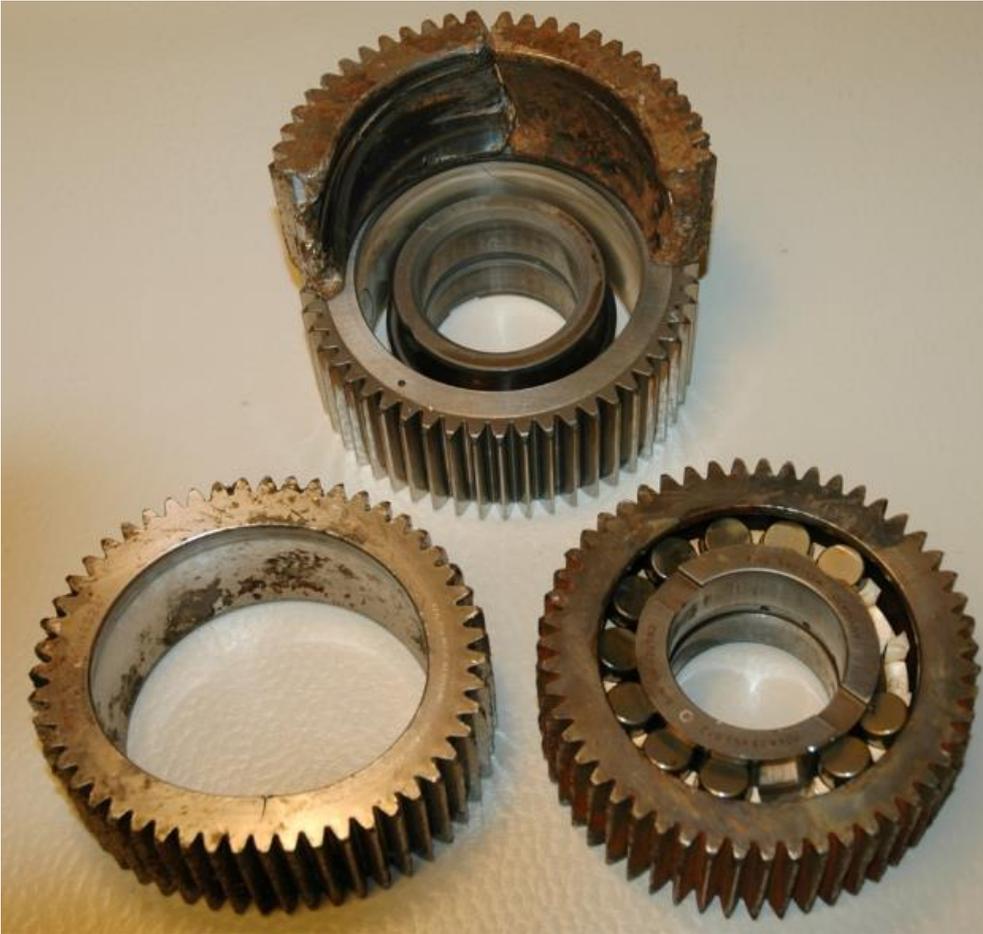
Figure 6: Parts from second stage planet gear. (The fractured gear is placed on top of a sample gear that was not involved in the accident.) Photo: AIBN

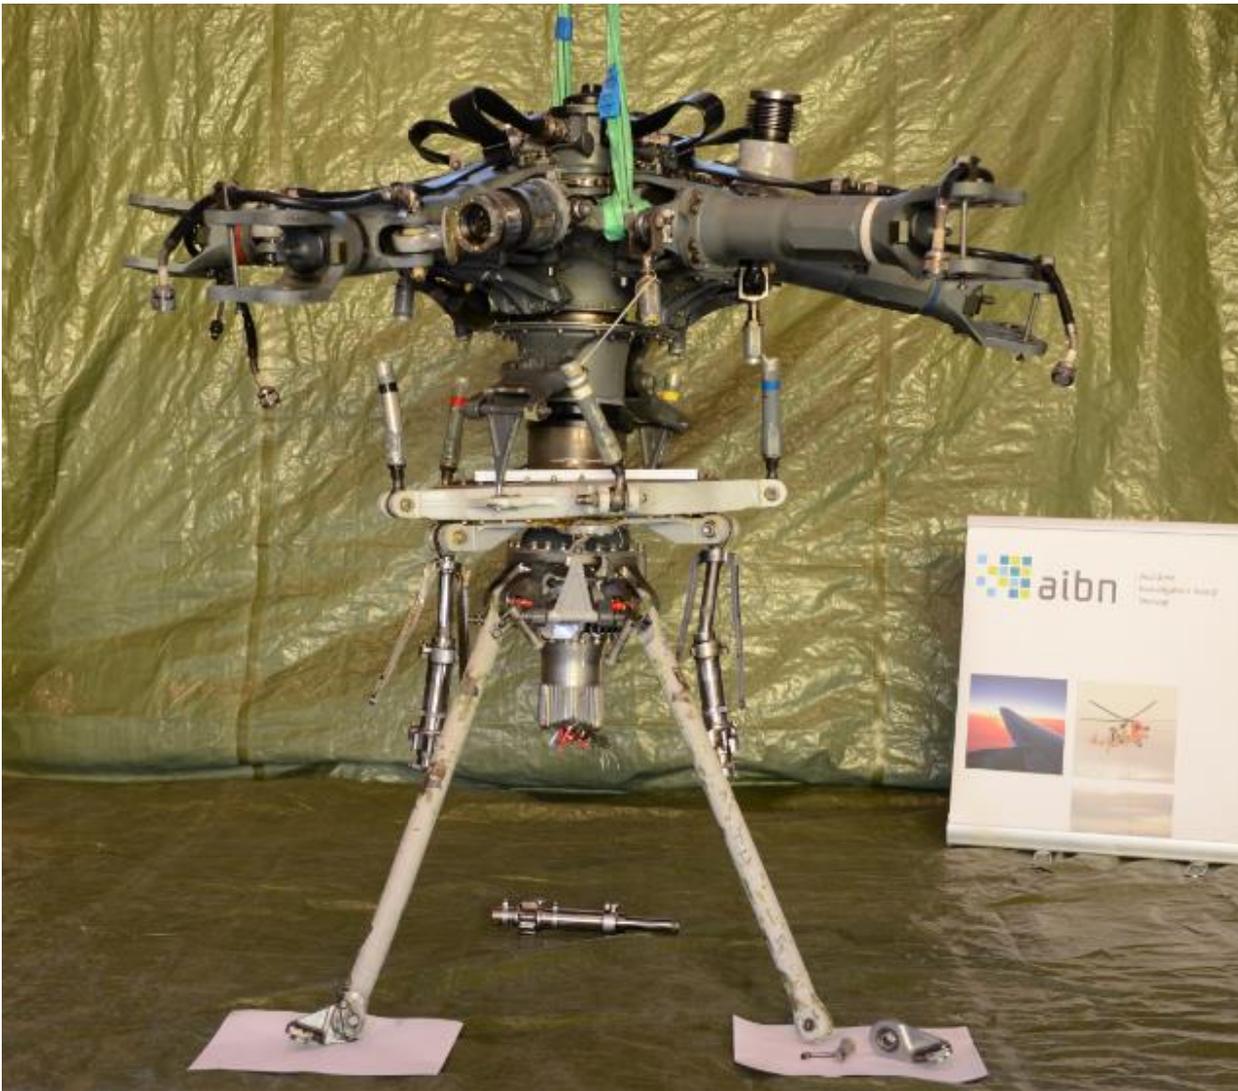
Figure 7: Main rotor head with rotor mast with aft suspension bars. Photo: AIBN
