SL 2018/07

REPORT ON SERIOUS AIRCRAFT INCIDENT AT LEKNES AIRPORT ON 24 JULY 2017 INVOLVING PIPER PA-34-220T SENECA V, N666NN

Date: 11.10.2018
SL Report: 2018/07

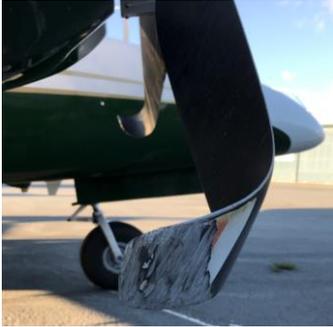
The commander has stated that he planned to carry out a touch-and-go procedure at Leknes for training purposes, this should be done in combination with carrying out brief sightseeing over the town¹. At the end of the approach, the plan was to reduce the number of degrees flaps to improve acceleration after the touch-and-go procedure. By mistake, the commander raised the handle for the undercarriage instead of the flaps. On short final in connection with the "GUMP" check (Gas, Undercarriage, Mixture, Propeller), he discovered that the undercarriage was no longer extended. He then accelerated the airplane from a particularly low altitude over the runway and started climbing, while at the same time he realised the possibility that the propeller blades had touched the runway.

The commander has explained that the airspeed was reduced, but he did not feel any vibrations from the propellers on the flight south toward Værnes. After landing at Værnes, it became clear that all six propeller tips had been bent backward, but the fuselage was unharmed (see Figures 1 and 2).

Figure 1: Damage to all six propeller blades. Photo: Police

After the incident, the aircraft was repaired at Værnes. When the commander was on his way from Trondheim to Zurich he experienced problems with the aircraft's radio equipment. It became necessary to make an unscheduled stopover in Germany to get the radio equipment repaired. At the maintenance facility, they found defects on the radio equipment, which had caused poor radio connection for some time. In connection with review of the draft report, the commander has documented repair of the aircraft audio panel and the two VHF radios.

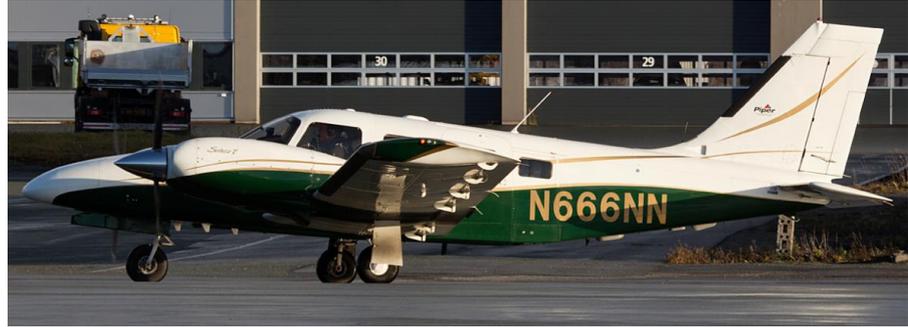
Figure 2: N666NN. Photo: Erlend Karlsen (Jetphotos)
