SL 2010/06

REPORT ON THE SERIOUS INCIDENT AT SKIEN AIRPORT GEITERYGGEN NORWAY (ENSN) ON 19 APRIL 2009 INVOLVING A CESSNA 172S SKYHAWK SP, LN-LVT

Date: 09.03.2010
SL Report: 2010/06

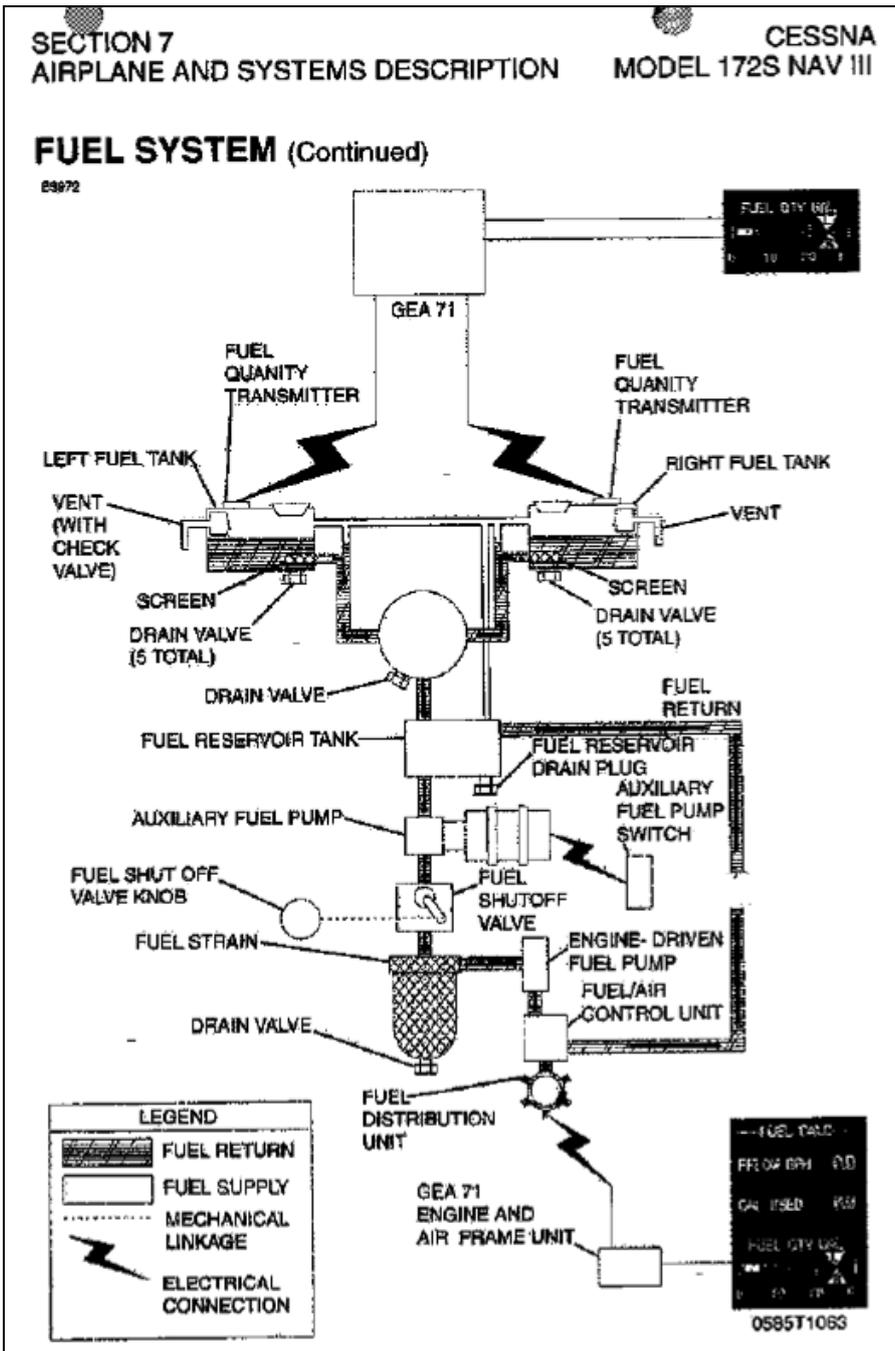
The two on board evacuated from the aircraft out on the runway. They observed that fuel had leaked out from the aircraft onto the runway, and that a lot of fuel continued to run under the engine cowlings. The aircraft's fuel shutoff valve (see Figure 1) was then closed and after some time the leak stopped. The airport's fire and rescue crew came quickly to the aircraft and covered the fuel on the runway with foam.

Figure 1: Schematic drawing of the fuel system.

As emerges from the schematic drawing of the fuel system (Figure 1), the auxiliary fuel pump is located so that it provides pressure in addition to the gravitational pressure from the fuel tanks, via the fuel strainer in to the engine-powered fuel pump in the aircraft engine.

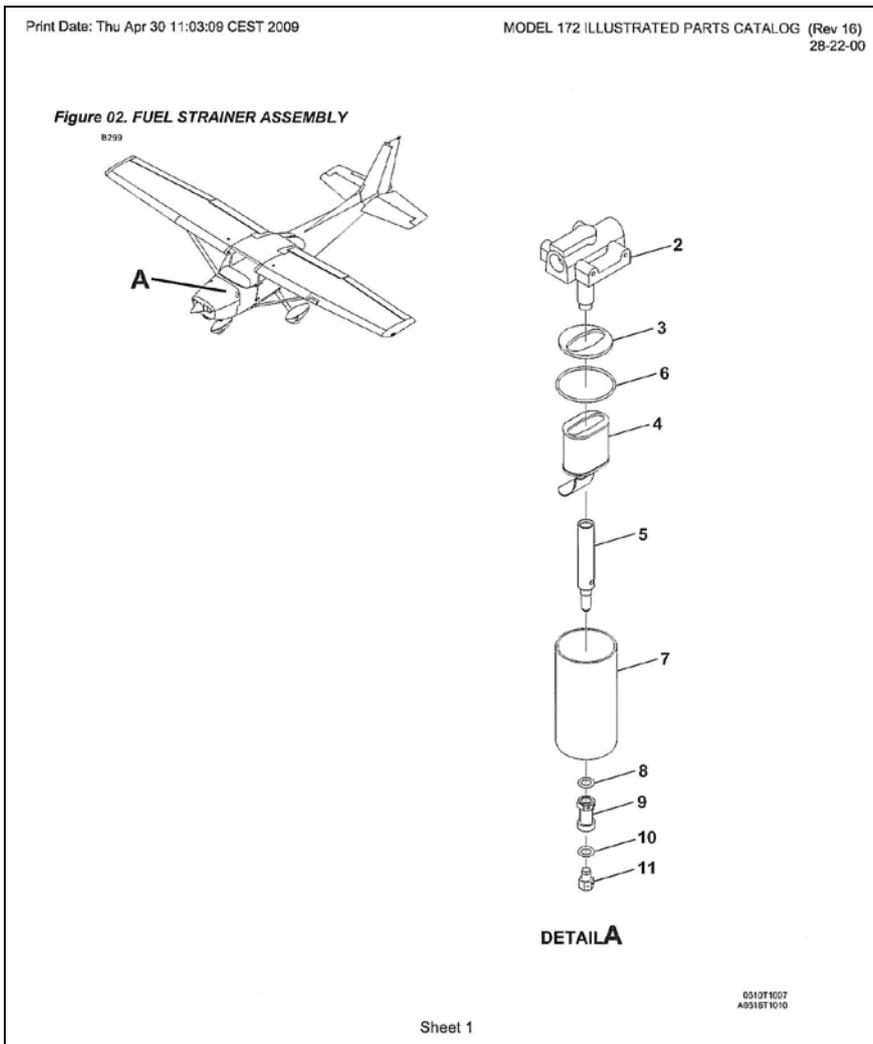
Upon further inspection, it turned out that the outermost thread of the 6 mm long thread section of the top assembly had been damaged (see Figure 5). The fuel filter in the fuel strainer encloses the standpipe and is fastened between this and the brass section of the top assembly (see Figures 2 and 6). The distance between the top assembly (with filter fitted) and the standpipe before the threads engaged was less than 2 mm (see Figure 6). The inner threads of the standpipe¹ do not go all the way out to the flange (see Figure 4).

Figure 2: Schematic drawing of the fuel strainer in the parts catalogue.

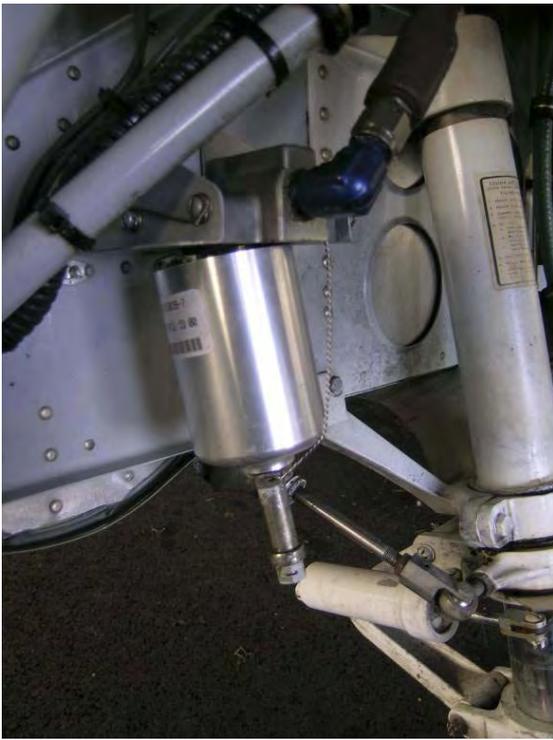
The investigation of the Accident Investigation Board revealed that the fuel strainer bowl had become loose (see Figures 2 and 3). The fuel strainer is located in the lower part of the engine compartment and is designed to capture any water and other contaminants before the fuel reaches the engine. There is a drain valve at the bottom of the unit. Figures 2 to 6 show the location and design of the fuel strainer.

Figure 3: Bowl which had come loose from the top assembly.

With regard to the report from Cessna Aircraft Company, the Accident Investigation Board refers to the note in Figure 5 which states that the scratch marks on the LN-LVT components were made after the incident. The scratch marks thus have no bearing on the incident, and are no sign of faulty maintenance of the aircraft prior to the incident. Furthermore, the Accident Investigation Board cannot see that Cessna has any factual basis for claiming that the fuel strainer was erroneously fastened with locking wire. As emerges from Figure 3, the fuel strainer was duly fastened with locking wire.

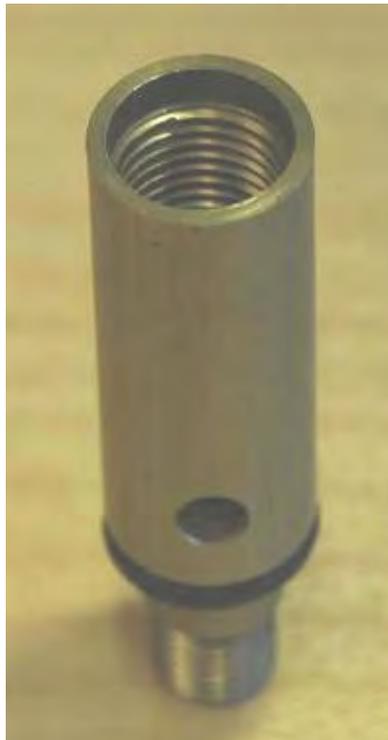
Figure 4: Standpipe (part number 0756036-2) with short thread section (inner threads starting 0.120" from the flange).

The engine stopped as a result of the fuel supply being interrupted when the bowl around the fuel strainer came loose. It was the connection between the standpipe and top assembly which became separated, and the AIBN believes that the too short thread sections constitute an unfortunate design feature. Minor wear to the threads can accordingly result in the parts becoming separated. During the period 1982 to 2000, Cessna delivered all single-engine aircraft with top assembly (0756039-6) in combination with standpipe (0756036-1 and 0756036-2), where the threads start some distance away from the flange. When the serious incident happened to LN-LVT, the aircraft was equipped with a standpipe with a short thread section. From 30th of Mars 2000, this type of aircraft was delivered with the same top assembly, but with a standpipe" (0756036-5) where the threads run significantly closer to the flange.

AIBN believes that standpipes with short threads should be replaced to provide a higher degree of assurance of the components not coming loose.

The joint between the top assembly and the standpipe in the fuel strainer came loose so that fuel supply to the engine was interrupted, resulting in the engine stopping just after take-off. Cessna has delivered several versions of the standpipe, of which 0756036-1 and 0756036-2 have short thread sections. The AIBN recommends that the EASA, who has given Type Certificate A.051 for the Cessna 172S, to consider the need for replacing the standpipes in question with a version with longer thread section.

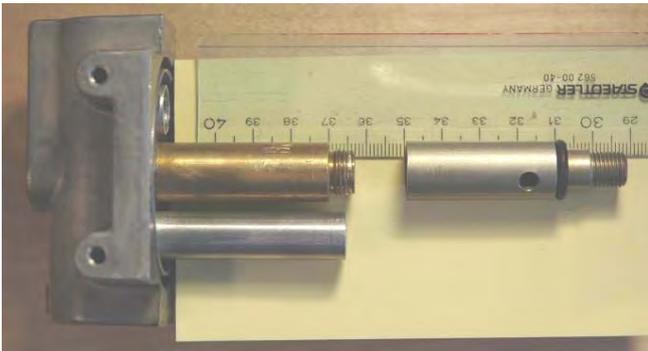
Figure 5: Top assembly with poor threads section. Standpipe to the right. (Note: scratch marks along the brass shaft are from after the incident.)

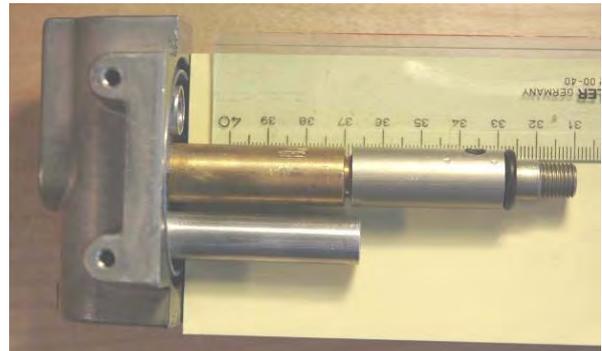
Figure 6: Remaining distance when the threads engage. (Note: Filter not shown, but shall be fitted between the two parts.)
