REPORT

SL 2011/25

REPORT REGARDING SERIOUS INCIDENT OVER
SVENSHEIA IN VEST-AGDER COUNTY, NORWAY
7 JANUARY 2006, AIRPROX BETWEEN SAS925
AND KLM1174

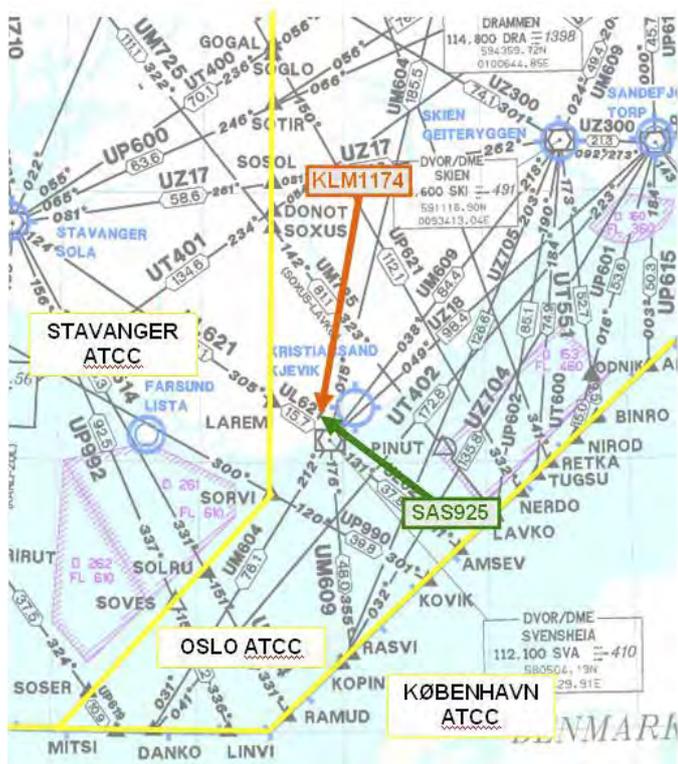
The incident took place at flight level (FL) 340, 2-3 NM north of Svensheia in Vest-Agder County. Svensheia (SVA) DVOR/DME is a key reporting point for en route traffic crossing Southern Norway. The air space is part of Oslo AoR, Sector Skagerrak.

Figure 1: Flights SAS925 and KLM1174 in Sector Skagerrak¹, Oslo ATCC.

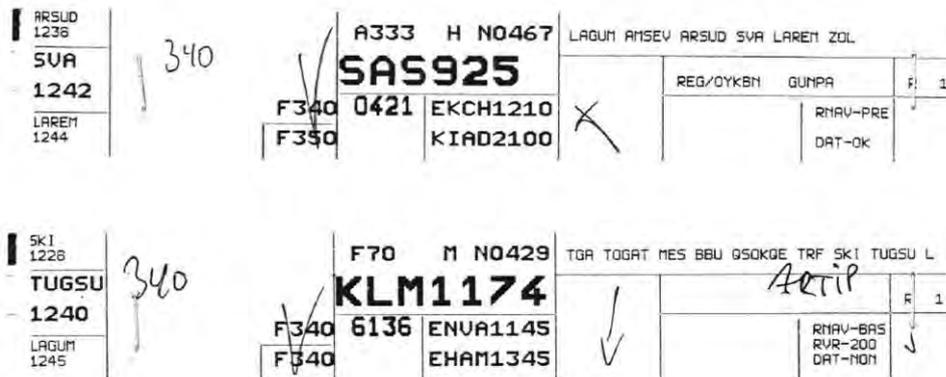
1.1.1.2 After the direct route "ARTIP" for KLM1174 had been coordinated by telephone with the air traffic controller (ATCO) in the adjacent sector, the ATCO in Sector Skagerrak wrote "ARTIP" on the Flight Progress Strip (See Figure 2).

1.1.1.3 The Copenhagen ATCC (ATCC) had recorded entry point KOPIN for flight KLM1174, but on the Flight Progress Strip it was recorded as TUGSU in Sector Skagerrak. Due to the discrepancy, the ATCO in Sector Skagerrak had the ATC assistant establish a telephone contact with the relevant ATCO at the Copenhagen ATCC. The ATCO in Sector Skagerrak was then involved in establishing a new exit point for the flight plan for KLM1174, so that the flight plan could be exchanged electronically between the two air traffic control centres.

Figure 2: Copy of relevant Flight Progress Strips.

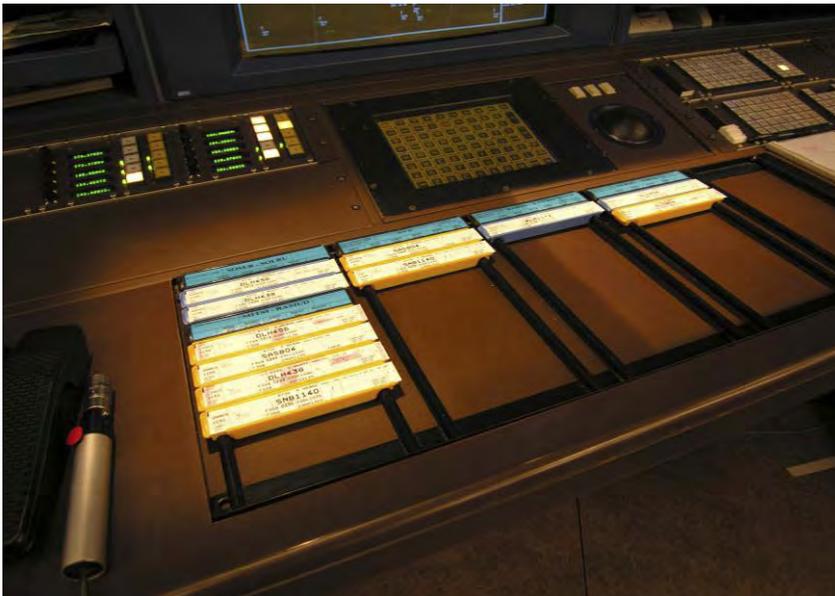
Figure 3: Showing the Flight Progress Board in Sector Skagerrak, with five sections, and the use of yellow and blue Flight Progress Strip holders (Note: The Flight Progress Strips are not from the actual incident).

2.4.2.3 Therefore, the Accident Investigation Board cannot see that the Flight Progress Board was a good tool in the air traffic controller's planning and conflict search. The number of Flight Progress Strips was inadequate for the existing conflict to be presented in a good manner. The sectioning of the Flight Progress Board was facilitated for point searches, and not zone searches, which could better have visualised flights assigned direct routes.

2.4.2.4 Avinor has, following the incident, changed the sections on the Flight Progress Board in Section Skagerrak. Zone search concept was implemented and regulations introduced stating that the air traffic controller must ensure that all flights are visualised with Flight Progress Strips in all zones that the flights enter. The Accident Investigation Board is of the opinion that Avinor has implemented suitable measures to improve presentation and detection of conflicts when using the Flight Progress Board in Sector Skagerrak, and therefore waive any recommendations to this regard.

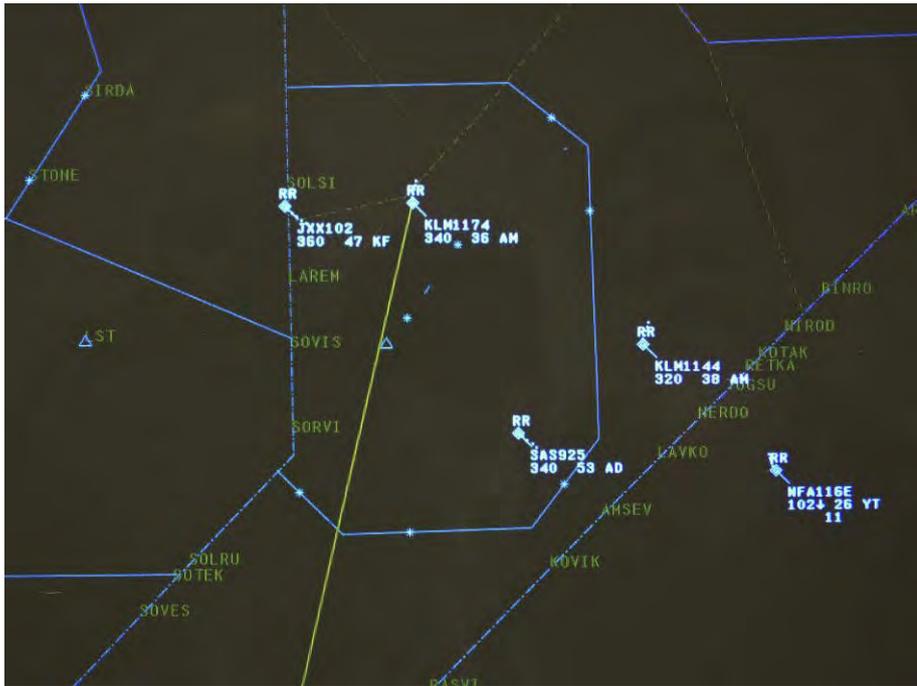
- 1.1.1.9 At the same time, a third aircraft, with call sign KLM1144, was in Sector Skagerrak (see Figure 4). KLM1144 flew at flight level 320. The aircraft was in the process of leaving Sector Skagerrak in south by southwest direction, when the ATCO at 1341 hours instructed the flight crew on KLM1144 to switch to the relevant Copenhagen ATCC radio frequency.

- 1.1.1.10 A fourth aircraft, with call sign JXX102, was in the process of leaving the sector westwards at flight level 360 (see Figure 4). This flight had received revised flight level from 320 to 360 by Copenhagen ATCC.

Figure 4: Section of radar image at approx. 1340 hours. Flight KLM1174 and SAS925 are on crossing courses at FL340. The air traffic controller had prepared distance and direction (yellow line) from KLM1174 in the direction of reporting point “ARTIP”. JXX102 flies at FL360, and is exiting Sector Skagerrak westwards. KLM1144 flies at FL320, and is exiting the sector in a SSW direction.

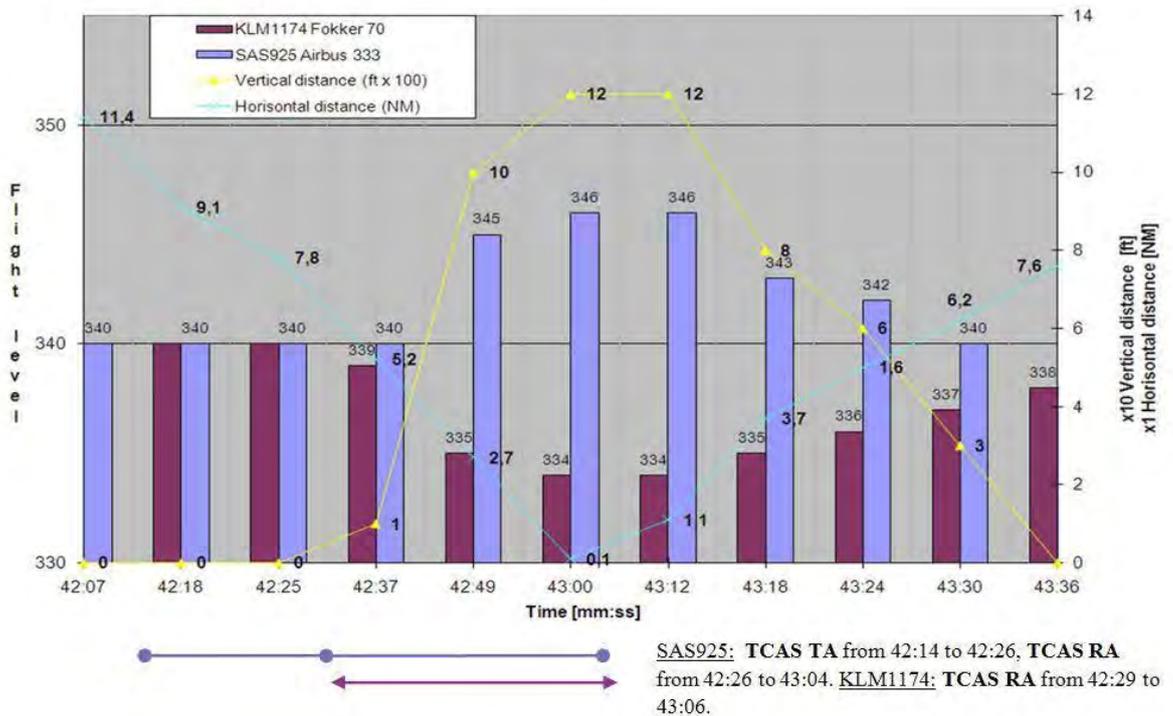
1.1.3.2 Reading of FDR data shows that the TCAS RA descend instructions lasted for 37 seconds (from 13:42:29 - 13:43:06 hours). During descent ground speed was reduced from 359 kt to 355 kt. KLM1174 descended to pressure altitude 33 329 ft. - a decrease of 690 ft.

Figure 5: The blue and purple columns show how SAS925 and KLM1174 respectively responded to their TCAS RA instructions. Vertical separation of 1 000 ft. was achieved at 13:42:49 hours. The horizontal distance was then 2.7 NM. The aircraft passed almost right above each other. The smallest horizontal distance between the aircraft was 0.1 NM (12:43:00 hours). The vertical separation was then 1 200 ft. Note: The scale is not constant as regards number of seconds between each column.

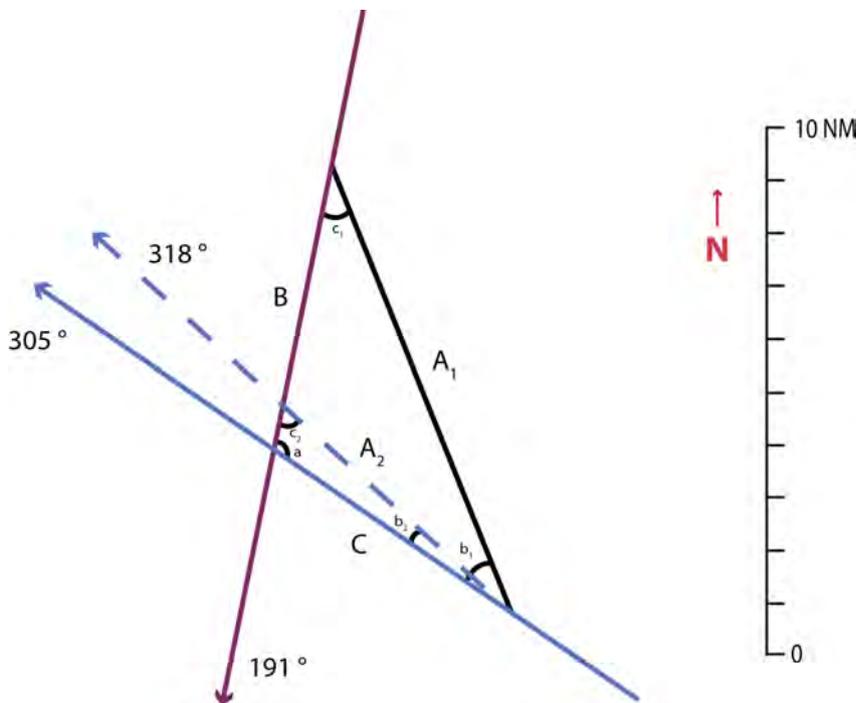
When the air traffic controller became aware of the conflict, the aircraft were, according to radar data, approx. 8-9 NM apart. Figure C shows the distance between the aircraft at this time, a line with a distance of 9 NM (A_1), and the respective magnetic headings of the aircraft (305° and 191°) form a triangle. The opposing angle to the 9 NM long line is estimated to 114° ($< a$). If none of the aircraft had changed horizontal courses or altitude, the point in this angle would have been the convergence point for the two flights. When using the sinus proportion¹³ we find that SAS925 had 5.2 NM left before the convergence point, whereas KLM1174 had 5.5 NM left.

Figure C: Estimated convergence point for SAS925 (blue magnetic heading) and KLM1174 (purple magnetic heading), if the altitude, flight level 340, and courses had remained constant.
