REPORT

SL 2012/01

REPORT ON AIRCRAFT ACCIDENT IN SIRDAL, VEST-AGDER, NORWAY ON 28 MAY 2010 INVOLVING CIRRUS SR20, LN-BCD

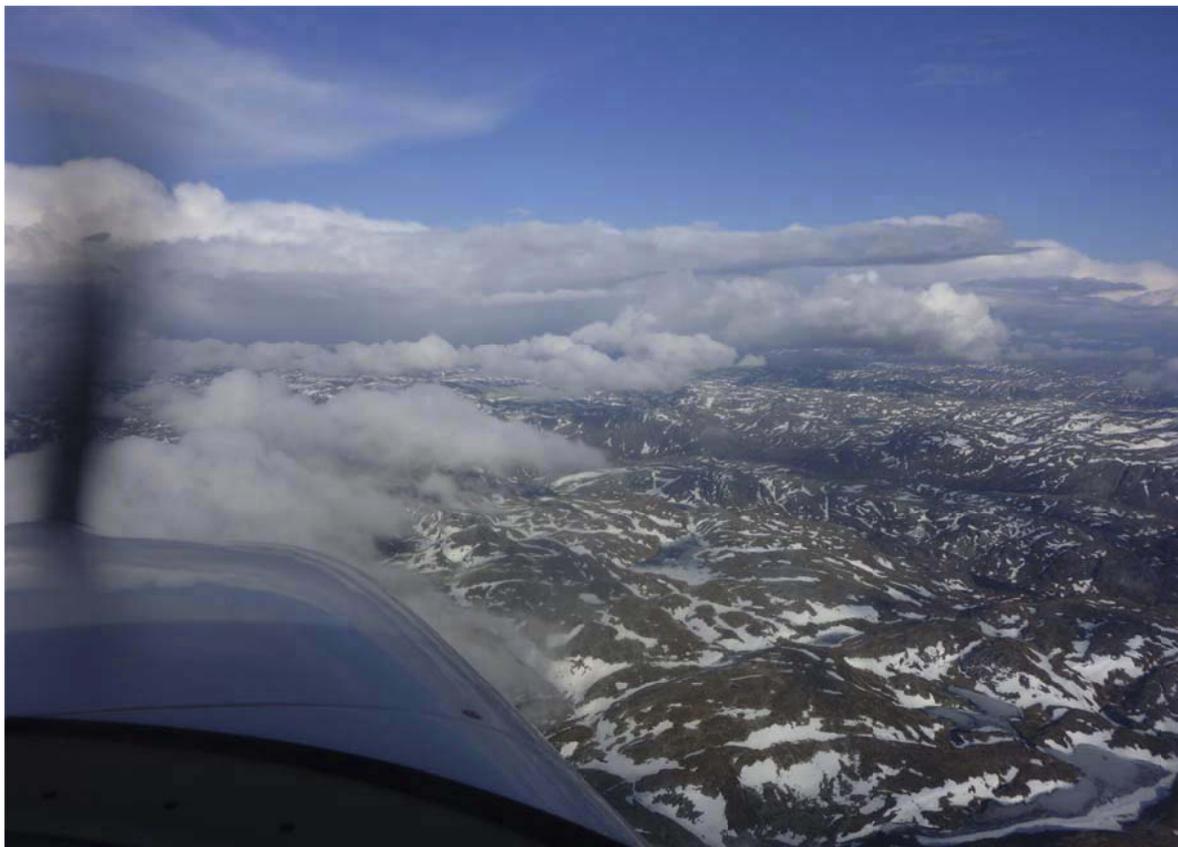
- 1.1.6 The pilot had access to relevant, decoded METAR and TAF for Torp and Kjevik on his smartphone while flying (Aeroweather application). He was aware that there were a lot of squalls in the area. The recorded radio correspondence shows that scheduled flights in the area requested course corrections to avoid the cumulonimbi and that a light aircraft flying VFR along the coast clearly struggled to stay VMC (visual meteorological conditions).

Figure 1: Photo taken at 18:54:24 hrs on the trip in question (about 12 minutes before the incident).

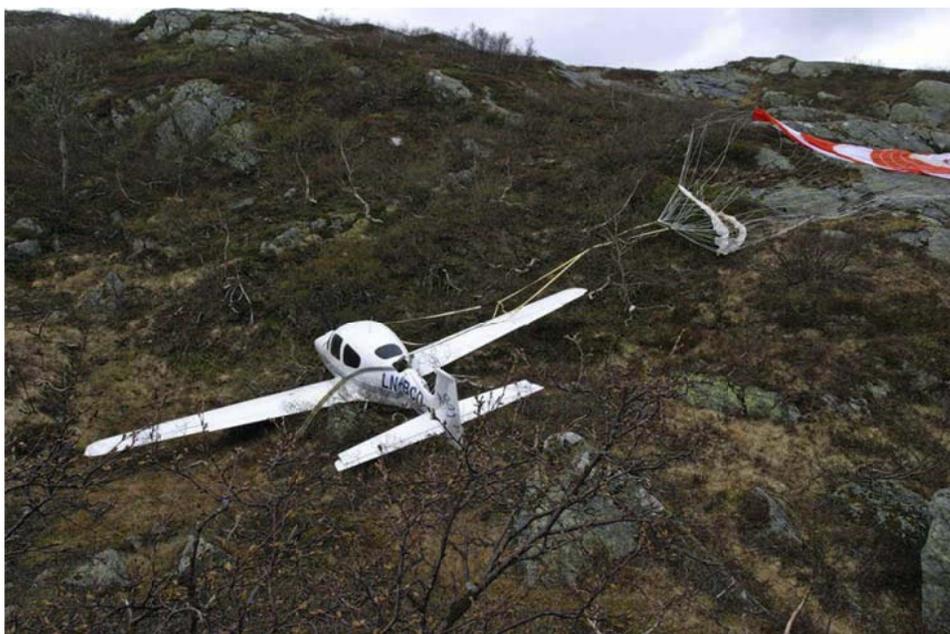
Figure 2: LN-BCD at the crash site on the day following the accident.
(Photo: The Police)

1.12.2.1 When the Accident Investigation Board examined the wreckage on the day after the accident, it was established that the fuselage (tail boom) had broken off behind the rescue parachute. The nose leg had broken, the propeller had hit the ground and the left wheel fairing was damaged. The lower cowling, left flaps and underside of the left wing were damaged. There were holes in the left fuel tank.

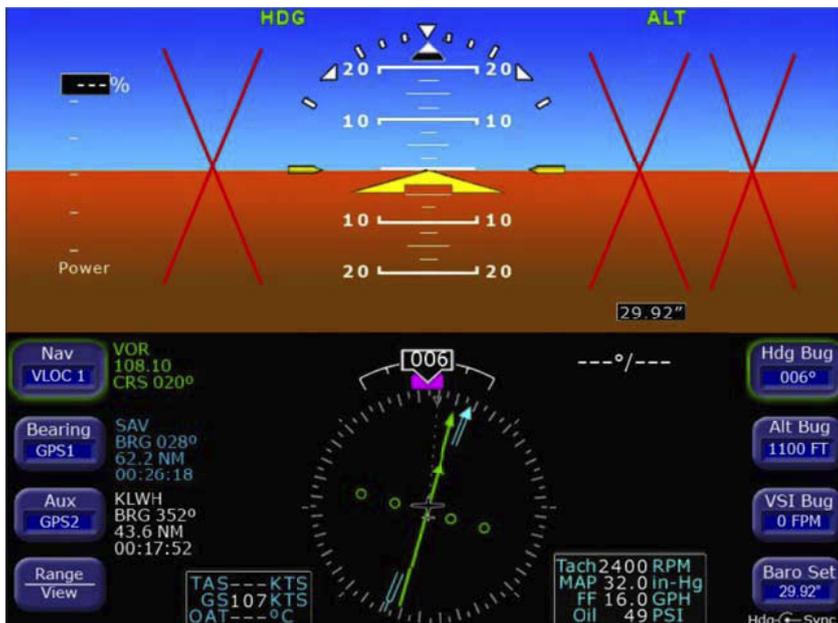
- 1.1.10 The pilot understood that the aircraft was stalling. He could not remember hearing any stalling warning. On the screen in front of him where the aircraft's speed, vertical speed and altitude are normally displayed, there were only three red X's (see Figure 3)

- 1.6.2.2 Should the PFD lose access to “air data” from pilot /static system, a red X will be shown on the screen instead of values for air speed, altitude and vertical speed, cf. Figure 3. In such cases, the pilot is assumed to refer to back-up instruments (conventional air speed indicator and altimeter)³.

Figure 3: Illustration of how PFD may look in the event of loss of air data. (Source: Entegra Cirrus EXP5000 Pilot's Guide)

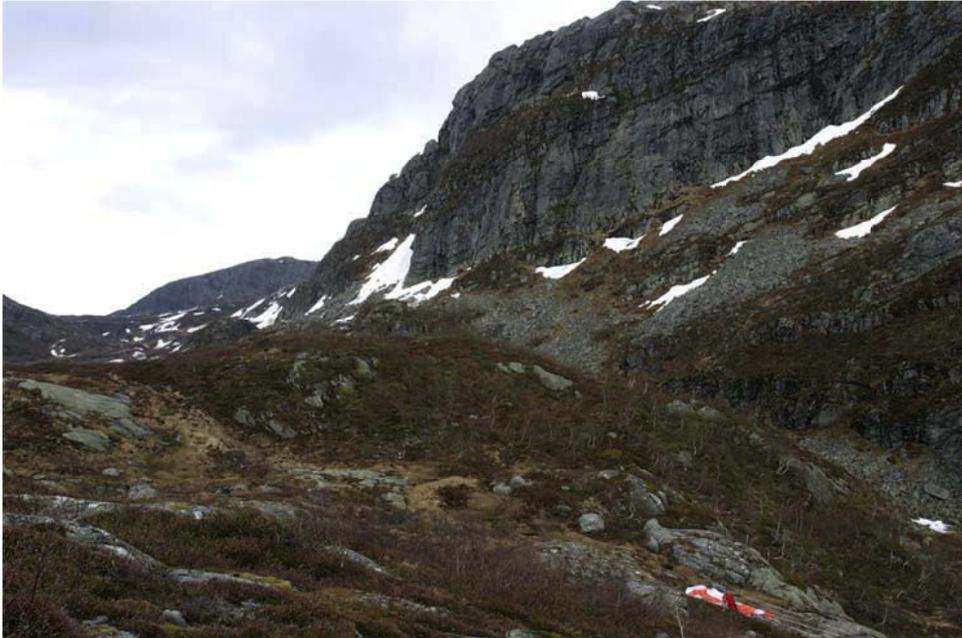
The crash site is situated in the Ørnefjell area in Sirdalsheiane, about 7 km north of Ådneram tourist cabin. The mountains in the area peak at 950-1 200 metres above sea level. (3 100 - 3 900 ft). The aircraft came down in a ravine where the ground was at about 770 AMSL (2 550 ft), see Figure 2 and Figure 5.

Figure 5: The area northeast of the crash site. The rescue parachute is visible in the bottom right of the picture.
