SL 2013/11

REPORT ON AIR ACCIDENT AT MOSS AIRPORT RYGGE, NORWAY, 16 JULY 2008 WITH EUROCOPTER AS 350 BA, LN-ORK

Type of incident: Air accident, fractured rotor head Starflex in connection with autorotation landing

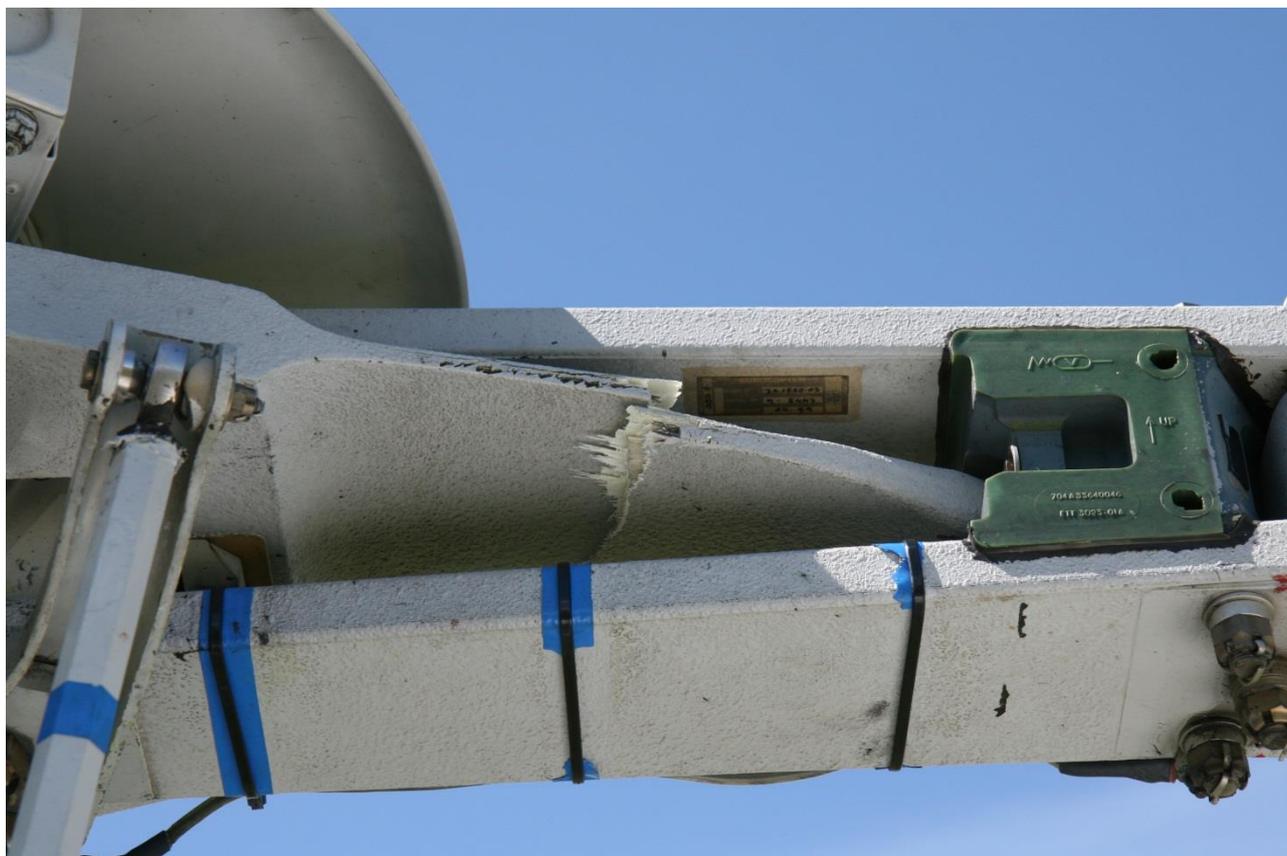
Damage to aircraft: A break in rotor head (Starflex) and "rubbing-damage" inside the engine

The instructor helped out with the controls, but this did not prevent the landing from being somewhat harder than normal. When white smoke was observed coming from the helicopter in connection with the landing, the personnel in the tower contacted the crew to hear if everything was OK. The engine was shut down; the electricity turned off and after an external inspection of the helicopter that did not reveal any problem, the helicopter was restarted. To fly it away from the runway it was lifted up in hover position. Straight away the crew noticed low-frequency vibrations and they landed the helicopter on the grass about 30 m to the right side of the runway. An inspection of the helicopter after landing revealed that the rotor head was seriously damaged with a fracture in the Starflex (see Figure 1).

Figure 1: Rotor head with a fracture in Starflex.
