REPORT

SL 2010/18

REPORT ON SERIOUS AIRCRAFT INCIDENT AT OSLO AIRPORT GARDERMOEN 25 FEBRUARY 2010 INVOLVING AIRBUS A320-214 VP-BWM, OPERATED BY AEROFLOT RUSSIAN AIRLINES

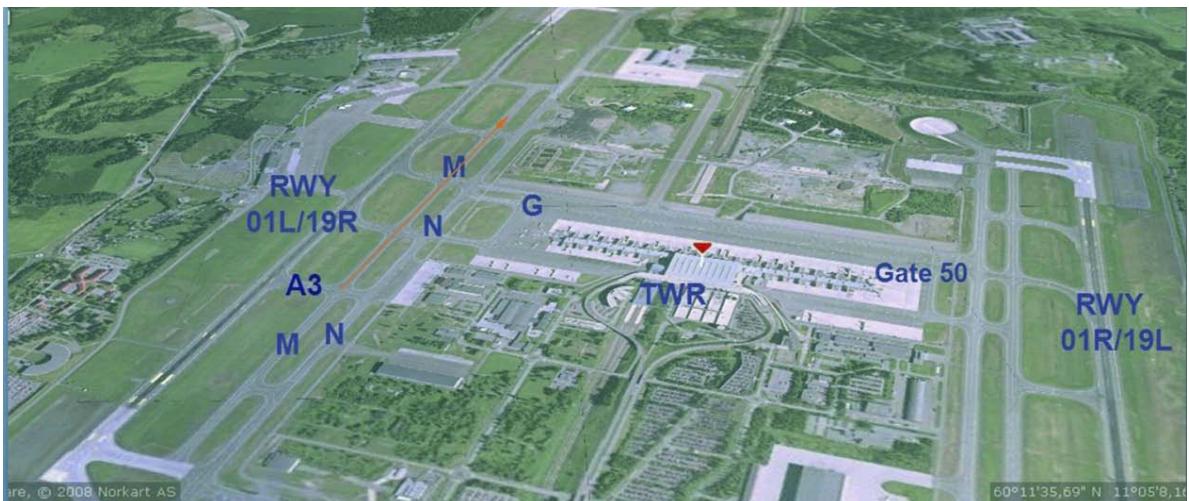
- 1.1.30 Playback of the aircraft's FDR data shows that the aircraft lifted its main wheels from the surface (lift-off point) at 15:19:07 hours, and that the achieved speed at this time was 149 kt. By applying the FDR data in the form of "start of take-off roll" and "lift-off point" it emerges that the distance used by the aircraft before the main wheels lifted from the ground was 1 245 m. The available taxiway length was 1 652 m (see Chapter 1.10.1.7). This means that 407 m remained to the end of the taxiway.

*Figure 1: Oslo Airport Gardermoen, (ENGM). The orange line indicates where the aircraft took off northbound on taxiway M, instead of on runway 01L, west of taxiway M.
See also the copy of Jeppesen's airport map in Appendix B.*

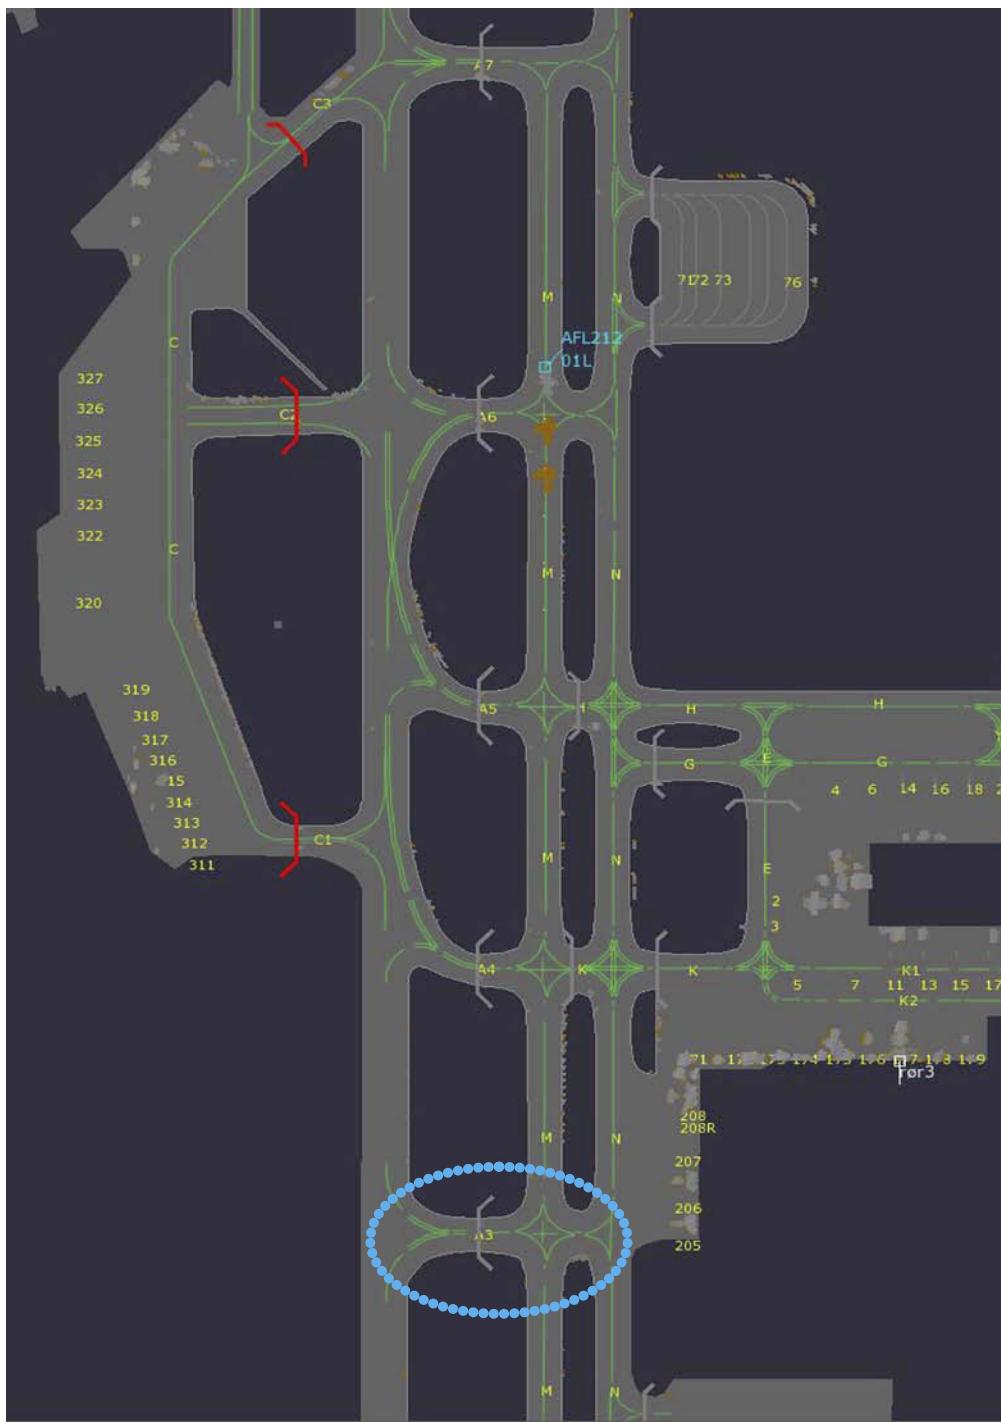
**Picture 1**

1.10.9.5 At the time of the incident, there were no lit stop bars between the main terminal and the western and eastern runway. The stop bars for holding positions C1, C2 and C3 for runways at the GA terminal were, however, were lit, as they always were, regardless of visibility conditions (see Appendix C, picture 1).

The figure shows a section of the ground monitoring system at Gardermoen (A-SMGCS). The intersection A3 – M – N is marked with a blue dotted ring. The aircraft (gray shadow) with blue label "AFL212" can be seen south of de-icing platform A-North. The aircraft's main wheels had at that time left the ground. The picture shows that there were no other aircraft or vehicles nearby. The picture also shows that all taxiway lighting had been turned on, and that the stop bars were only lit in holding positions C1, C2 and C3.

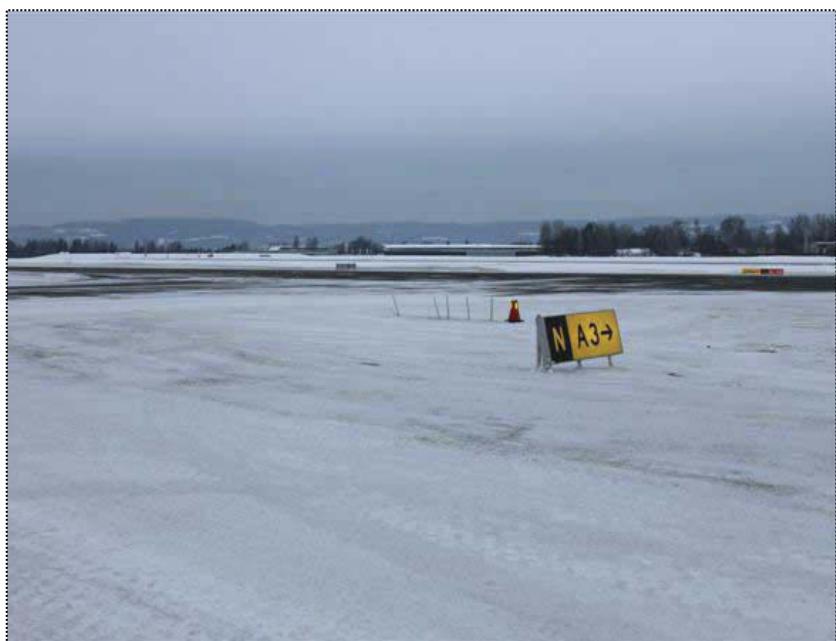
Picture 2

- 1.1.14 The commander, who controlled the aircraft, observed the sign on the right-hand side stating that they were on taxiway N and that intersection A3 was the first on the right. There was nothing indicating that taxiway M was between the taxiway N and holding position A3. First to the right was also taxiway M (See Appendix C, picture 2).

The picture was taken at ground level about one hour after the incident. The black field on the picture is taxiway M, and the piece of asphalt between taxiway N and M. (Taxiway N is not shown, only snow-covered field on the taxiway shoulder). The sign in front is on the right side of taxiway N, and shows that A3 is the first exit to the right. The sign gives no information about taxiway M being between N and A3. Photo: OSL

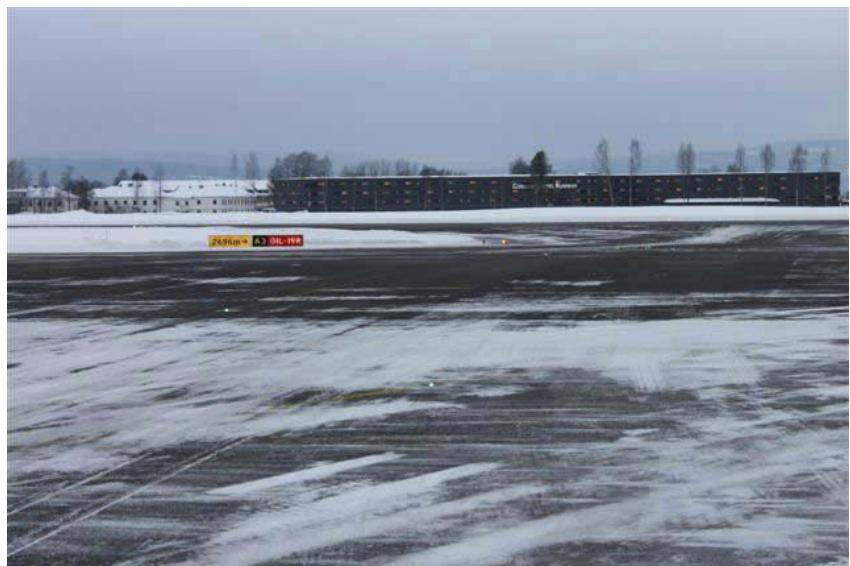
Picture 3

- 1.1.15 The commander stated in his interview with the Accident Investigation Board that he observed that there was less snow on taxiway M than on taxiway N, and that he interpreted this to mean that he was taxiing onto a "black" runway (see Appendix C, picture 3).

- 1.10.5.5 All holding positions had red and white "RWY AHEAD" markings. From the pictures taken the same day, the painted field appeared to be worn. It was also partially covered by snow. (See Appendix C, picture 3).

Although the "RWY AHEAD" markings on the ground were worn, the red and white paint on the ground was probably visible from the cockpit.

The picture has been taken at ground level about 1 hour after the incident, and shows the area towards holding point in A3. "RWY AHEAD" can only be glimpsed in the holding position. The picture shows the left intersection take-off sign in A3, which indicates the take-off runway available (TORA) of 2 696 m. The green taxiway lights can be glimpsed, as can the flashing runway guardlights. The stop bar is not lit. Photo: OSL

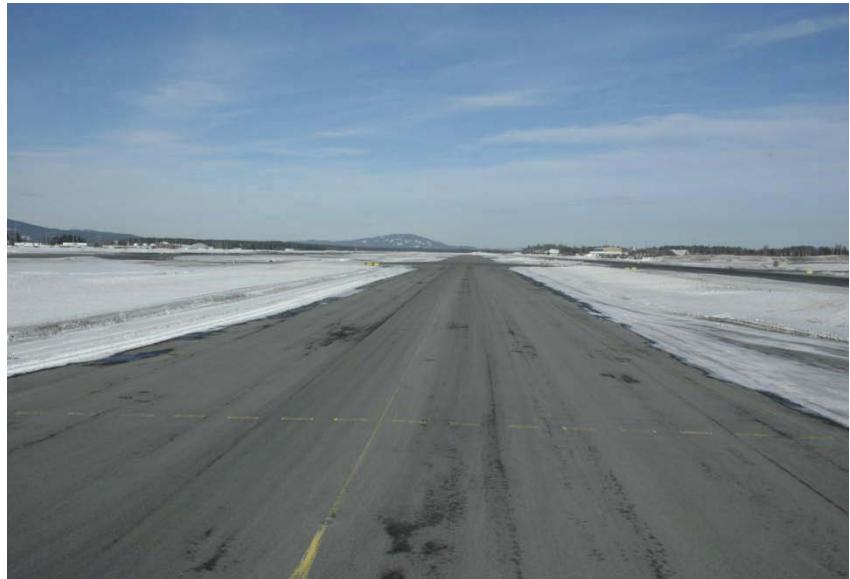
Picture 4

- 1.10.6.1 On 9 March 2010, 12 days after the incident, two accident investigators from the AIBN inspected the area at Oslo Airport. The AIBN investigators used a vehicle with a lift in order to observe the area from the same height as the crew in the cockpit of an Airbus A320, i.e. approx. 4 m over the ground. The accident investigators visited the areas taxiway N-M-A3, as well as the corresponding area on the east side of S-T-B6, to assess the visual aids available to the flight crew in the form of markings, signs and lighting. It was furthermore observed that the "RWY AHEAD" markings on the ground in holding position A3 were worn, but more visible from 4 metres up than on the ground.

The picture was taken during the Accident Investigation Board's inspection at Gardermoen on 9 March 2010, and shows taxiway M looking northwards from A3. The picture was taken from a height of 4 m above the ground (Airbus A320 cockpit height above ground). There was a thin layer of snow on the taxiway on 25 February, but the commander saw the yellow taxiway markings. Photo: AIBN.
