SL 2012/14

REPORT ON SERIOUS AVIATION INCIDENT AT HØNEFOSS, NORWAY 10 JUNE 2007 WITH REIMS AVIATION SA F182Q, LN-HOA

Date of issue: 02.11.2012
SL Report: 2012/14

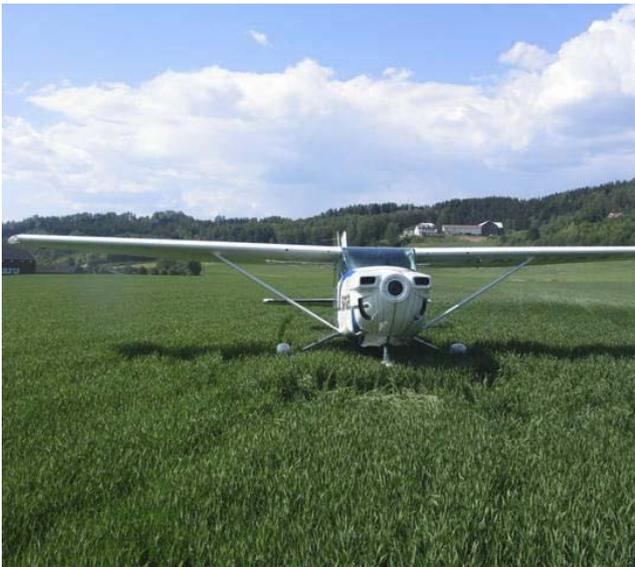
The engine did not start, and the aircraft commander registered that she was unable to see the propeller as expected when it moves more slowly/ ceases to turn. The aircraft commander aimed for a dead stick landing at the airport. She made a radio call on the Eggemoen frequency and said that they were approaching for landing without engine power. After a while she realised that they did not have sufficient height to reach the plateau on which the airfield is located. She therefore chose a lower-lying field approx. 1 km south of the airfield, which she knew was free of overhead cables, and turned east to reach it. The descent rate and speed was as for a standard approach: approx. 500-600 ft/min at approx. 80 KIAS. She set full flaps just before landing. The surface was dry and flat, covered in approx. 20 cm high, soft grass. The touchdown and landing roll went without problems, and the aircraft came to a halt after approx. 250 m (see fig. 1).

Figure 1: Landing site.

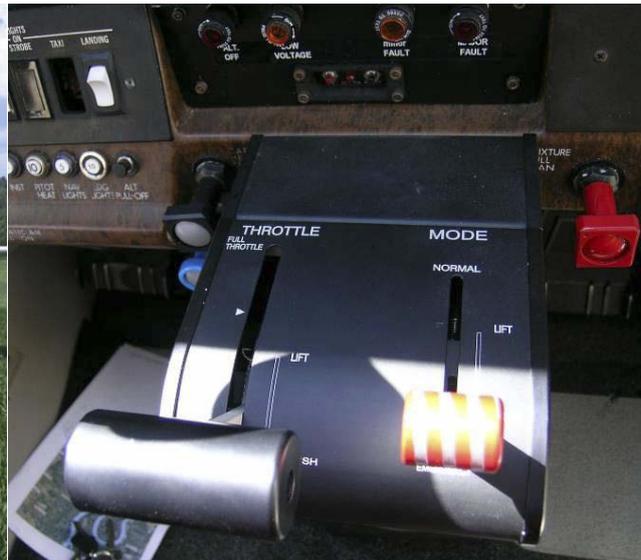
There were some thermal up-currents as a result of the weather. The aircraft commander has explained that she registered some minor vibrations in the aircraft as they were bypassing Hønefoss northeast of the centre. She pulled the throttle back a few millimetres, whereby the engine power would normally have been considerably reduced, but which had no effect whatsoever in this particular case. After a second or so, everything went quiet and the aircraft commander immediately implemented the procedure for restarting the engine after stoppage. The procedure involves pulling back the throttle and moving the mode handle from the normal mode to the emergency mode, so as to override the automatic adjustment of propeller pitch and fuel supply according to throttle position. Afterwards, the throttle must be pushed slowly forward so as to start the engine by windmilling the propeller. The aircraft commander observed that neither the orange warning light for “minor fault” nor the red warning light for “major fault” lit up (see fig. 2).

Figure 2: Throttle, mode handle and warning lights.

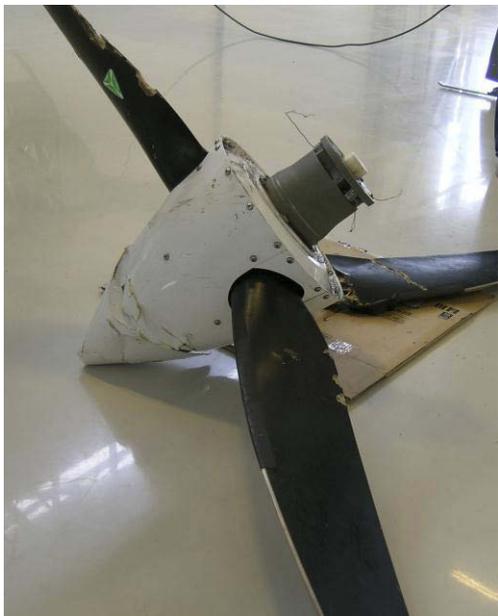
Figure 3: The propeller in the state it was found.

Following the accident a search for the propeller was initiated and it was found after three days. The propeller was found with three of the bolts still attached to the propeller flange and secured by locking wires as described in the assembly instructions. The corresponding mounting flange on the engine side is supported by the crankshaft.

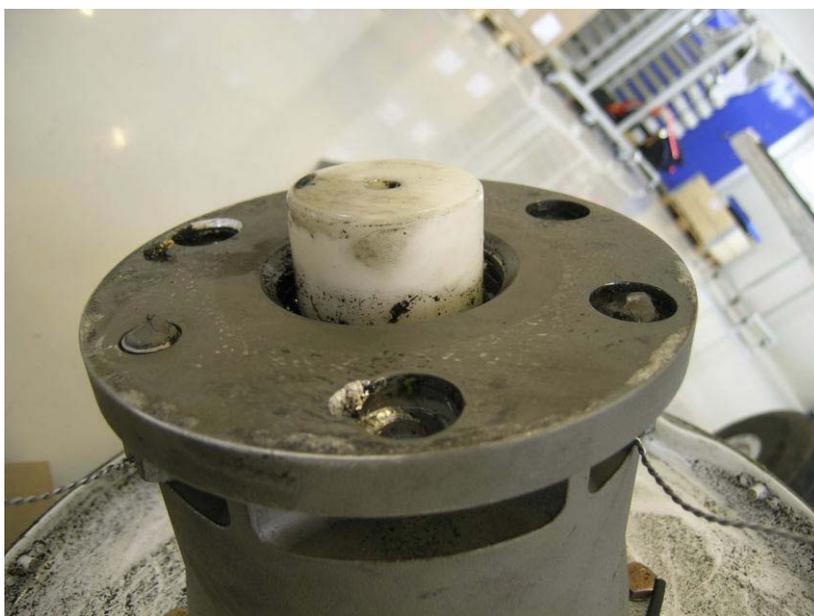
Figure 4: The propeller's mounting flange on which two of the Three remaining bolts can be seen. The locking wires are still attached to the bolt heads. Minor fretting marks can be seen on the outer diameter.

Three bolts – bolts nos 1, 3 and 5, were found in the propeller flange, see fig. 4. The remaining parts of these bolts were left in place in the propeller flange. These bolts are positioned right next to the three propeller blades, while the other three are in intermediate positions directly opposite the blades.

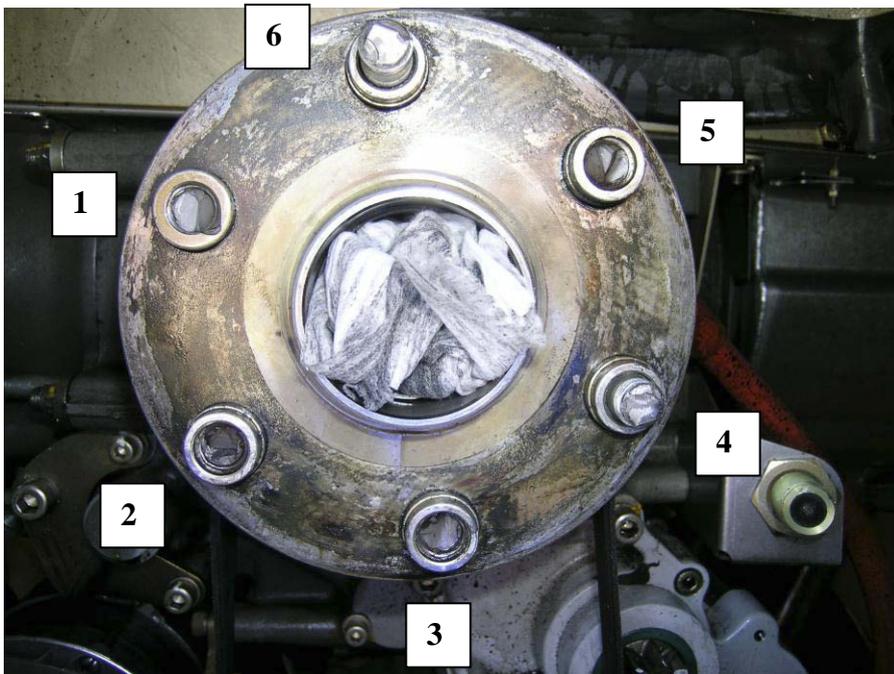
The crankshaft flange has six guide studs, designed to pass through the starting gear ring and into the propeller mounting flange. One of the six guide studs is shorter than the others and passes through the starting gear ring only. At the centre of each guide stud is a threaded hole for fitting the bolts attached to the propeller flange. Parts of the bolts were found in each the treaded holes. These bolts were removed and photographed, see figures 5 and 7, and figures 2 and 3 in appendix A. The bolts left in the propeller were also removed. In order to do so, the propeller was brought to AIBN's premises where the propeller hub was cut apart. Fretting is normally a result of loose connections. The contact surfaces showed some fretting, but no significant. The starting gear ring was found inside the aircraft's engine cowling. The starting gear ring is made of anodised aluminium. There was no significant fretting damage to this component either. One of the holes had a torn off edge and there was quite a deep imprint on the opposite side.

Figure 5: The flange on the engine crankshaft, showing the bolts in the state that they were observed when the aircraft had landed. The bolts were numbered as shown in the photo. Minor fretting marks can be seen on the outer diameter. Guide 1 is the shorter one.

The bolts were numbered from 1 to 6, see fig. 5. There were major similarities between the fracture surfaces of bolts 2, 4 and 6. Bolts 2 and 4 had fracture surfaces on both sides of the flange and, in bolt 6, a crack had been initiated which, if subjected to continued load exposure, would have caused the same chain of events as in bolts 2 and 4. All these bolts had broken, so that the fitted nuts (bolt heads) had come loose and were lost.

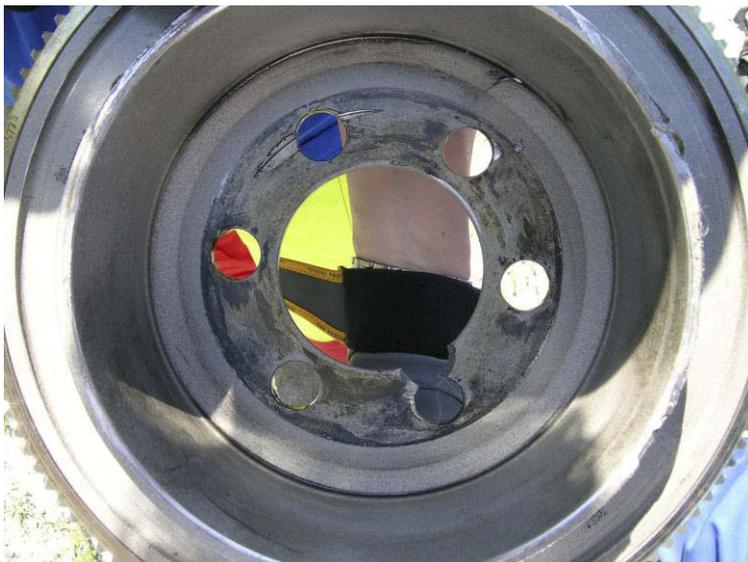
Figure 6: Starting gear ring with fretting and imprint from tilting.

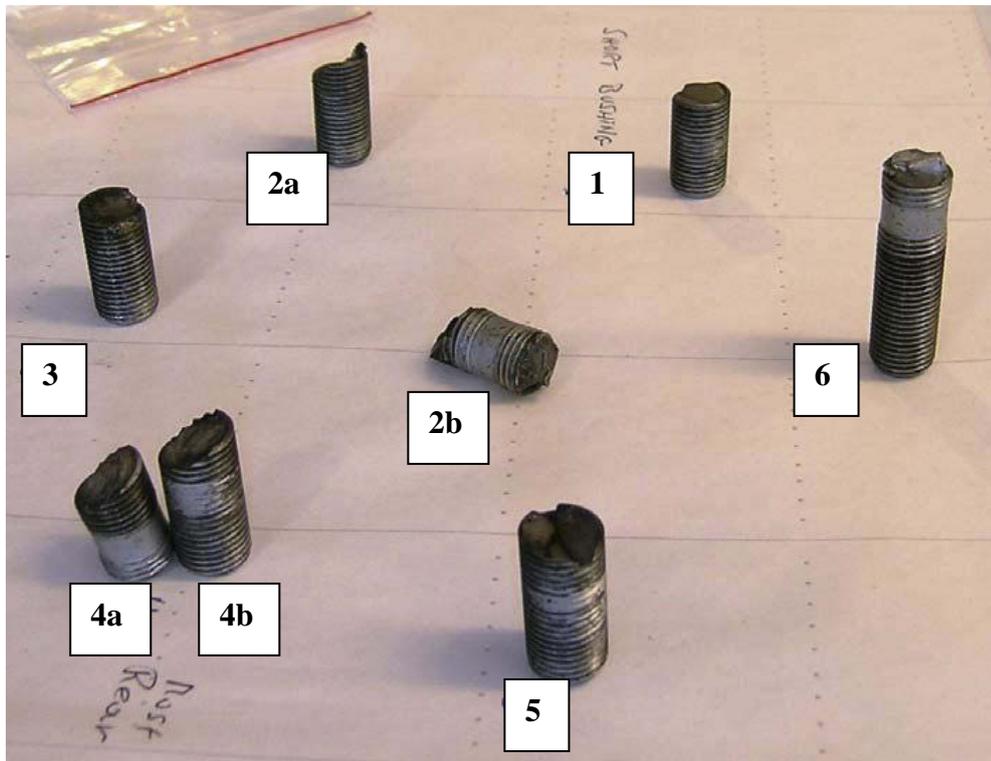
All the fractures were initiated at the root of the threads.

Figure 7: The bolts that were removed from the engine flange. Bolts 1, 3 and 5 have similar fracture pattern and different from 2, 4 and 6 which together have similar fracture pattern.

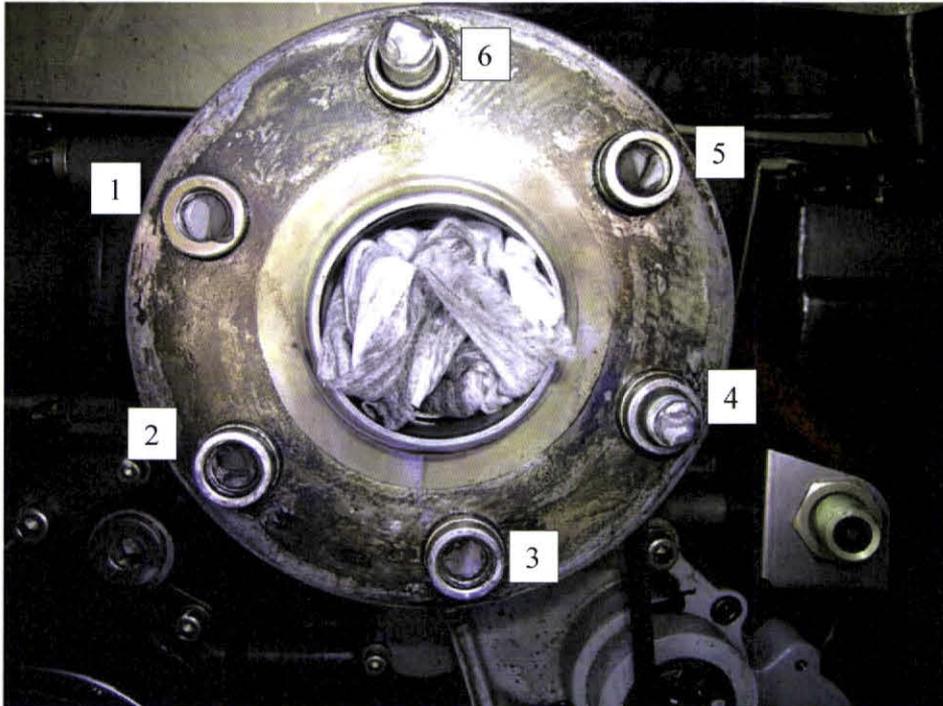
A picture of the fractured bolts as observed on the airplane is shown in Figure 2. The bolts are numbered for identification through the investigation. An overview picture of the bolts is shown in Figure 3. Bolts 2 and 4 showed two fractures and are identified as 2ab and 4 ab respectively. Three bolts were later found on the propeller, and these bolts are shown in Figure 4. Bolts 2 and 4 had fractured at two different locations. An additional crack was later observed on bolt 6, the crack was forced opened in the laboratory and the fracture surfaces added to the investigation.

Figure 2 Picture of fractured bolts still mounted on the aircraft. Picture from AIBN.

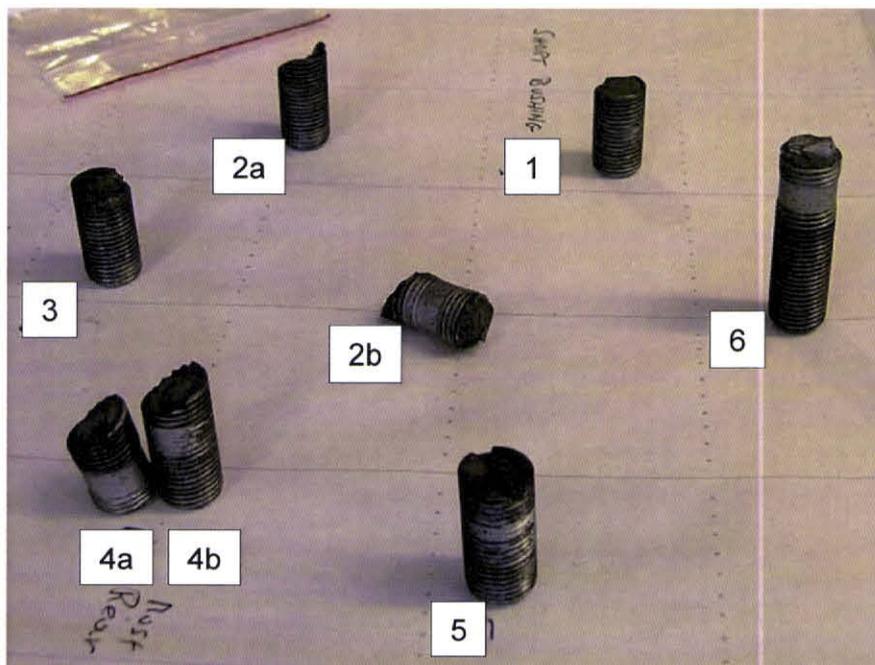
Figure 3 Overview picture of bolts after dismounting.

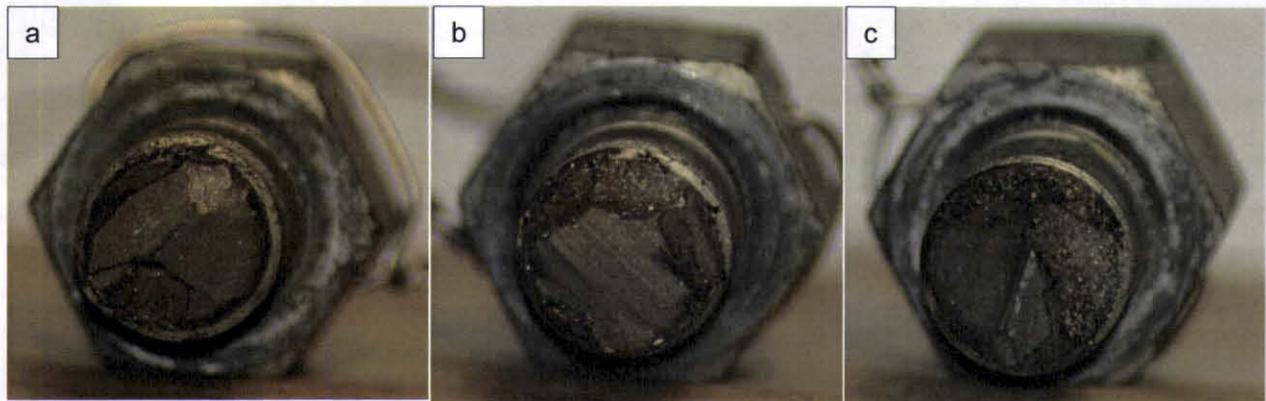
Figure 4 Picture of fractured bolts dismantled from propeller. a: Bolt 1, b: Bolt 3, c: Bolt 5, see Figure 2 and 3.

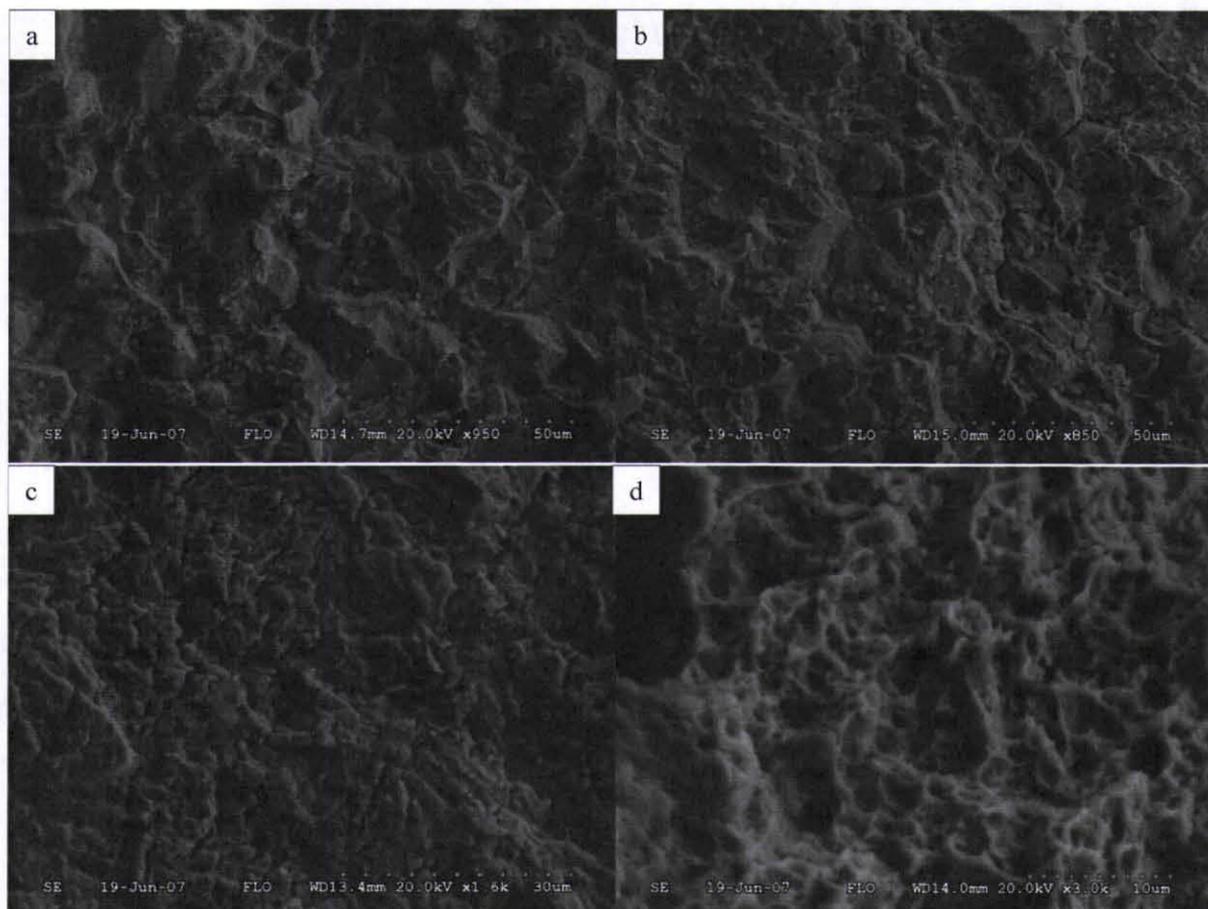
The fracture surfaces were characterised using SEM in order to reveal mechanisms for the crack propagation. In general the fracture surfaces show a mixture of intergranular and fatigue crack propagation. Several cracks seem to have initiated from areas showing a brittle intergranular fracture surface. As the crack has developed, characteristics typical for fatigue is readily observed. The final fracture when observed is very small and ductile indicating low loading at the time of the final fracture. Characteristic pictures of the fracture surface for bolt 6 are shown in Figure 5, pictures obtained from all six bolts are shown in Appendix 1.

Figure 5 Representative picture of fracture surface as observed in SEM for bolt 6.

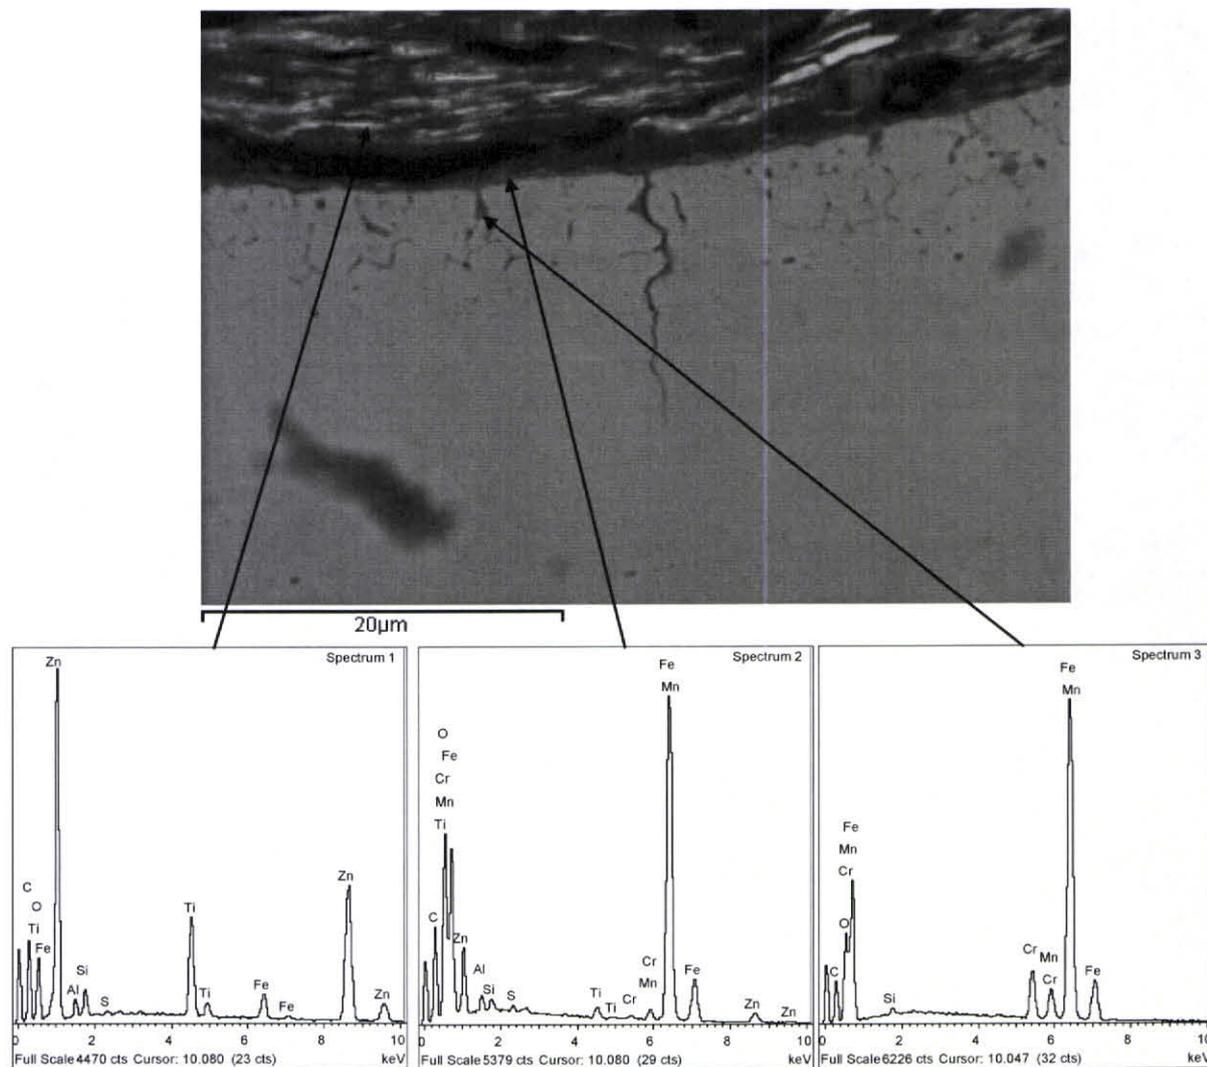
A cross section was made through bolt 4a, see Figure 3, the specimen where mounted and processed for metallographic examination including SEM equipped with EDS. Figure 6 show a picture of the cross section through one of the thread roots. The picture and the attached EDS spectrums show that the bolt has been coated with a zinc based corrosion protective layer, the bolt surface is however covered with a iron oxide layer, further chromium rich particles are readily observed along the grains at the base material towards the surface. The picture also identifies what appears to be a small crack. Figure 7 show a picture at lower magnification of the same area shown in Figure 6, the picture show two additional possible crack initiations and an uneven distribution of the zinc based coating. Figure 8 show two pictures of the cross section through fracture surface of bolt 4a in Figure 3. The pictures show a rough intergranular surface appearance with indications of small secondary cracks. Further the images and EDS spectrums in Figure 9a-c show traces of corrosion products and micro cracks within the cross section of the fracture surface. The hardness profile shown in Figure 10 did not reveal any major variations in the hardness through the cross section of the bolt. The microstructure of the bolt base material is shown in Figure 11 and consists of tempered martensite. The bulk hardness was measured to be 43 HRC.

Figure 6 Picture of cross section through fractured bolt number 4a in Figure 3. The attached EDS spectrums show: Spectrum 1 Zinc based corrosion protective coating. Spectrum 2 Oxides at the coating/base material interface. Spectrum 3 Chromium rich particles along grain boundaries.

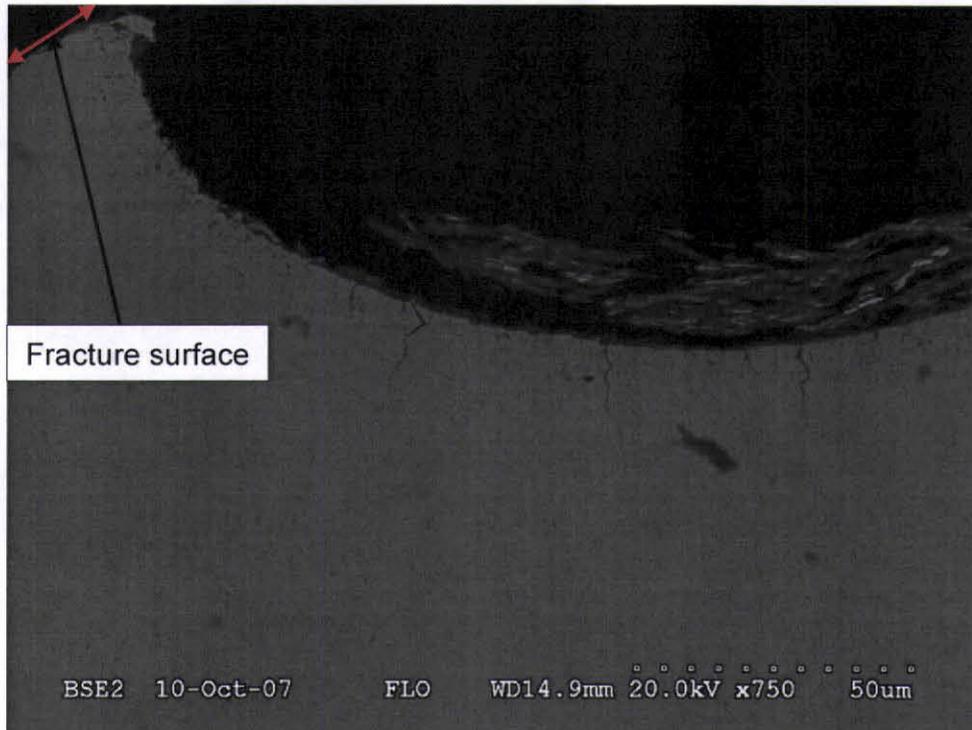
Figure 7 Picture of cross section through thread root close to the bolt fracture. Area also shown in Figure 6.

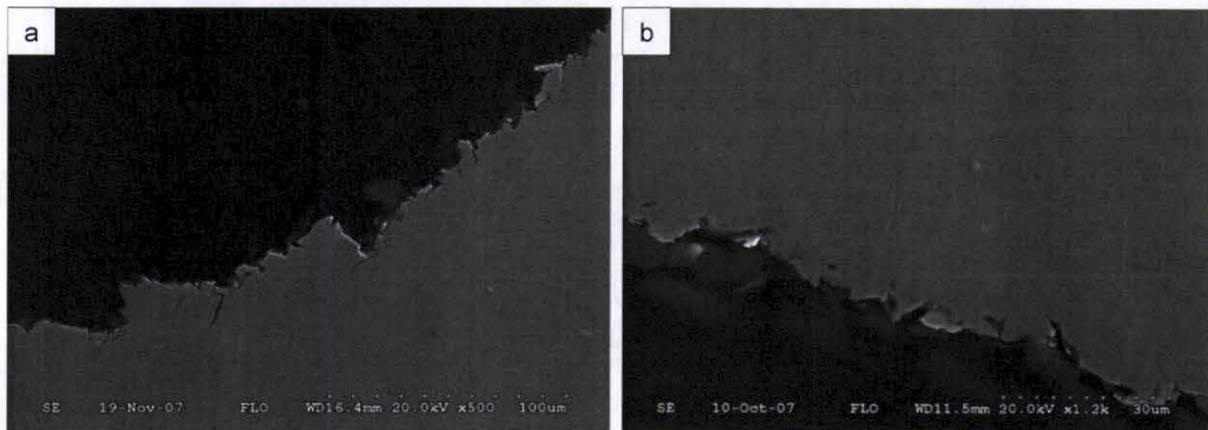
Figure 8ab Picture of cross section through fracture surface 4a in Figure 3.

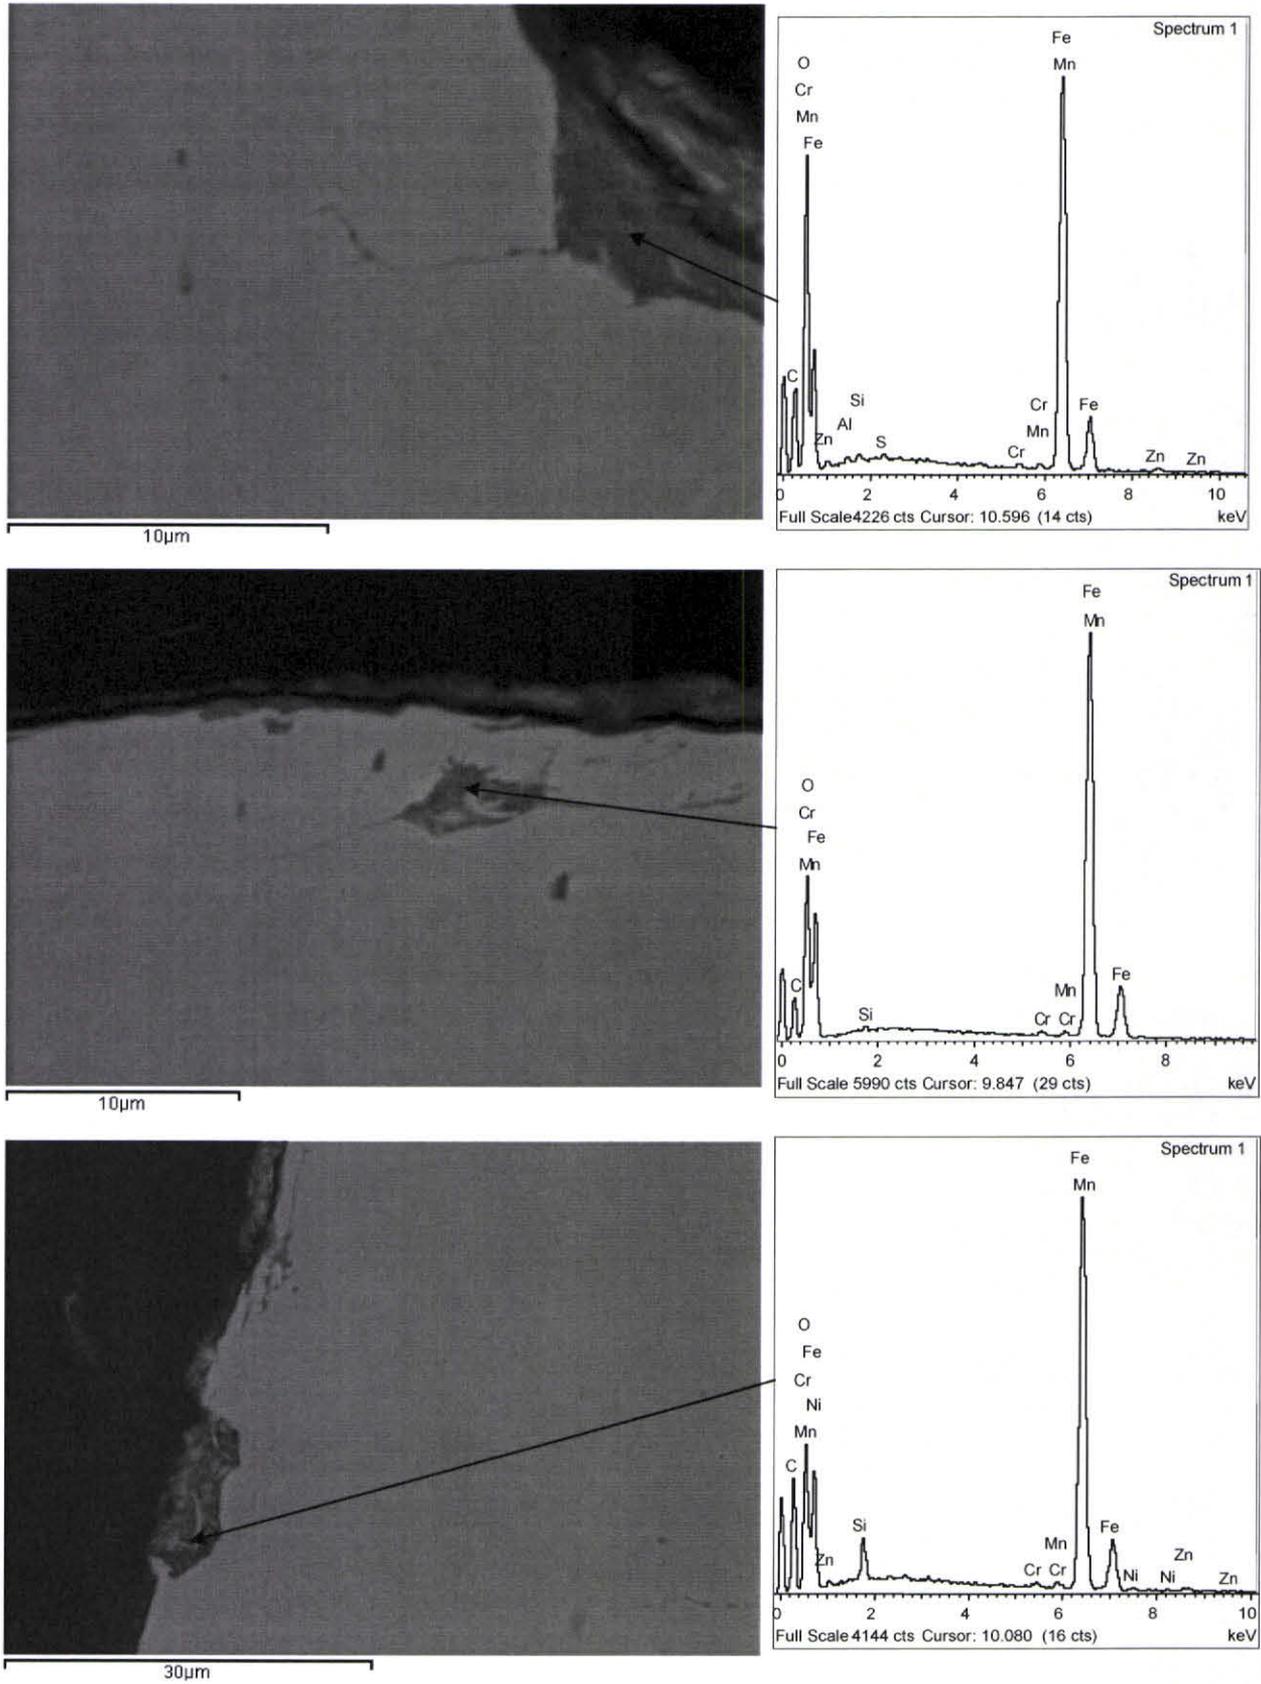
Figure 9 a-c Picture from the cross section of fracture surface 4a in Figure 3 with EDS spectrums showing traces of iron oxides.

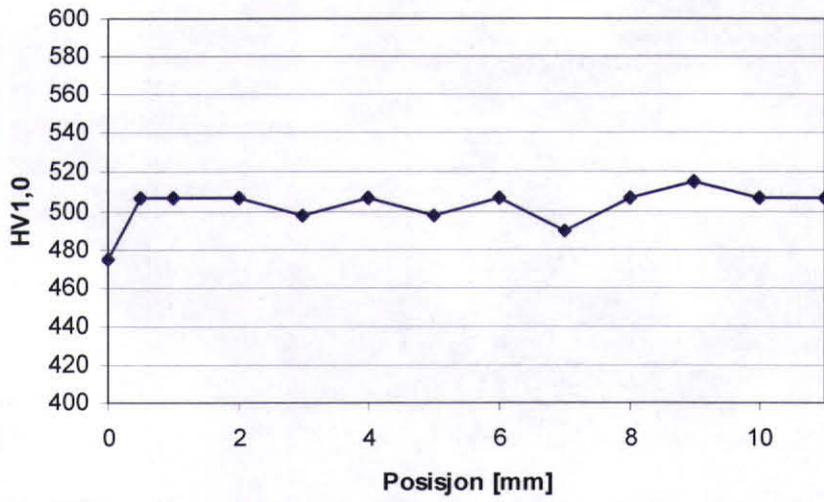
Figure 10 Hardness profile through the cross section of bolt 4a in Figure 3.

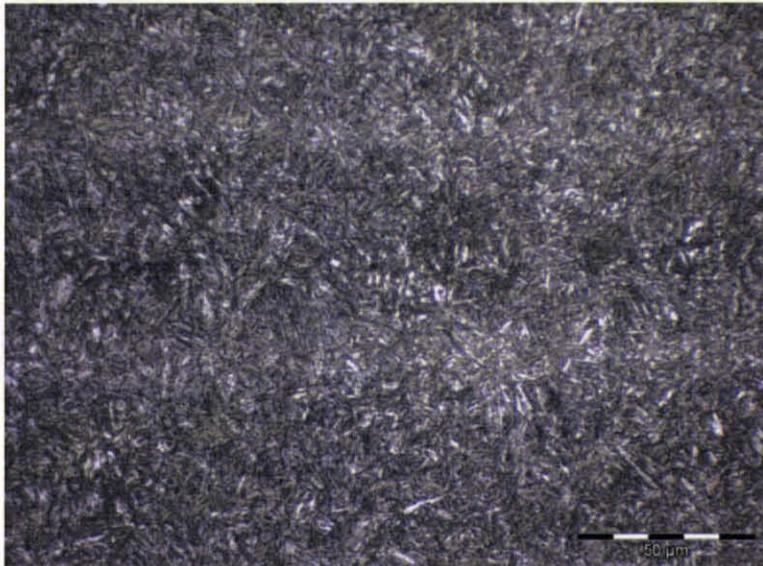
Figure 11 Base material microstructure for bolt 4 a in Figure 3. Polished specimen etched in Nital.

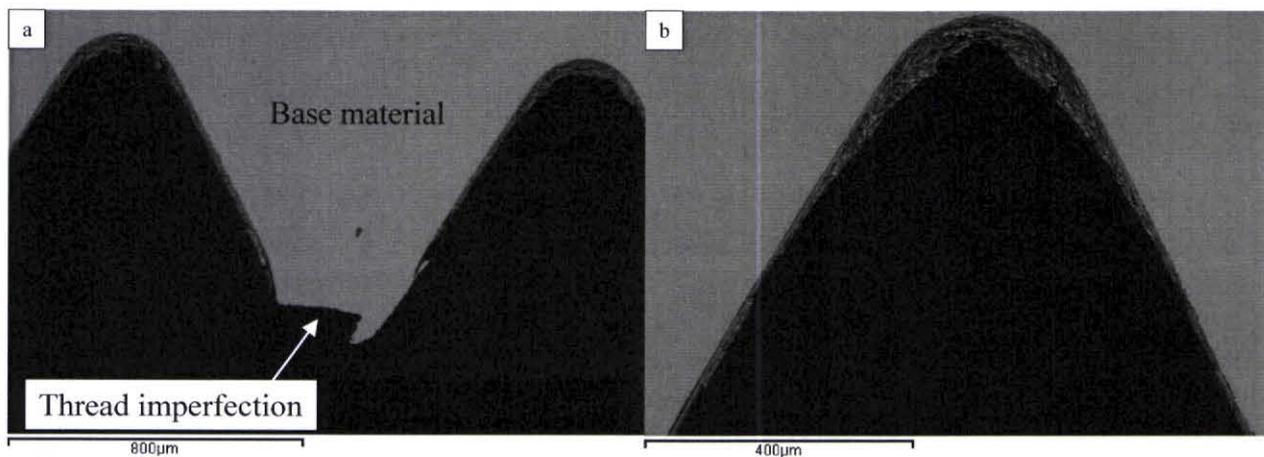
In order to reveal if the bolt quality of the failed bolts were similar to other bolts in production, three reference bolts were received for comparison. Cross sections were made through the bolts for metallographic investigation. Figure 12ab shows overview pictures of the cross section through reference bolt threads. The pictures reveal the presence of an imperfection at the thread top, and an uneven distribution of the corrosion protective layer. A picture of a thread root at higher magnification is shown in Figure 13, the attached EDS spectrums identifies the presence of an oxide layer at the coating base material interface, chromium particles at the grain boundaries in the base material towards the thread surface and a zinc based corrosion protective layer. The corrosion protective layer was unevenly distributed and features showing possible crack initiations were observed at some thread roots, as shown in Figure 14. A cross section through this area was made and a crack initiation was readily observed as shown in Figure 15. The microstructure of the bolt is shown in Figure 16, showing a structure consisting of tempered martensite. The bulk hardness was measured to be 41 HRC.

Figure 12 Overview picture in SEM of cross section through threads. a: Picture of thread imperfection. b: Picture showing uneven distribution of coating.

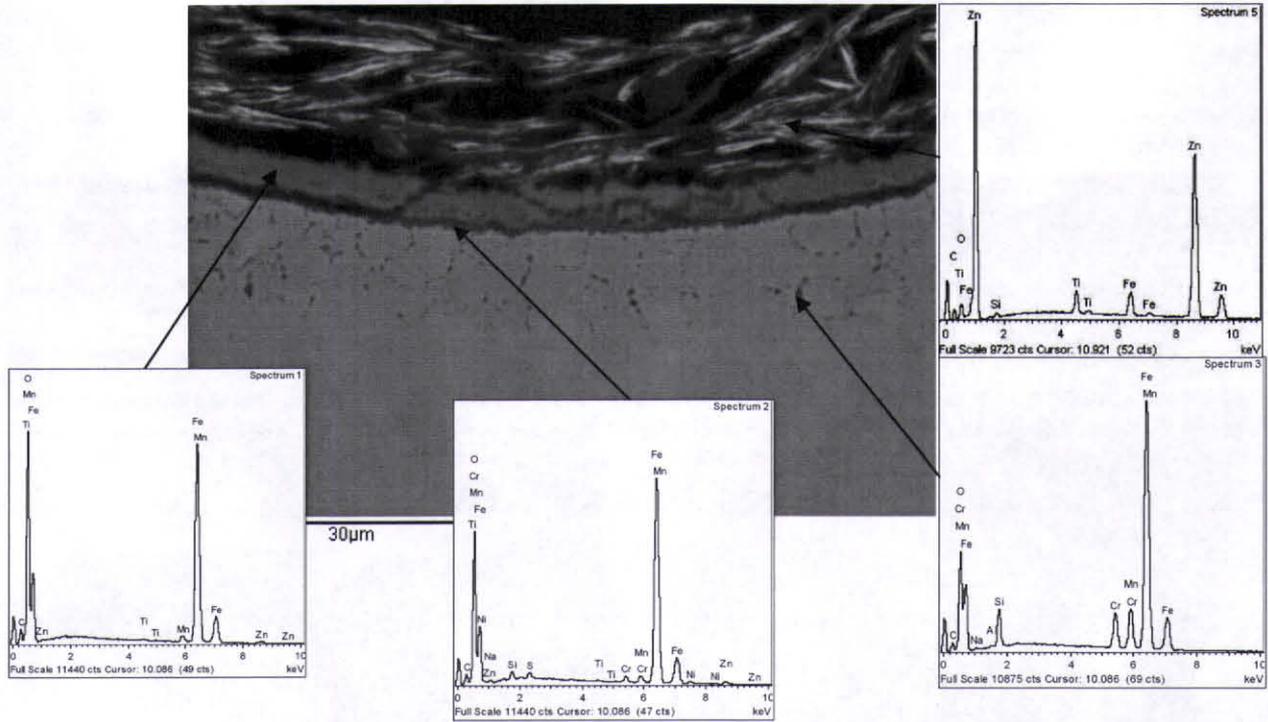
Figure 13 Picture of cross section through reference bolt. The attached EDS spectrums show: Spectrum 1 and 2 Oxides at the coating/base material interface. Spectrum 3 Chromium rich particles along grain boundaries. Spectrum 5 Zinc based corrosion protective coating.

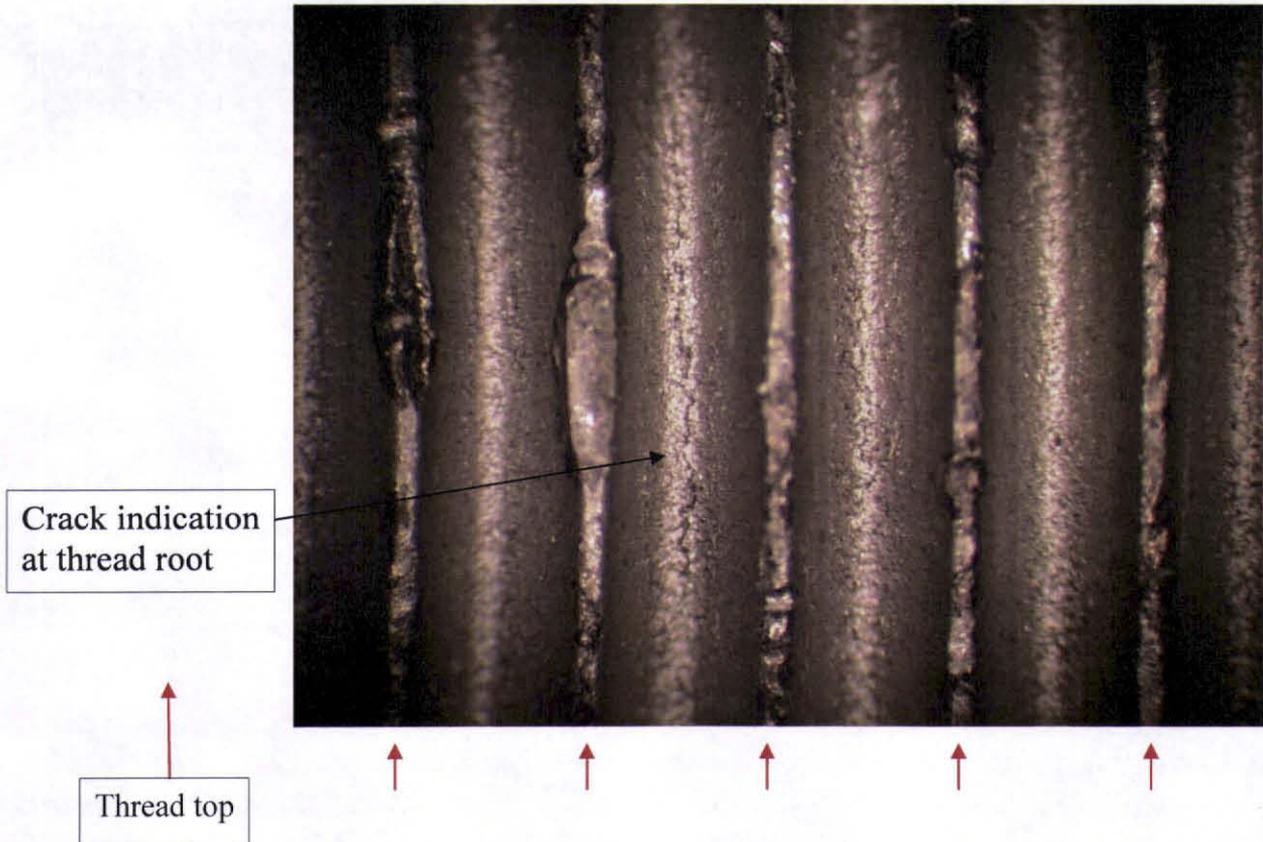
Figure 14 Picture in stereo light microscope of thread with crack indication. Thread tops are identified by red arrows.

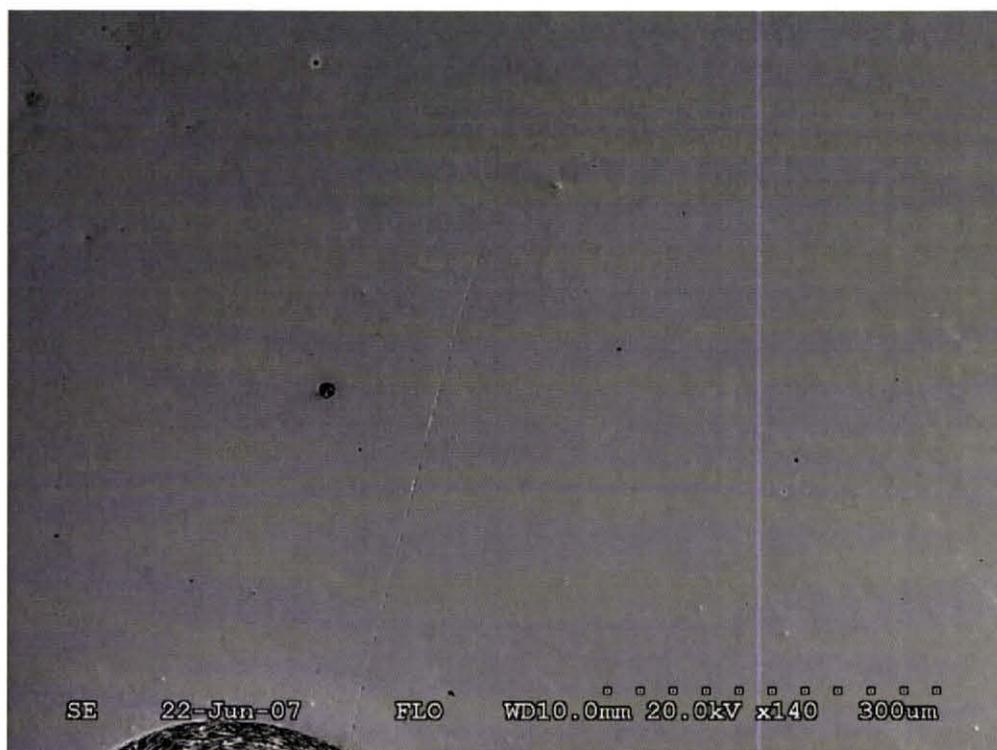
Figure 15 Cross section through the area with crack indication at thread root as observed in SEM.

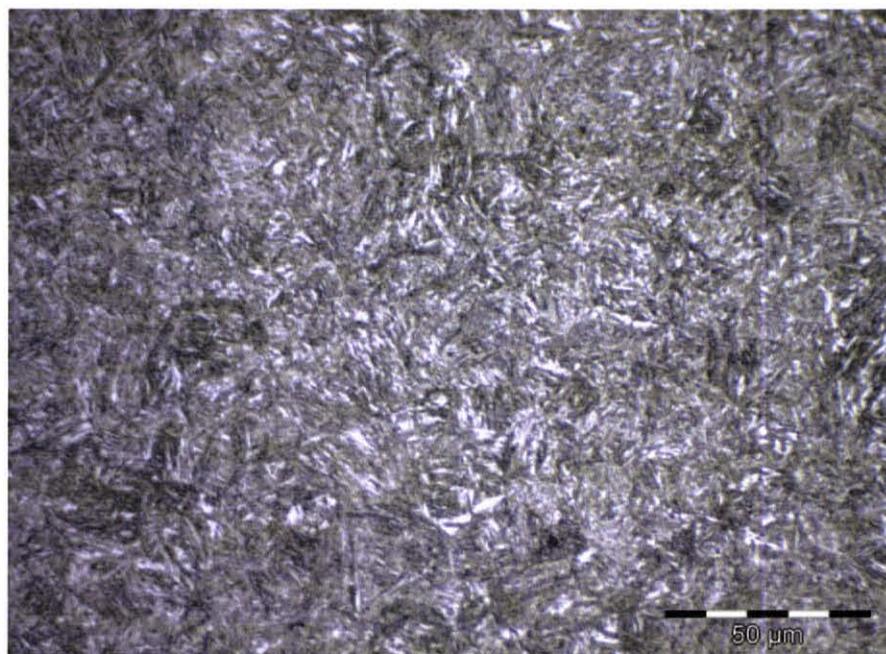
Figure 16 Microstructure of reference bolt. Polished sample etched in Nital.
