SL 2013/03

REPORT ON SERIOUS INCIDENT AT BERGEN AIRPORT 9 NOVEMBER 2007 WITH ATR-42-300, OY-JRY

Issued date: 23.01.2013
SL Report: 2013/03

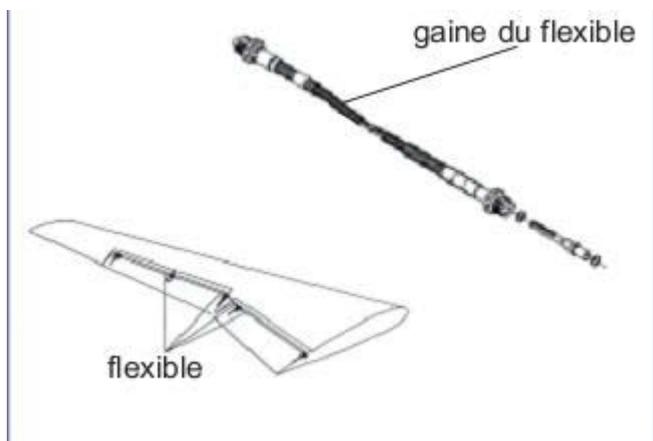
The failure message was related to a failure in the mechanical flap system: hoses, worm screws, transmission brakes. The transmission of movement is made by hoses composed of steel / carbon cables passing through Teflon ducts.

Water had entered when these hoses were removed. This water froze during the flight, which took place entirely at negative temperatures, and caused blockage of the flap movement transmission. The operator launched an inspection campaign of all hoses in flap systems. Services responsible for monitoring of airworthiness were informed about this event and its circumstances.

Note: It is possible that high pressure injection of the de-icing fluid from the trailing edge facilitated this condition. The ICAO manual on ground de-icing and anti-icing operations describes the usual wing and stabiliser de-icing / anti-icing procedure that consists of spraying fluid from the leading edge to the trailing edge and from the highest point of the camber to the lowest point.

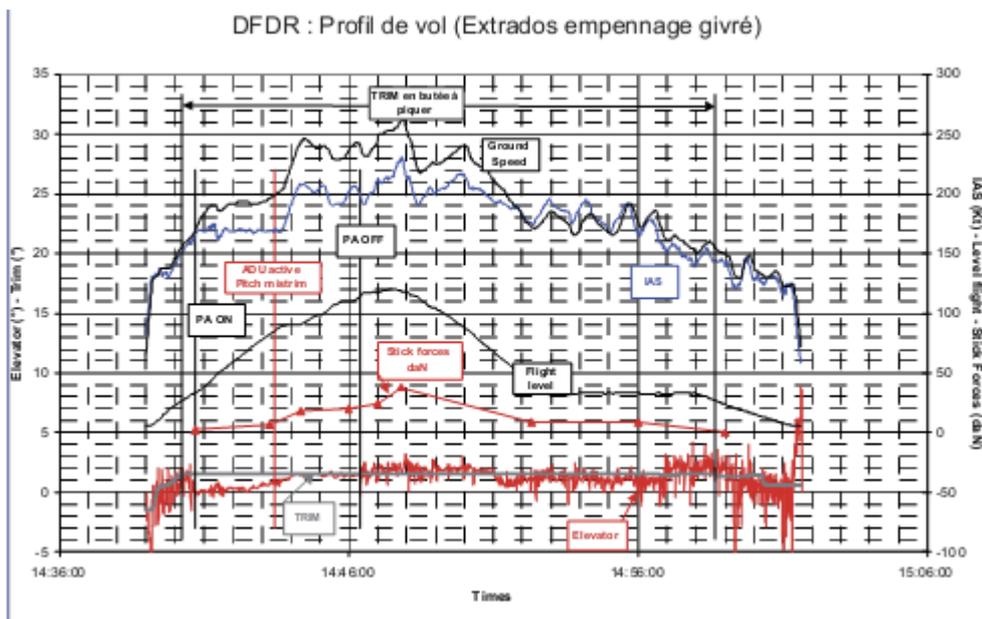
DFDR: Flight profile (tail assembly upper surface iced up)

On the ground, it was found that there was a 0.5 cm layer of rime ice covering the upper part of the elevator and the horizontal stabiliser (no rime ice on the trim tab).

The FCOM (manufacturer’s operations manual) specifies that during a takeoff with residual ice or during severe icing, the elevator hinge moment may be affected. This is what happened during this flight, and the consequence was a mistrim of about 2°.

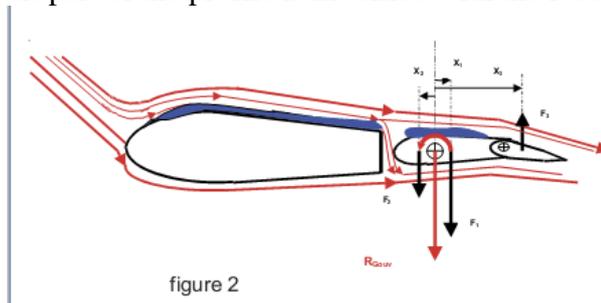
If ice forms on the upper part of the horizontal stabiliser and the elevator, the boundary layer in the aft part of the profile is modified with the result that the elevator tends to pull up.

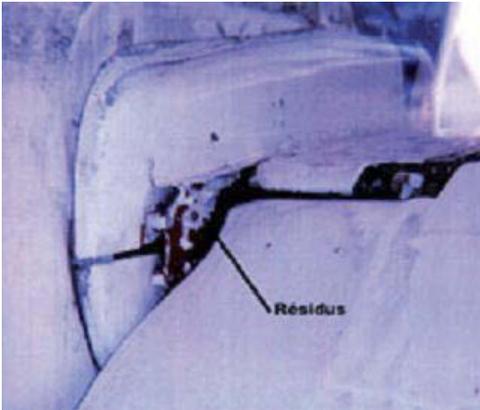
The crew recovered use of the elevator at about 1,000 feet and landed without damage 17 minutes after the warning appeared. On the ground, residues from the de-icing fluid that were still melting were found in the joints between the elevators and the control tabs.

The residues found were analysed. They comprised a gel originating from an acrylic polymer used as a thickener in type II and IV de-icing/anti-icing fluids and a very small quantity of propylene glycol (less than 1%), and paint debris and water (photo 1).

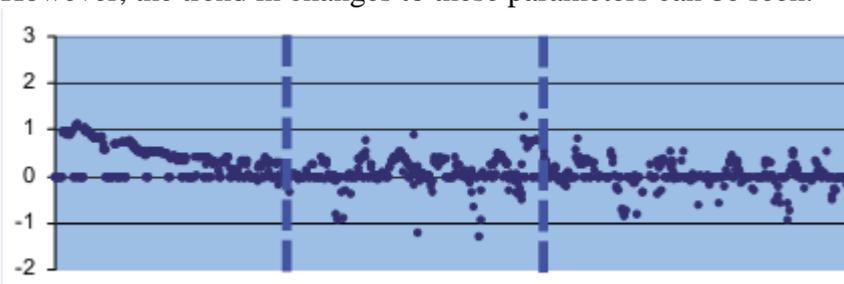
Position of the elevator control

- The third phase is characterised by relative stabilisation of the trim, while oscillations of the elevator control around the neutral are observed. Rapid displacement of the trim towards a nose-down position then occurs, immediately followed by a return to a slightly negative position.

The backward movement of the elevator control and the sensation of stiffness in the controls can be interpreted by considering a scenario determined after work done in cooperation with the manufacturer and the operator. Based on the parameters, system characteristics and reported or supposed actions by the crew (considering procedures and practices) and subsequent inspections made on the aircraft, the event can be explained as follows:

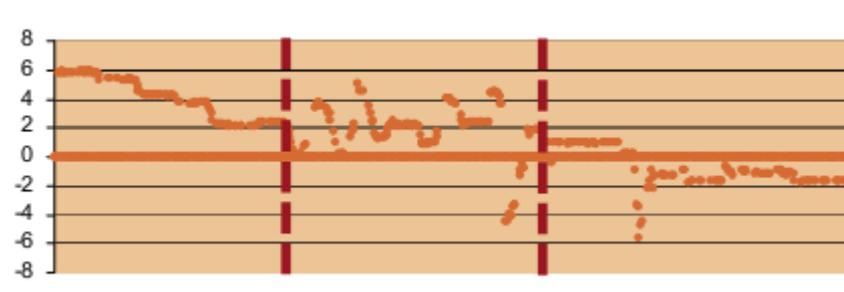
Position of the pitch trim

- The phenomenon occurred while the speed was increasing from 170 kts to 200 kts.
- The autopilot was activated in a pitch attitude hold mode. The autopilot was disconnected at a time that cannot be identified with any certainty. In attempting to control the pitch, the autopilot uses electric motors to control the position of the elevator control, immediately followed by trim compensation.

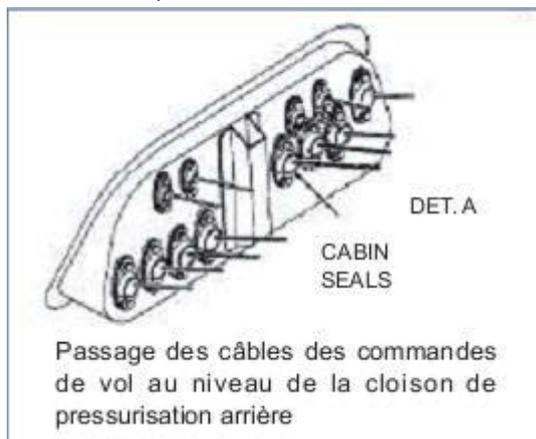
Passage of flight control cables at the aft pressurized bulkhead

The snow covering the aircraft before departure was probably heavy and sticky. It stuck to the fuselage particularly and consequently to the horizontal stabiliser. As the outside temperature was increasing before takeoff, the snow was transformed into water which penetrated into the tail fin box, probably through the vent panel. This water could not all escape through the drains provided for this purpose before takeoff, because this area of the aircraft was more or less covered with debris. The climb under freezing conditions caused this stagnant water to freeze. Friction phenomena at the cable passage generated large forces on the elevator control. Consequently, operation of the autopilot was abnormal, creating particular difficulties in stabilising the aircraft, thus causing the oscillations observed in phase 2. Observing unusual movements of the elevator control, the crew disconnected the autopilot and performed the pitch trim procedure. The high forces felt on the controls could also be the result of this abnormal friction.
