REPORT

ROAD 2014/02

REPORT ON OVERTURNING ACCIDENT INVOLVING A TRUCK ON FV 12 BY ALTEREN WEST OF MO I RANA ON 3 OCTOBER 2013

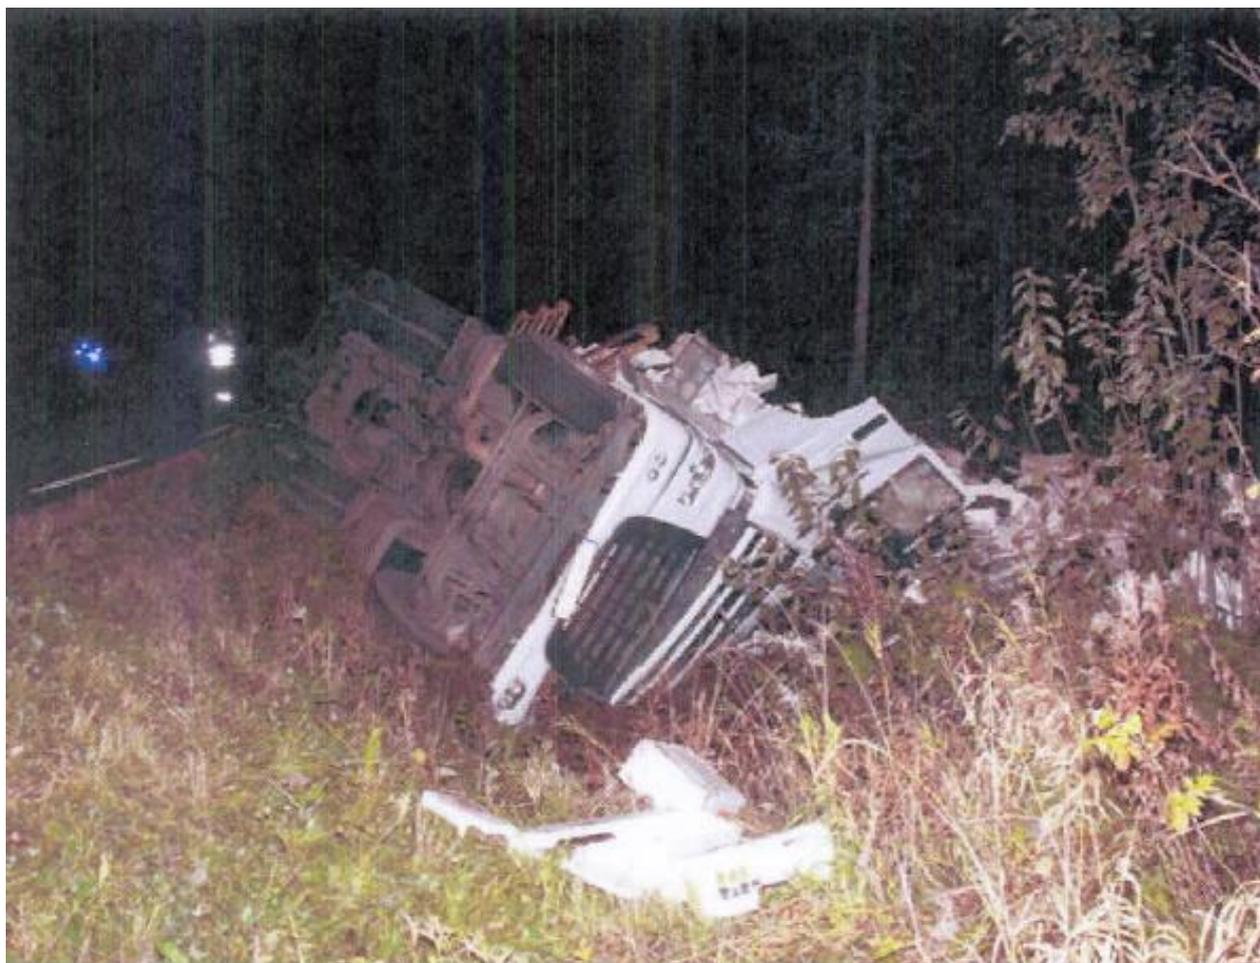
Figure 1: The overturned semi-trailer truck. Photo: the Police

After the truck toppled over, it skidded along the road and ended up in the ditch. The driver's cab hit the side terrain with its left-hand side and the roof. The cab was heavily deformed, particularly near the driver's seat. The driver's survival space³ was considerably reduced. The semi-trailer cabinet also sustained major damage, and the fish cargo was scattered across the side terrain.

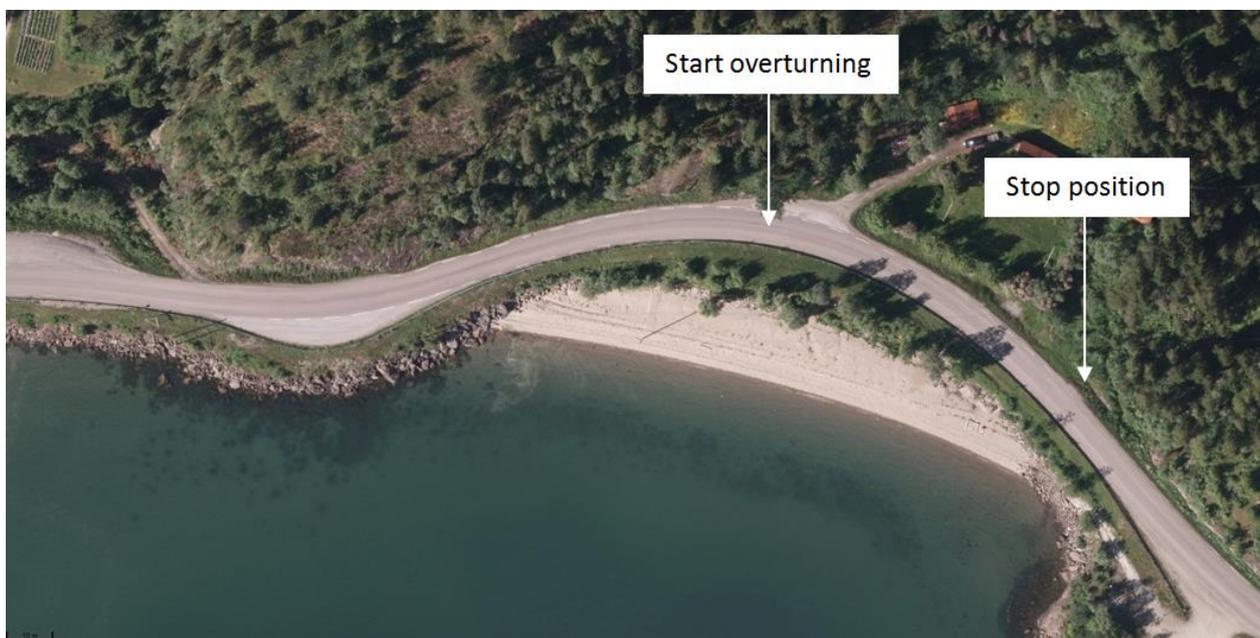
Figure 2: Overview picture of the curve where the truck toppled over. Shows the area where the overturning starts and the side terrain where the truck ended up on the left-hand side of the road. Picture: The Norwegian Mapping Authority, Geovekst and municipalities, ill.: AIBN

The road characteristics at the site, with several successive curves, present special challenges in terms of stability and tilting. The driver had no information about the curves except the visual impression from the driver's seat. He maintained a speed close to the signposted speed limit when the truck overturned. It can be challenging for drivers to adjust their speed in sharp curves, and this is even more difficult in the dark and when driving on unfamiliar roads.

theoretical overturn velocity is estimated at 60 km/h. In this respect, the speed limit at the accident site did not provide a safety margin against overturn of the truck in this case.

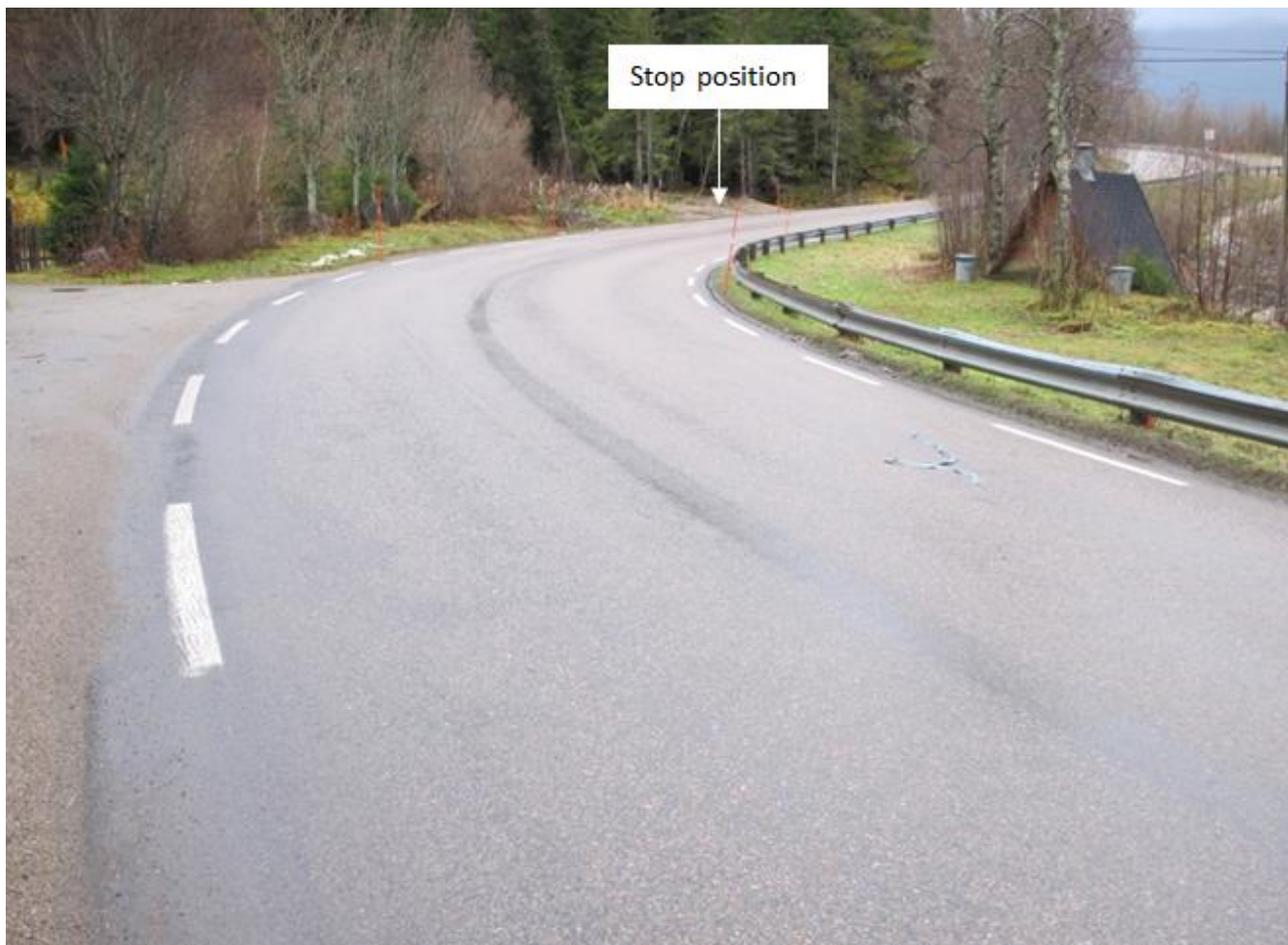
Figure 3: The curve the truck entered as it toppled over. The photo was taken on 25 October 2013. The tracks on the road were not made by the truck that overturned. Nor does the loading strap in the road belong to the truck that overturned. Photo/ill.: AIBN

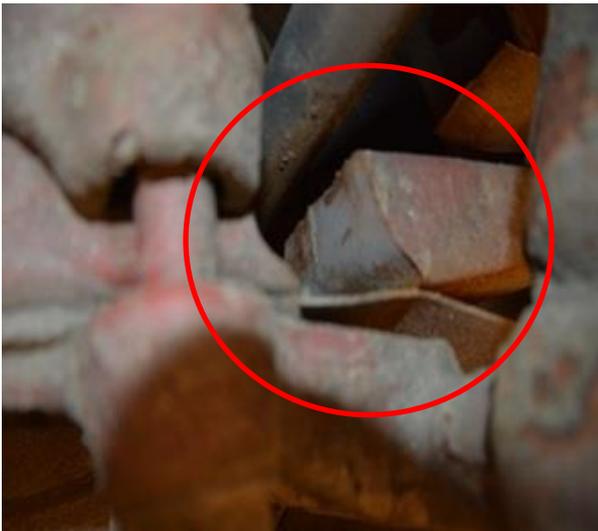
1. A draw spring on the left-hand side on the second axle was broken just by the axle's fastening point (see Figures 4 and 5). The picture in Figure 4 was taken during the Norwegian Public Roads Administration's inspection of the semi-trailer after the accident. The photo shows partly corroded sections on the fracture surface. This may indicate that there was previous fracture formation in the draw spring, and that the breakage occurred as the semi-trailer toppled over.
2. The rear axle on the semi-trailer was steerable (friction-controlled⁴). Findings from the investigation indicate that this was in the open position prior to the turnover.

Figure 4: Sheared axle draw spring. Photo: Norwegian Public Roads Administration, ill: AIBN

The investigation has uncovered a sheared draw spring on the left-hand side of the semi-trailer's second axle. Having examined the sheared spring, the AIBN finds it most likely that there was a fracture in the spring and that the breakage occurred as the truck toppled over. However, the AIBN cannot rule out that the breakage occurred as a result of the load whilst driving in the curves and that this contributed to the truck overturning.

In the AIBN's opinion, a sheared draw spring combined with an open steerable rear axle on the semi-trailer are familiar issues that must be followed up as part of maintenance and controls by the authorities.

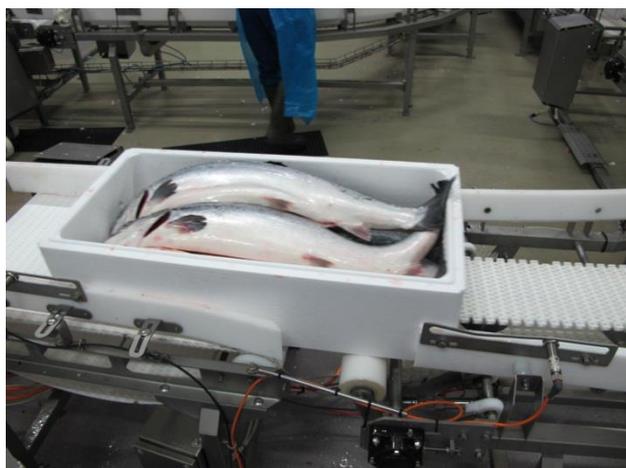
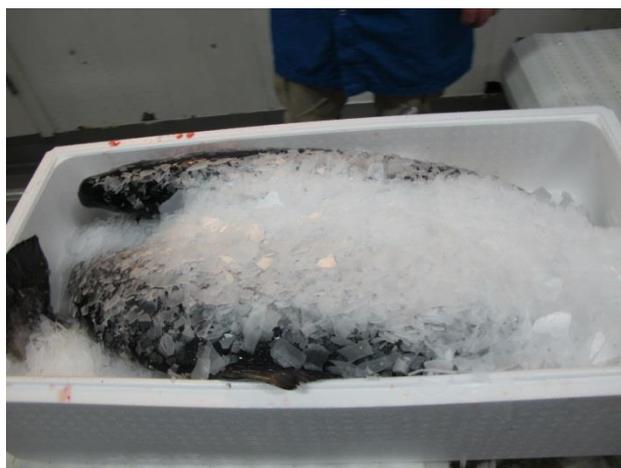
Each case packs about 22 kg of salmon and 3 – 4 kg of ice. The number of salmon in each case depends on the size of the salmon. In cases with one or two large salmon there is some extra space. The amount of ice seems to be constant, regardless of the number of salmon in the cases. Figures 6 and 7 show fresh salmon in cases before and after having been filled with ice.

Figure 6: Approx. 22 kg of salmon in the case before it was filled with ice. Photo: AIBN

Figure 7: Approx. 2-3 kg of ice covering the salmon. Photo: AIBN

Based on observations, the AIBN believes that salmon, ice and water may be able to shift sideways somewhat inside the polystyrene cases when driving through curves. If this happens in several or all of the cases, the total sideways centre of gravity may be affected.

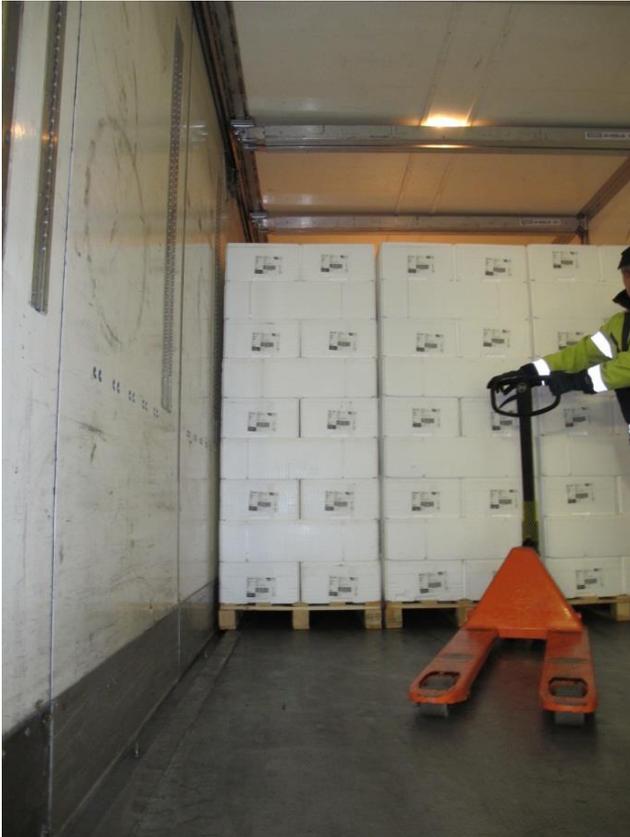
During interviews the AIBN has conducted with drivers with experience from transporting fish, information has emerged that the cases at the bottom of fish cargo can become deformed in transit due to the weight of the cases above. Moreover, the AIBN's observations of the loading process have shown that there is some clearance between the wall and the cargo in the cargo hold, as the cases do not fill the entire width of the cargo hold. During interviews with the drivers, information also emerged that some drivers fill in/wedge the clearance with boards on either side, between the cargo and the cargo hold wall, to prevent the cargo from shifting sideways.

Figure 8: Loading pallets in an almost identical semi-trailer. Note the clearance between the locker wall and the cargo on the left-hand side. Photo: AIBN

The investigation has shown that friction between the pallets/cases in a longitudinal direction is high and that this stabilises the load. Based on observations of the loading processes and the information that the cases at the bottom sometimes become deformed, it is still a possibility that cargo moves in transit. Furthermore, the investigation has shown that it is possible for the whole cargo of fish cases to shift sideways somewhat in transit when it has not been secured with bracers. In the AIBN's opinion, these factors may, individually or together, have a negative impact on stability. This could be investigated further, but the AIBN has decided not to proceed with this in this investigation.

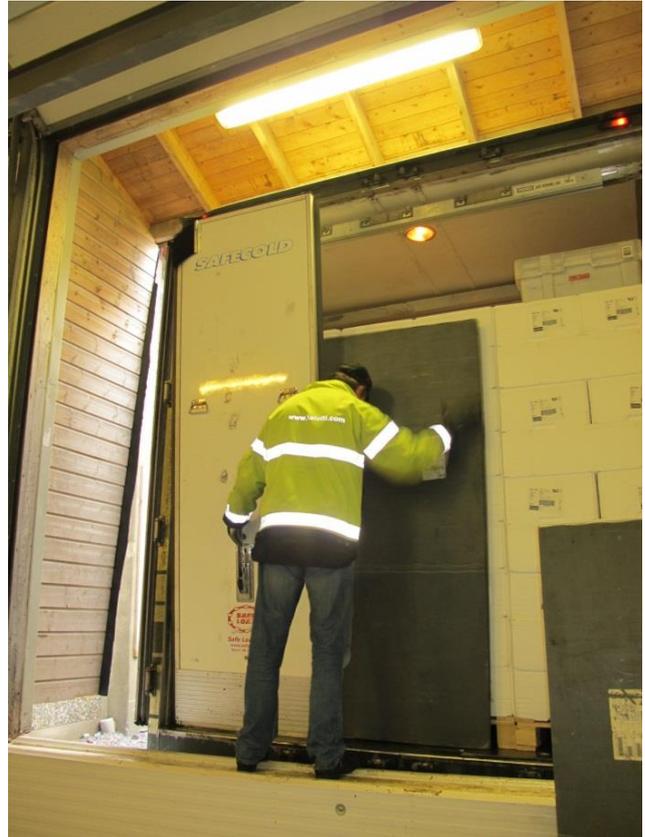
Figure 9: Loaded almost identical semi-trailer with boards to brace toward the back. Photo: AIBN
