# REPORT

SL 2009/01

## REPORT ON ACCIDENT SVOLVÆR AIRPORT HELLE, NORWAY (ENSH) 6. JULY 2007 INVOLVING PIPER PA-28-181 ARCHER III, D-EZEB

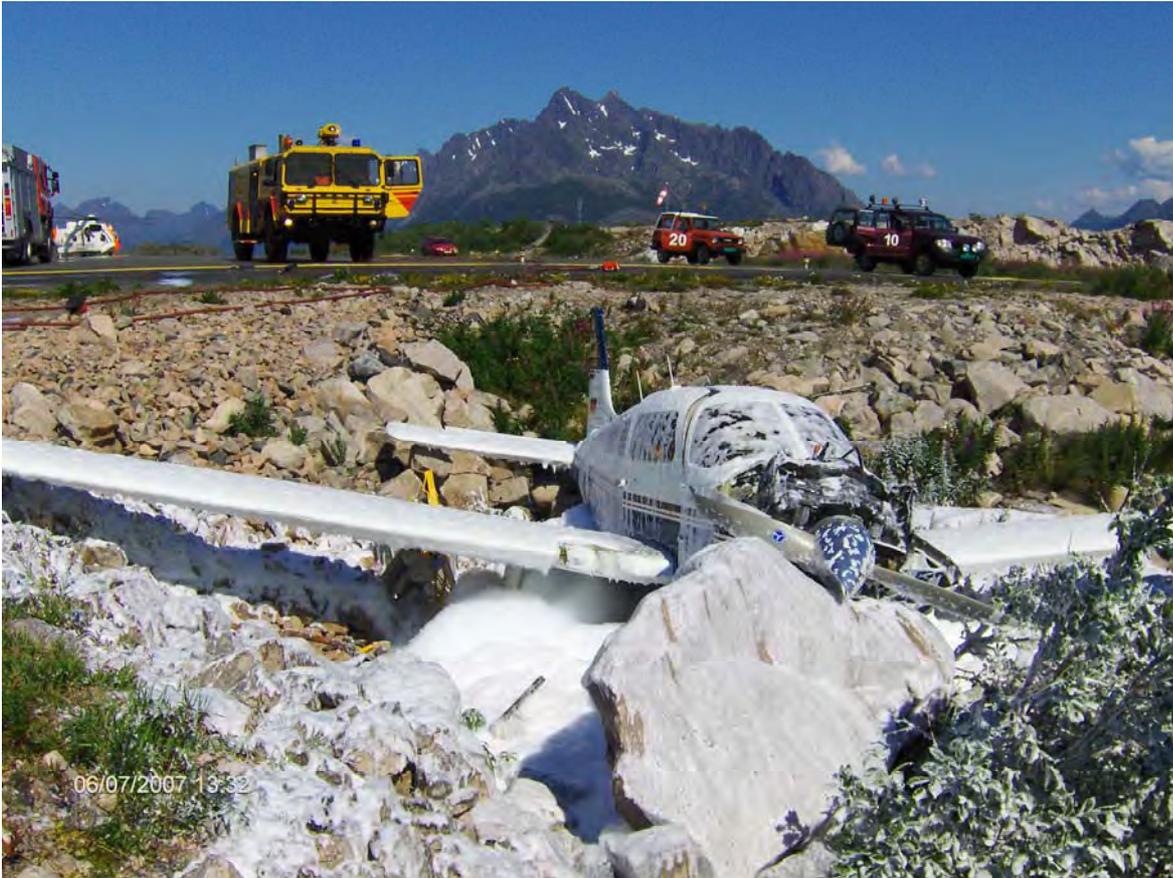
The Commander of D-EZEB did not succeed in stopping the aircraft, and the AFIS officer estimated that the aircraft departed the end of the runway at a speed in the range of 70 km/h. At the extension of the runway there was a slope, and on its way down the slope the aircraft broke an approach light before coming to a abrupt halt against a large rock (see figures 1 and 3). There was no fire.

*Figure 1: The wreck's position in relation to the runway and the terrain at the end of the runway at the time. (Photograph: Avinor)*

The Commander was seriously injured and D-EZEB was significantly damaged as a result of the collision with a large rock. As a result of the safety area to the south being extended to 185 metres beyond the threshold, the AIBN is of the opinion that the risk of damage as a result of a corresponding excursion has been significantly reduced.

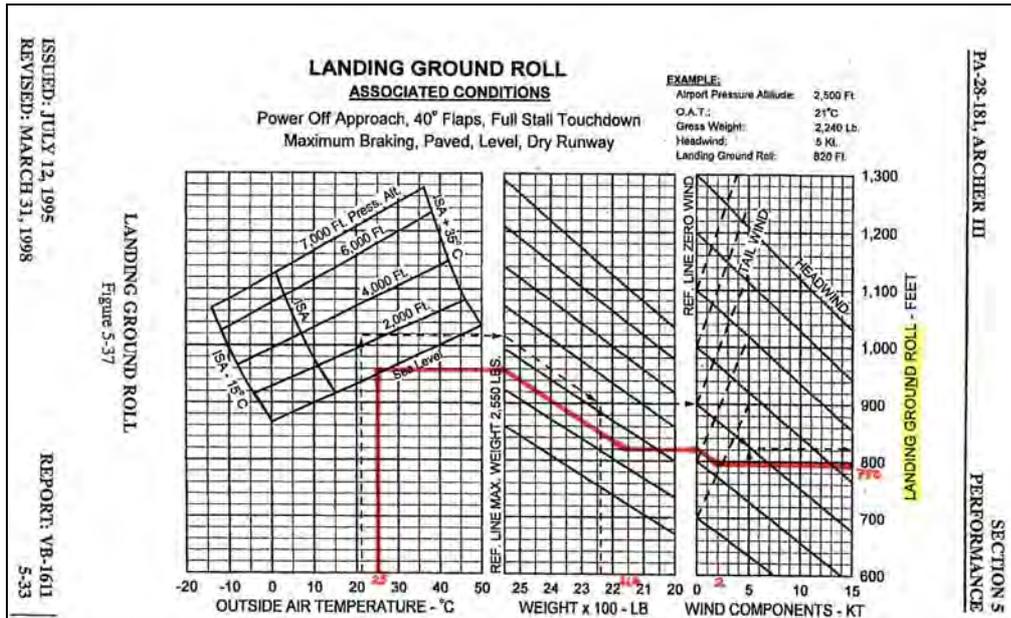
Based on the Aircraft Flight Manual, the AIBN has calculated the landing distance requirement. The following figures form the basis of the calculation: temperature: 25 °C, airport height above sea level: 27 ft, aircraft landing weight: 980 kg (2 160 lbs), headwind component: 2 kt, flaps 40°. Providing the aircraft was landed fully stalled with power off and maximum braking applied, the landing ground roll requirement is as illustrated in figure 2.

Figure 2: Shows that approx. 790 ft (240 metres) landing ground roll is required. (The corresponding figure when passing 50 ft above the threshold is approx. 390 metres)

As apparent from figure 2, the aircraft requires approx. 240 metres of runway to roll out and stop, provided the aircraft was fully stalled when landing. The AFIS officer observed that the aircraft had a relatively high speed when it left the runway. The AIBN is of the opinion that this indicates that the aircraft was landed with excess speed and/or that the Commander did not apply maximum braking.

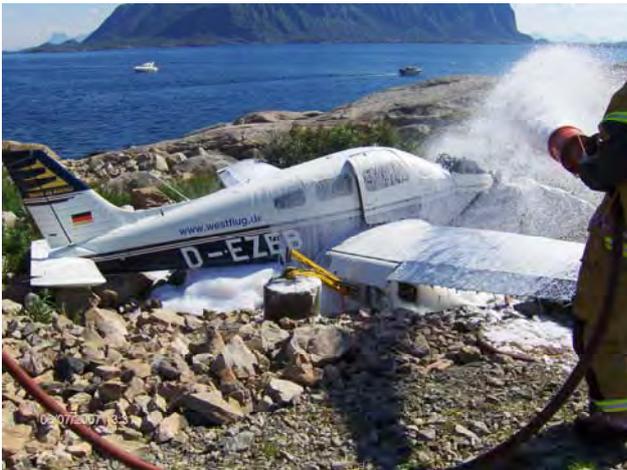
*Figure 3: D-EZEB covered with foam, the site of the accident, broken approach light and uneven ground at the extension of the runway. (Photograph: Avinor)*
