REPORT ON AVIATION ACCIDENT ON 24 OCTOBER 2004 AT BREISTEIN FERRY QUAY IN ÅSANE, HORDALAND, NORWAY INVOLVING ENSTROM 280C, G-ECHO

Submitted
September 2007

REPORT ON AVIATION ACCIDENT

Type designation: Enstrom 280C¹

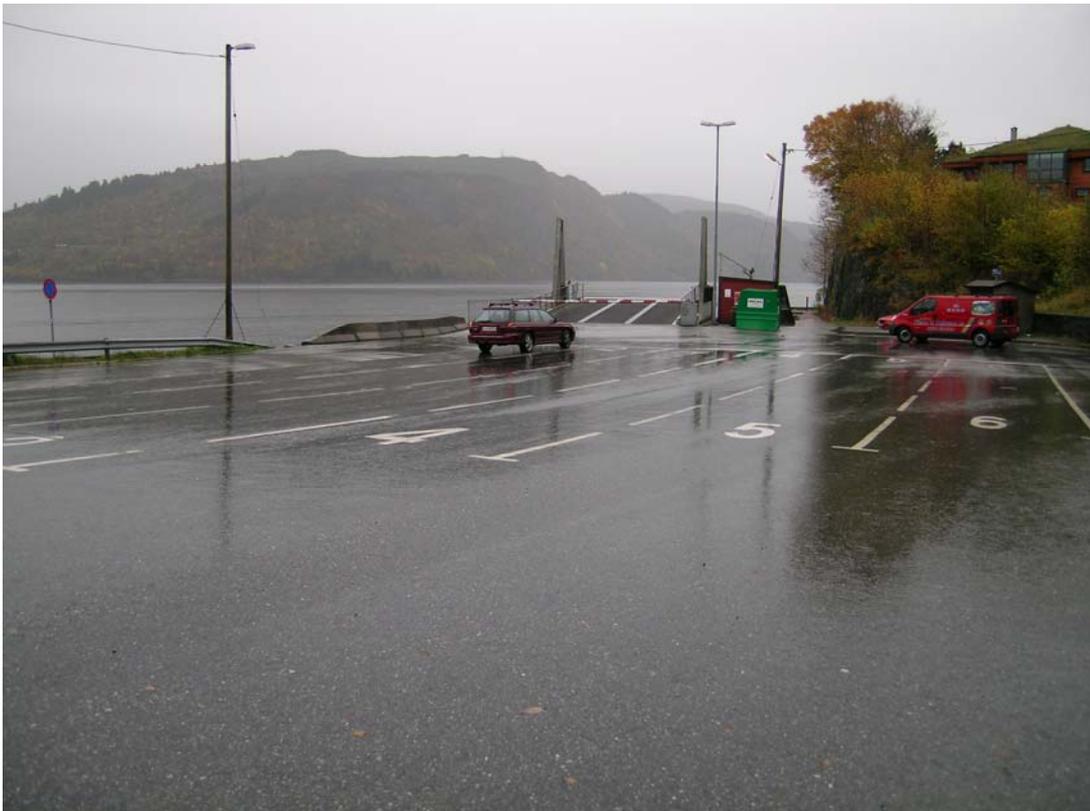
Figure 1: Picture taken towards the east. The helicopter was parked approximately beside the number 6 and took off in the direction of the front of the brown car.

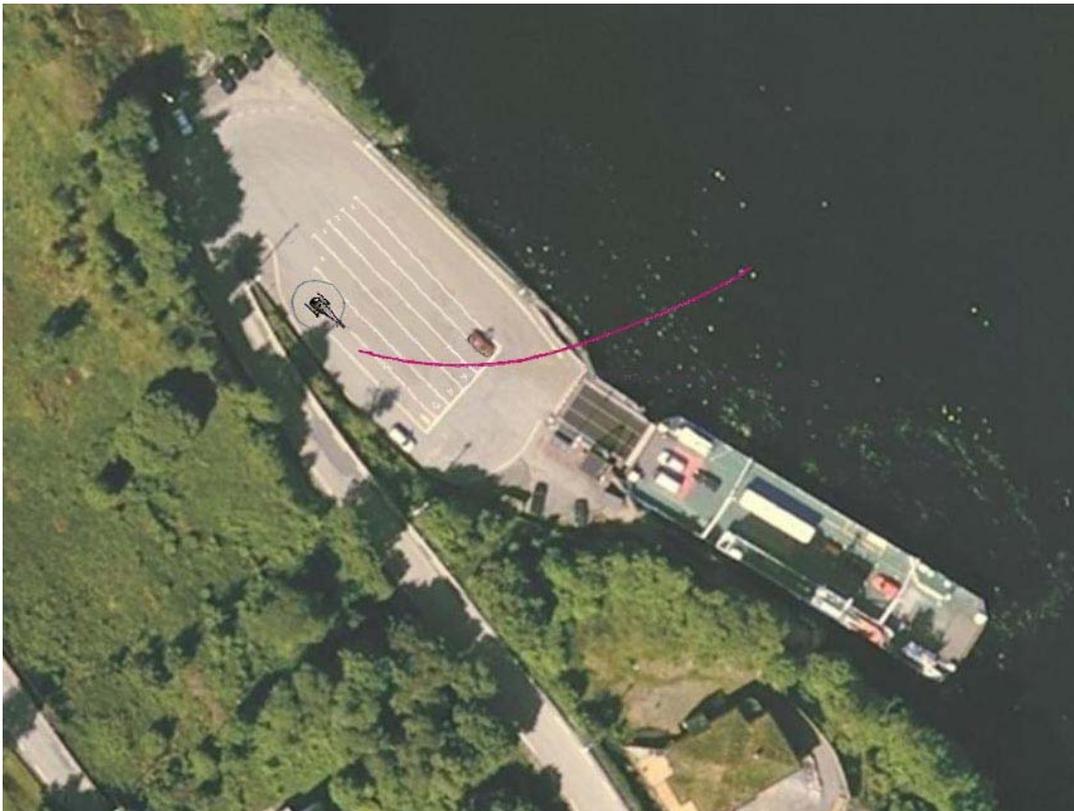
Figure 2: Manipulated image showing approx. where the helicopter started and the assumed flight path.

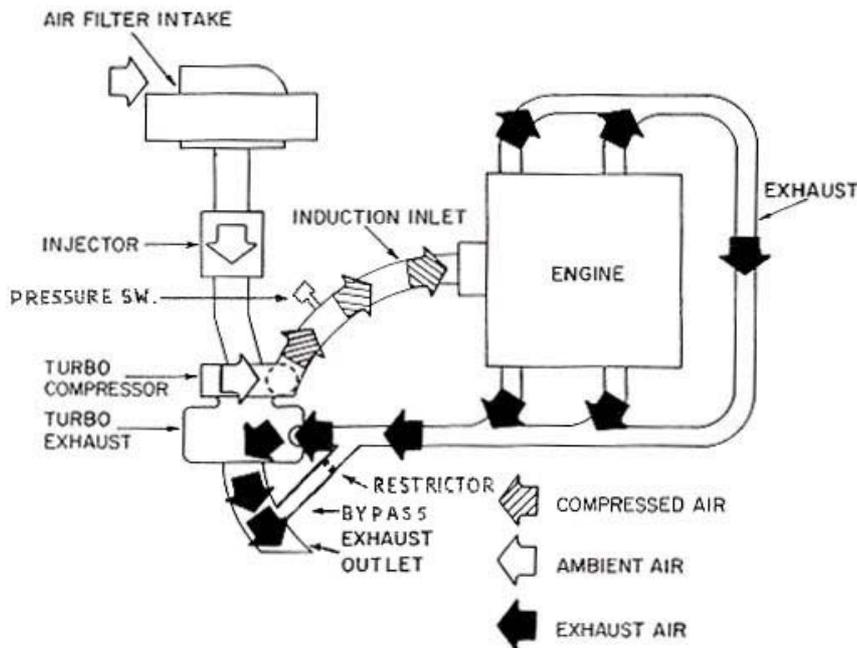
Figure 3: Illustration of the turbo system on the Enstrom 280C

- Mixture Control was found in the “full rich” position.
 - The turbocharger was not damaged and rotated freely. No signs of restrictions or leaks in the exhaust pipes were found. However, it was discovered that the exhaust bypass tube lacked a restrictor (see section 1.6.5). There was no indication that such a restrictor had been installed in the tube.

- 2.4.3 Missing restrictor in bypass tube
- 2.4.3.1 The examination of the engine revealed that the turbocharger’s bypass tube lacked a restrictor (see fig. 3). According to the manufacturer, a restrictor should have been fitted to the turbocharger in question. No traces indicate that there has ever been such a restrictor in the tube. The AIBN is of the opinion that the tube lacking the restrictor has at some point been erroneously installed. This is quite possible because the tube without the restrictor was standard equipment on the turbocharger before the modification of June 1977. The AIBN has not allocated resources to determine when the wrong pipe was installed. The fault may be difficult to detect during routine inspections and requires the exhaust system to be dismantled. If no one questions the engine’s performance at high altitudes, the fault may remain undiscovered for a long time. The AIBN is therefore of the opinion that the helicopter manufacturer Enstrom should inform all users of 280C of the possible fault and describe a procedure for the inspection of the bypass tube in question.

- t) The missing restrictor in the bypass tube in the turbo system had only a theoretical effect on the course of events. It is not to be expected that this fault could have been discovered during ordinary maintenance inspections.

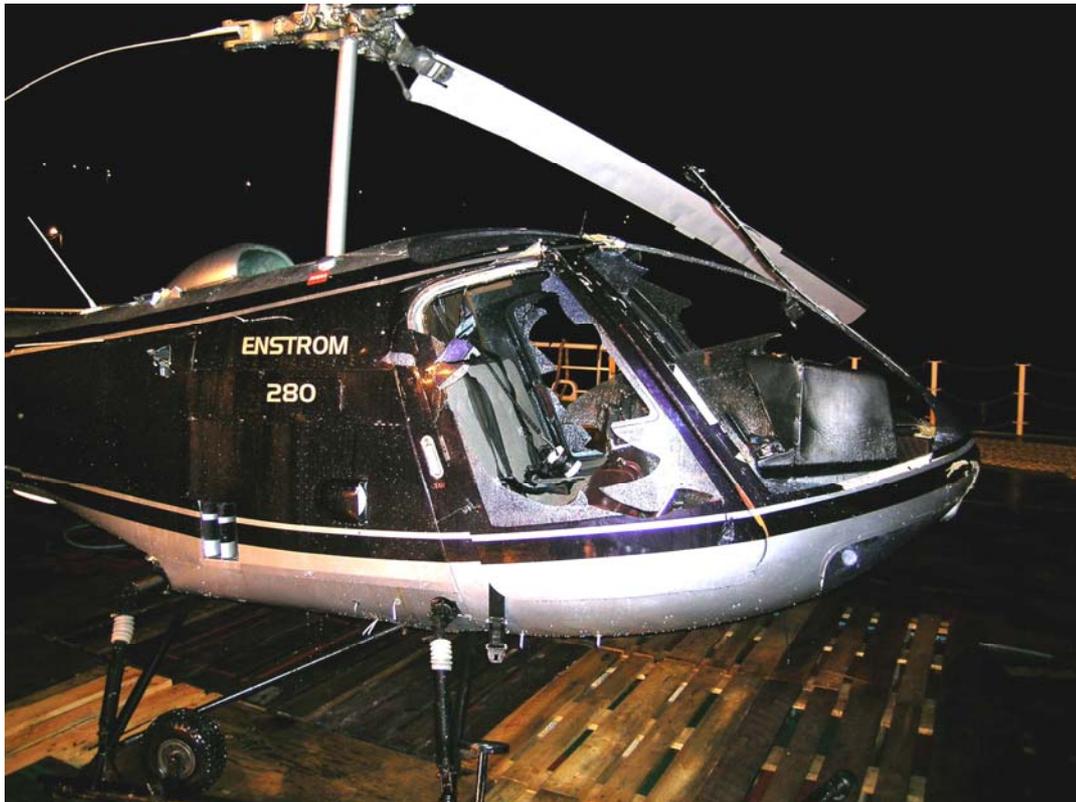
Figure 4: The helicopter photographed at night after it had been salvaged. The front windscreens and the windows in both doors are shattered. Further, the damage on the front and the bending of the main rotor blades are visible.

- Both front windscreens shattered and the middle column broken at the top
- Moderate impact damage to the nose
- The window in front of the rudder pedals on the left side broken
- Right door open
- The windows in both doors broken
- Right skid bent upwards somewhat at the front
- All main rotor blades bent downwards in an even arc
- Some smaller dents along the tail boom
- Vertical tailfin knocked loose
- Left horizontal fin bent upwards
- Damage to tail boom after contact with tail rotor blade (with rotation of tail rotor)
- Moderate bending of both tail rotor blades

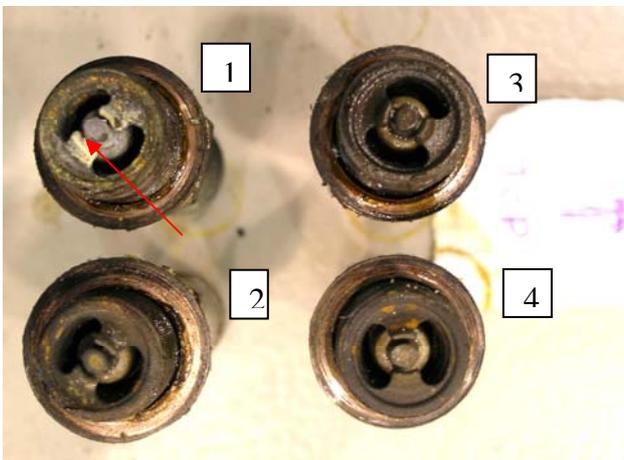
- No metal particles were found in the oil sump or oil filter.
 - The spark plugs were removed and examined. The upper spark plugs were in a relatively good condition, but the spark plug in cylinder no. 1 was short-circuited by a lead ball. These plugs were of the type Champion RHB 32E. The lower spark plugs of the type Champion RHB 36P were worn and had large spark gaps (see table 4).

Figure 5: Upper spark plug set. The plugs are marked with the cylinder numbers. The red arrow indicates the lead ball in the plug from cylinder no. 1

| Cylinder no. | Position | Spark gap Thousandth of an inch | Description |
|---|---|---|---|
| 1 | Upper | 20 | Moderately worn. Lead ball in spark gap. Light yellow-brown |

2.4.2.1 The upper spark plug in cylinder no. 1 was found to have a lead ball in the spark gap (see fig. 4). It is very likely that this was present before the helicopter crashed into the sea. A build-up of lead in spark plugs happens over time and is not unusual. High lead content in the AVGAS 100LL fuel easily leads to the condensation of lead vapour which is deposited in the coolest areas of the cylinder head. This usually happens in the coolest part of the spark plug and rarely occurs on the electrodes. Even though it is unusual, it is possible that lead deposits from other areas of the cylinder head or piston head may have come loose and then stuck in the spark gap. Regardless of the origin of the lead ball, a short-circuited spark plug can lead to some loss of power. Such a short-circuit should ordinarily be discovered during a correctly performed magneto test, which should be performed before each departure.

2.4.2.2 By comparing the colour of the four upper spark plugs one can see that the spark plug from cylinder no. 1 is considerably lighter than the three others. The colour of the plug is normal for a "good" engine, but also indicates that this plug has been hotter than the others and that soot and oil has been burnt off to a greater degree. This may be due to normal variations in oil consumption and combustion temperature. Another explanation may be that the lead ball, due to insufficient cooling, has started to glow. This could have led to premature ignition and a significant loss of power. Such a problem may have built up over time, but the consequences may only have become critical during the last departure with a high power output and thereby high spark plug temperatures.

- a) The investigation has revealed a lead ball in the spark gap of the upper spark plug in cylinder no. 1. This may lead to a significant loss of power, particularly during high engine strains. This may have been the cause of the loss of power and thereby the reduction in engine RPM.
- b) The investigation has revealed that the lower spark plugs in the engine were worn and that they had large spark gaps. Large spark gaps may lead to a significant loss of power, particularly during high engine loadings. This may have been a cause of the loss of power and thereby the reduction in engine RPM.
- c) It may appear that the flight was planned with little regard to assessing safety margins in relation to the helicopter's performance and the landing conditions at Breistein ferry quay.
- d) No one on board was wearing a life jacket. This may have been crucial to the ability to survive.

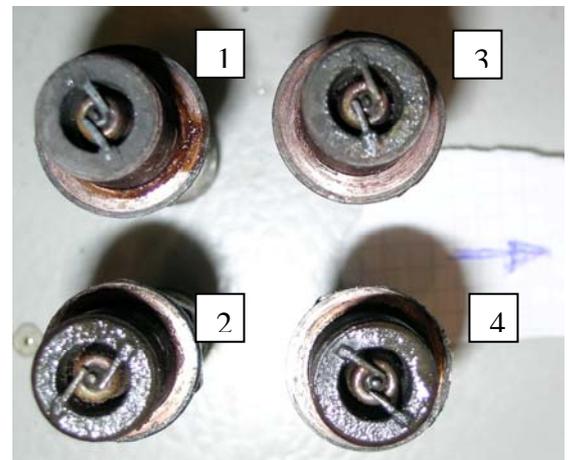
Figure 6: Lower spark plug set. The plugs are marked with the cylinder numbers

| Cylinder no. | Position | Spark gap Thousandth of an inch | Description |
|---|---|---|---|
| | Lower | 24 | Worn centre electrode. Soot-coloured |
| | Lower | 32 | Worn centre electrode. Soot-coloured |
| | Lower | 24 | Worn side electrodes. Some oil. Soot coloured |

- 2.4.2.4 A large spark gap arises over time and will eventually place high demands on the rest of the ignition system. It may lead to starting problems and RPM drops in excess of permitted values during the magneto check. A large spark gap may further lead to a weak or missing spark when pressure is high in the cylinders (high manifold pressure). It cannot therefore be ruled out that the high manifold pressure that was required during takeoff from Breistein ferry quay with a heavy helicopter induced ignition failure. This could have happened although the ignition system seemingly worked satisfactorily during the magneto test and previous less demanding departures.

- 2.4.2.5 The AIBN has noted that the spark plugs of the type RHB 36P, which were found in the lower position on the engine in G-ECHO, are not specified in the aforementioned Service Letter published by the engine manufacturer Lycoming. In the opinion of the AIBN this has no practical implications because the heat value (36) lies between the two recommended values (32 and 37, see section 1.6.6.4), and that platinum (P) and solid steel (E) electrodes are normally interchangeable on other comparable engines.
