# REPORT

JB 2008/04

## REPORT ON ACCIDENT AT LILLESTRØM STATION 02.10.2006, TRAIN NO. 1606.

Date issued: 08.05.2008  
JB Report: 2008/04

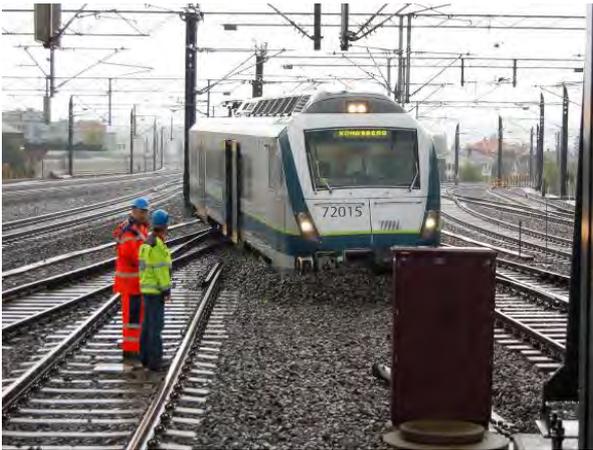
Figure 1: The derailed train - view from platform.

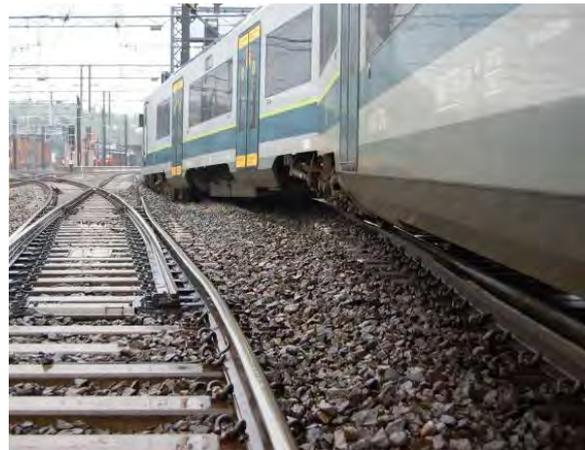
Figure 2: The derailed train - view towards platform.

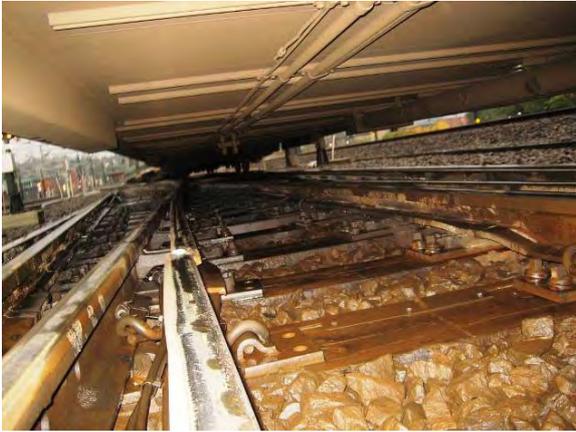
Figure 3: Break in the point blade under the train.

A break was found at the heel of a point blade in switch no. 47/20. A horizontal distance of 4-5 cm was observed and a difference in height of approx. 2 cm between the broken sections after the derailment (see figures 3 and 4). The running and side surfaces on the Oslo side of the break were deformed. The break had occurred in the interval between the last fixed sleeper and the first sleeper with a slide chair. In this area, the height of the blade web changes. The break surfaces appeared slightly corroded approx. 2 hours after the derailment, unlike the rail's running surfaces which were still shiny (see figure 4). The rails were damp at this time as a result of light drizzle. Marks left by the derailed wheel were found on the rails and sleepers after the break site.

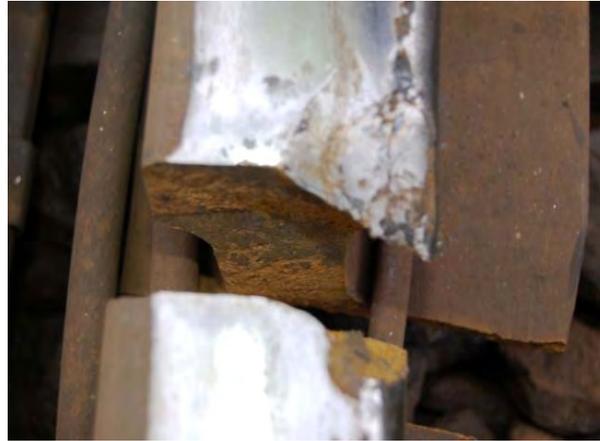
Figure 4: Close-up of the break in the point blade.

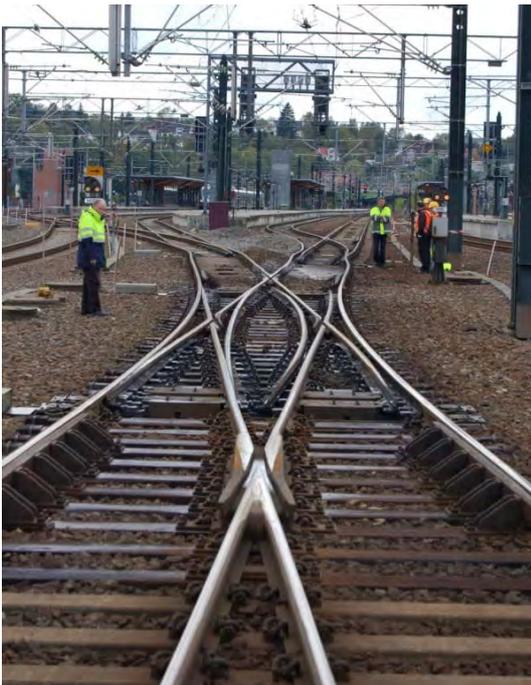
Figure 5: The points intersection where the derailment occurred (after removal of the train).

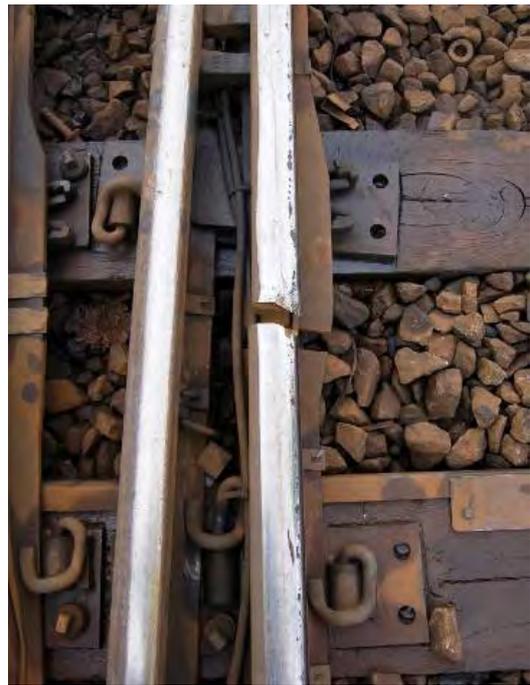
Figure 6: Close-up of the break (after removal of the train).

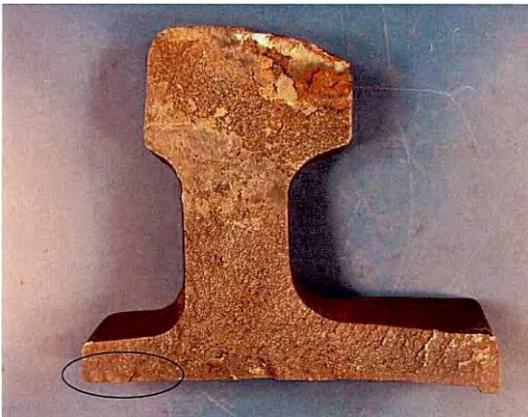
*The probable cause of the damage is development of a fatigue break from cracks or corrosion pitting. The rough striation lines and the large resulting break indicate major tensile stress in the underside of the rail. The fatigue break in turn triggered the resulting clean break as the train passed.”*

*Figure 7: macro picture of the break surface. The ellipse marks the area of the fatigue break. Photo: National Institute of Technology, Norway.*

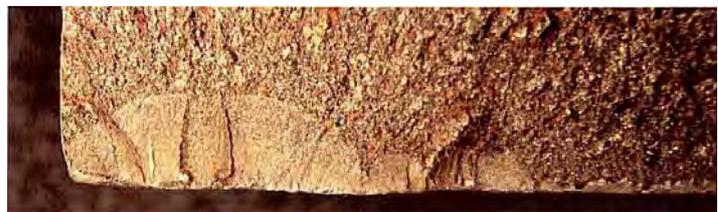
*Figure 8: Fatigue break in bottom left part of cross section. Photo: National Institute of Technology, Norway.*
