REPORT

Date: 20.12.2007
SL Report: 2007/35

- Type and reg.: Eurocopter EC 135 P2, LN-OOD
- Manufacturing year: 2004
- Engine(s): 2 Pratt & Whitney Canada PWC206 B2

Type of occurrence: Aircraft accident, material damage during landing
Type of flight: Commercial, ambulance flight (HEMS)
Weather conditions: Wind: 010° approx. 5 kt. Visibility: 2-8 km. Overcast.
Temperature: 0 °C. QNH: 990 hPa

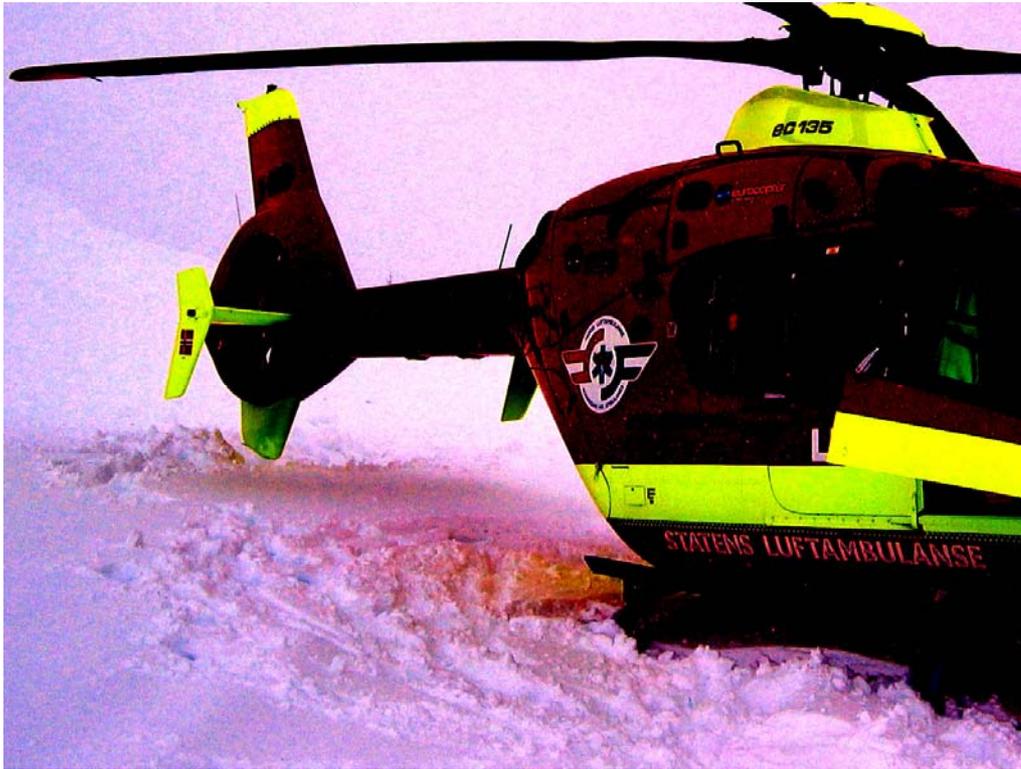
- There was a pile of loose snow on the ground to the right of the tail bumper/Fenestron.
- There were traces of snow spray on the ground on the left side of the Fenestron.

Fig. 1 Note the pile of snow to the right of the tail bumper (brightness/contrast adjusted to show details in snow)

The tracks at the landing site show that the helicopter's nose attitude immediately prior to landing was high enough to allow contact between the tail bumper and the snow-covered terrain. The tracks also show that the bumper ploughed up loose snow, which collected on the right side of the tail and was sucked through the Fenestron.

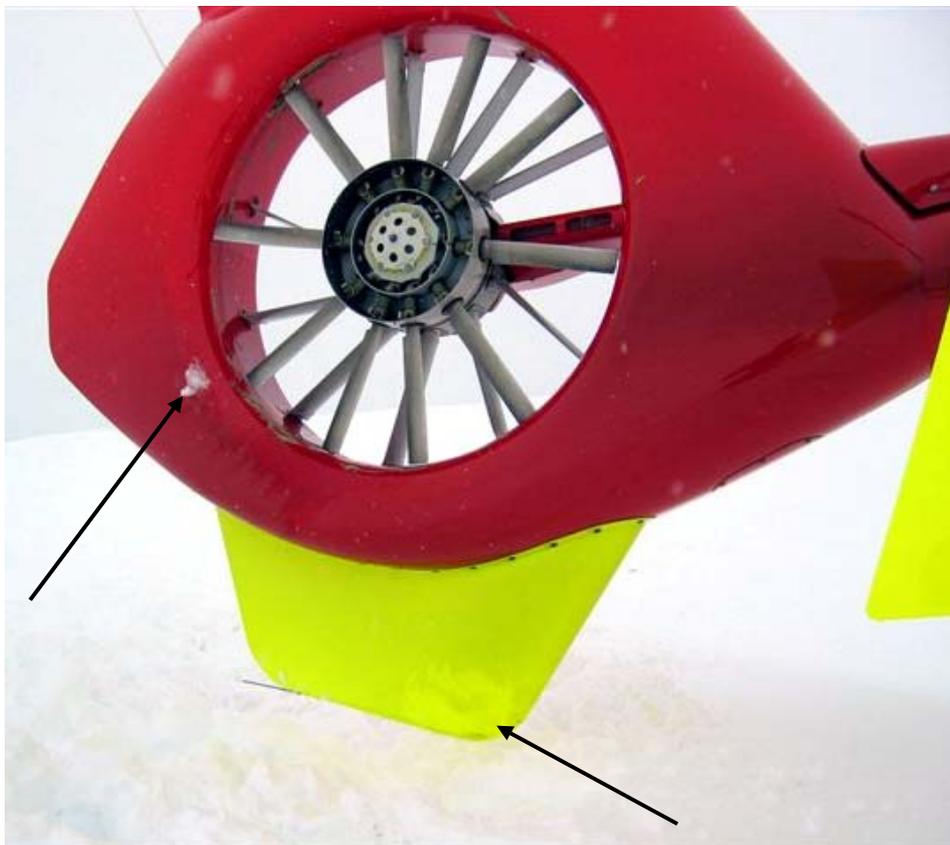
They had landed across a hard packed snowmobile track with approx. 25 cm of loose snow on top of it. The HEMS crew member jumped out and checked that the helicopter was standing secure. He noticed that the tail bumper had come into contact with the ground during the landing, but did not observe any damage. The engines were now pulled back to idle and the collective lever was lowered. The HEMS crew member and doctor went straight to the patient, while the commander spent a short time completing his work in the helicopter before stopping the engines and joining them. As he left the helicopter, he looked back to ensure it was standing secure. At that moment he realised that something was wrong. The cover of the hub in the Fenestron was missing and when he came closer he saw considerable damage to the Fenestron and the surrounding tunnel (fig. 2). Parts of the cover were scattered on the snow on both sides of the Fenestron.

- There was a snow mark a little way up on the right side of the Fenestron.

Fig. 2 Fenestron. Note the missing hub cover, the snow mark on the side and "clean" marks on the bumper

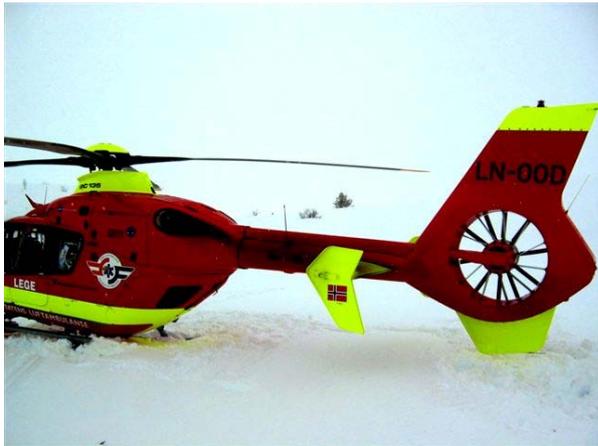
Fig. 3 Left side

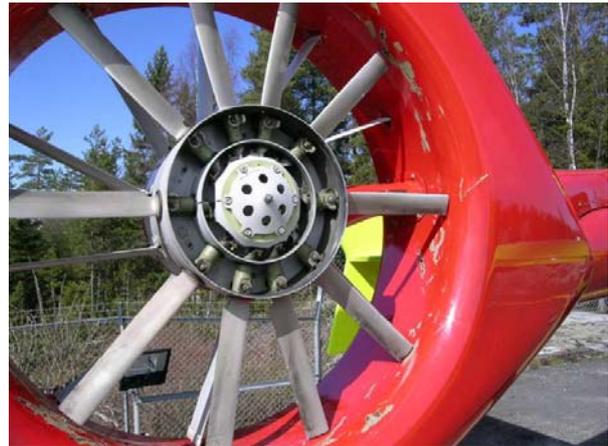
- There was various chipping and damage to several of the stator and rotor blades in the Fenestron.
- The tips of all ten rotor blades were deformed (bent out to the right by 1-3 cm).

- The two rotor blades positioned “singly” between the groups of four suffered most bending.
- The composite structure in the tunnel surrounding the Fenestron had various holes and gashes.

Fig. 4 Damaged tunnel and deformed blade tips

The AIBN has concluded that a considerable amount of snow passed through the lower part of the Fenestron during landing, resulting in permanent deformation of all the rotor blades. The phenomenon is well known in cases where a rotating propeller suddenly operates in a medium which is denser than air – water or snow, for example. The tips are then bent forward. In this case the snow only passed through the lower part of the Fenestron, which meant that the loads were very uneven, and a pulsating force could be generated.

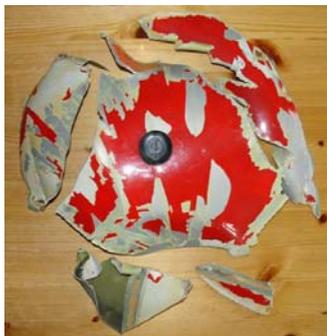
- The hub cover in the Fenestron had loosened and been sucked into the fan where it was cut into bits.
- All or parts of four of the six clips with bolts holding the cover in place were found at the site. All the clips had rubber coating and the bolts were tightened.

Fig. 5a Pieces of the hub cover

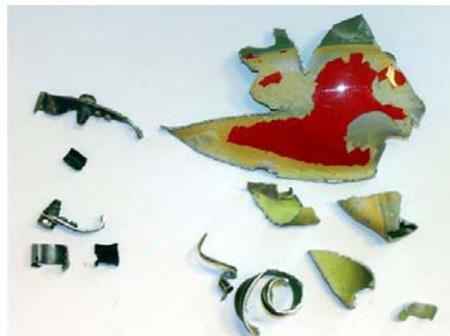
Fig. 5b More pieces of the cover and clips with bolts

Available information indicates that the hub cover was fixed as required. It is AIBN's opinion that the dislodging of the cover can be explained by the identified flexibility in the hub. The pulsating forces that bent the blades were transferred to the hub, which assumed an oval shape. The clips then become disengaged from the edge in rapid succession and the correctly mounted cover "popped" out of the Fenestron hub. The cover was sucked into the rotor where it was chopped to bits, causing extensive damage to the blades and surrounding tunnel.

The accident has revealed that the hub cover of the Fenestron on EC 135 can loosen when the rotor tips are bent out. A loosened cover will be sucked through the Fenestron and cause extensive damage. AIBN recommends that Eurocopter consider whether the fixing mechanism between the cover and hub could be changed to prevent loosening.

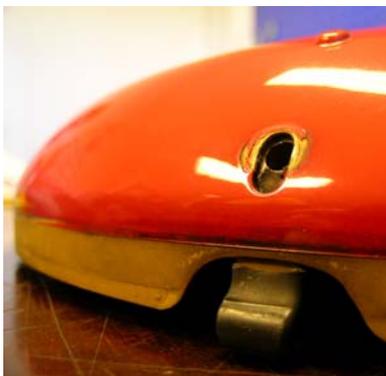
The hub cover was held in place by six retaining clips in a lip around the inner circumference of the Fenestron hub (ref. fig. 5-6). The clips are tightened with bolts. The commander was sure that the cover had been in the correct position and had not rotated in relation to the hub when he made his routine inspection prior to take-off. A painted-on guiding mark makes it easy to see any rotation.

Fig. 6a Illustration photo: Cover with retaining clips (bolt not mounted)

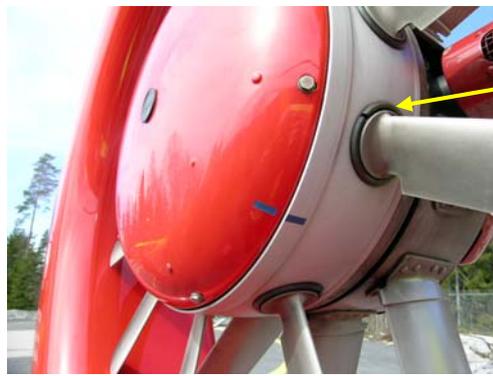
Closer investigation showed that the Fenestron hub does not retain its circular shape if the blade tips are bent out manually over right side until flush with the tunnel opening. This is due to the fact that the blades go into the hub through bushings, with movement in the blades transferred to the hub via these bushings (see fig. 6b). Ovality was measured while the tips of four blades were held in tension. There was 7-8 mm flexing. The hub with an original diameter of 370 mm changed its shape to an ellipse with symmetrical lines of 363 mm and 378 mm.

Bushing
on the
hub

Fig. 6b Illustration photo: Undamaged mounted cover with guiding mark
