REPORT

REP: 4/2001
Date: 18 January 2001

-type & reg.:	Cessna C 650, LN-NLD and Airbus A 320, HS-IPZ
Radio call sign:	NOO 03, SWR 417
Date and time:	02 June 2000, 1525 UTC
Location:	Approximately 20 NM south of ENGM
Type of occurrence:	Air traffic incident, AIRPROX
Type of flight:	Ambulance flight / commercial airline operation
Light cond.:	Daylight
Flight cond.:	IMC, both aircraft
Flight plan:	IFR, both aircraft
Information sources:	Report from ATC, Commanders reports and AAIB/Ns own investigations.

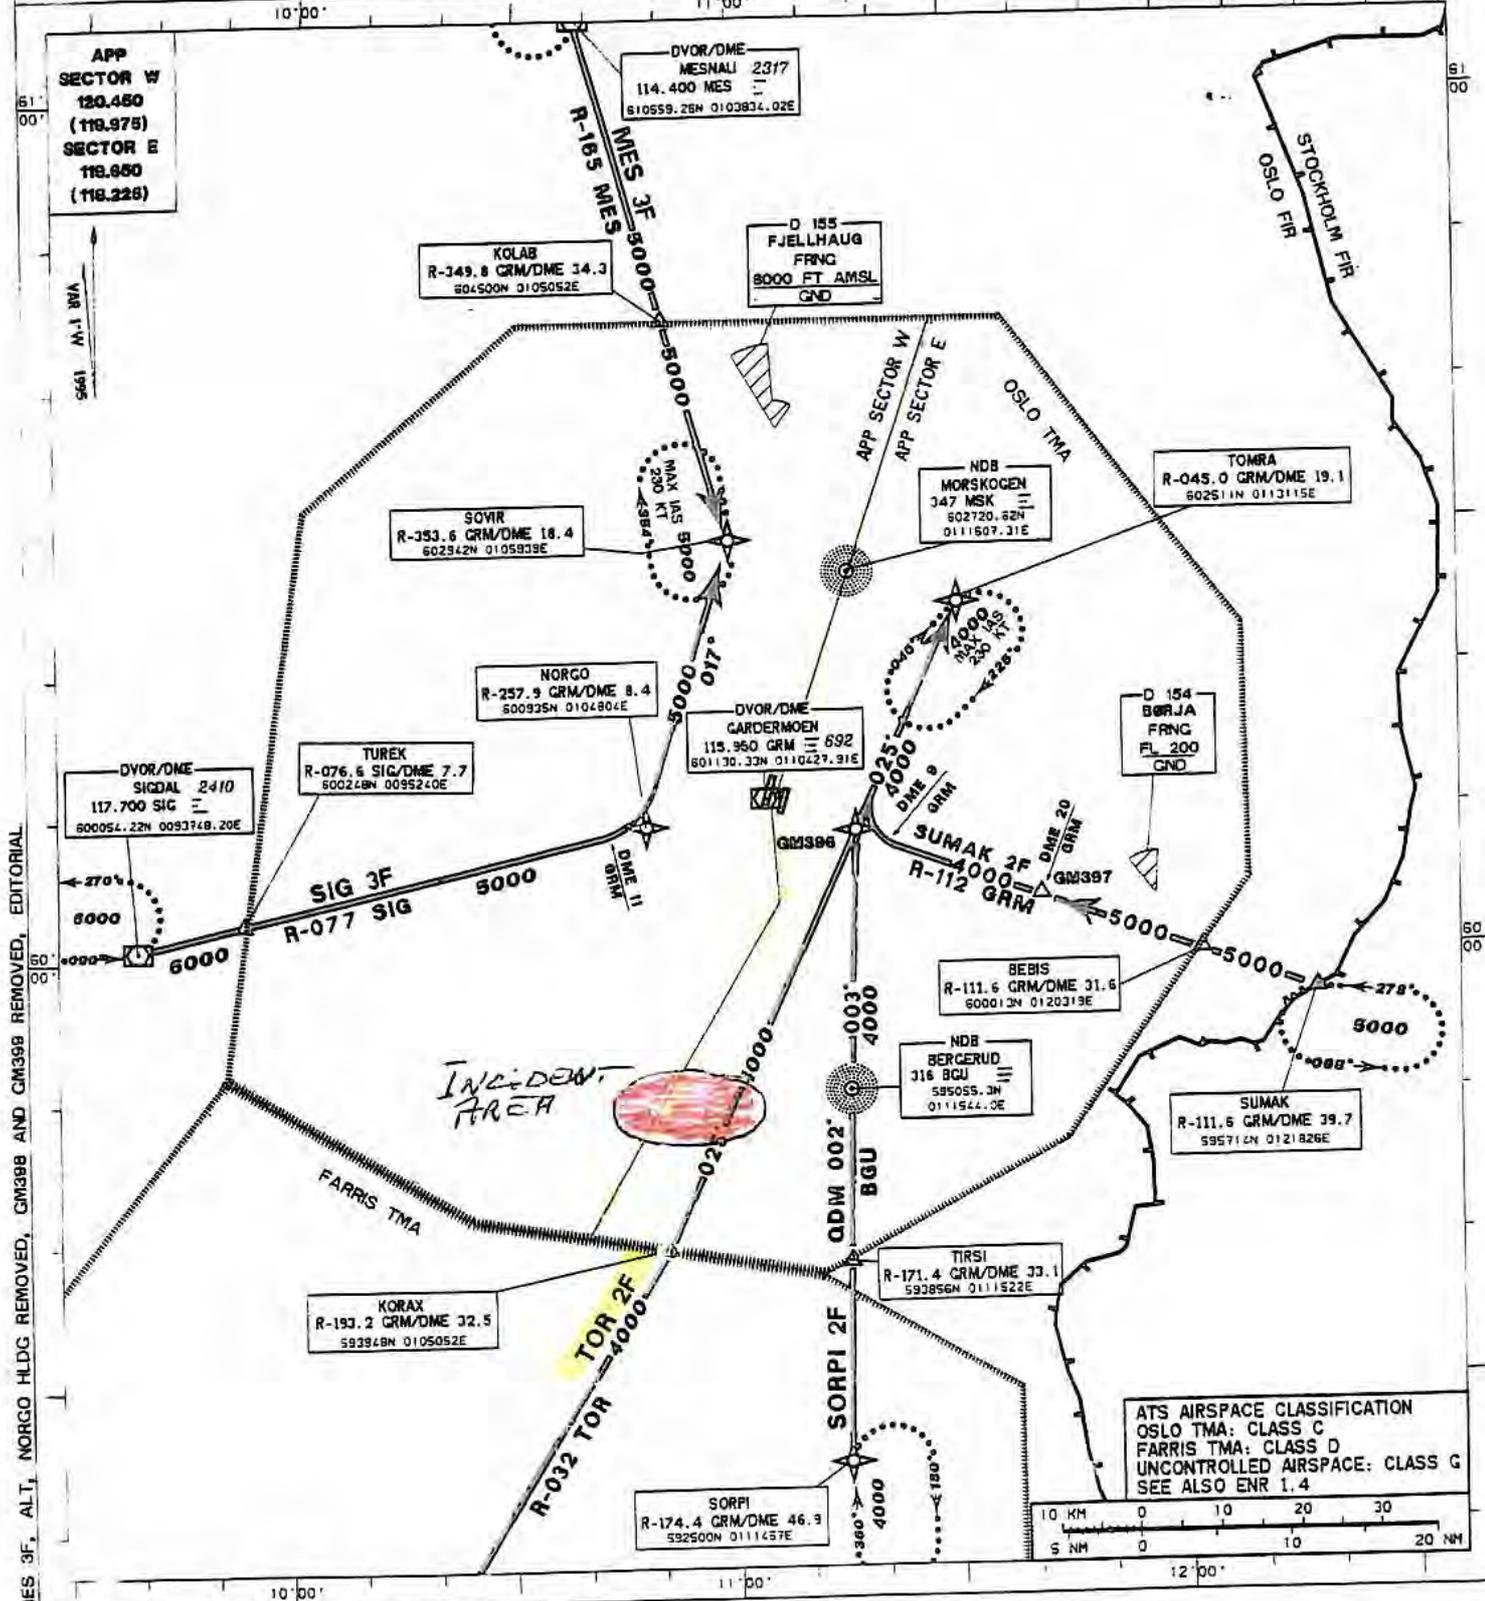
STANDARD ARRIVAL CHART
INSTRUMENT (STAR) - ICAO

The STAR TOR 2F and SID SKI 2C are located in different sectors of OSLO TMA. The STAR and the SID are located close to the common border between the two sectors.

SID SKI 2 C contains a noise abatement procedure involving a left turn after take off, bringing the tracks of SID SKI 2C and STAR TOR 2F closer than 5 NM from each other at a point approximately 8 NM south of the departure end of RWY 19L. The result is a situation that may cause insufficient lateral separation between aircraft operating on the STAR and SID respectively. Close co-ordination between the two controllers in order to ensure sufficient vertical separation is therefore a requirement when both procedures are in use simultaneously.

The AAIB/N recommends that the CAA/N consider a revision of all aspects concerning the STAR and SID procedures at Oslo Airport Gardermoen in order to ensure adequate separation between arriving and departing aircraft (Recommendation no. 4/2001).
