REPORT

Date: 01 Nov 2004
SL Report: 40/2004

- Type and reg.: Airbus A321-232, OY-KBK
- Manufacturing year: 2001
- Engines: IAE V2530-A5

Type of occurrence: Incident, early rotation on take-off

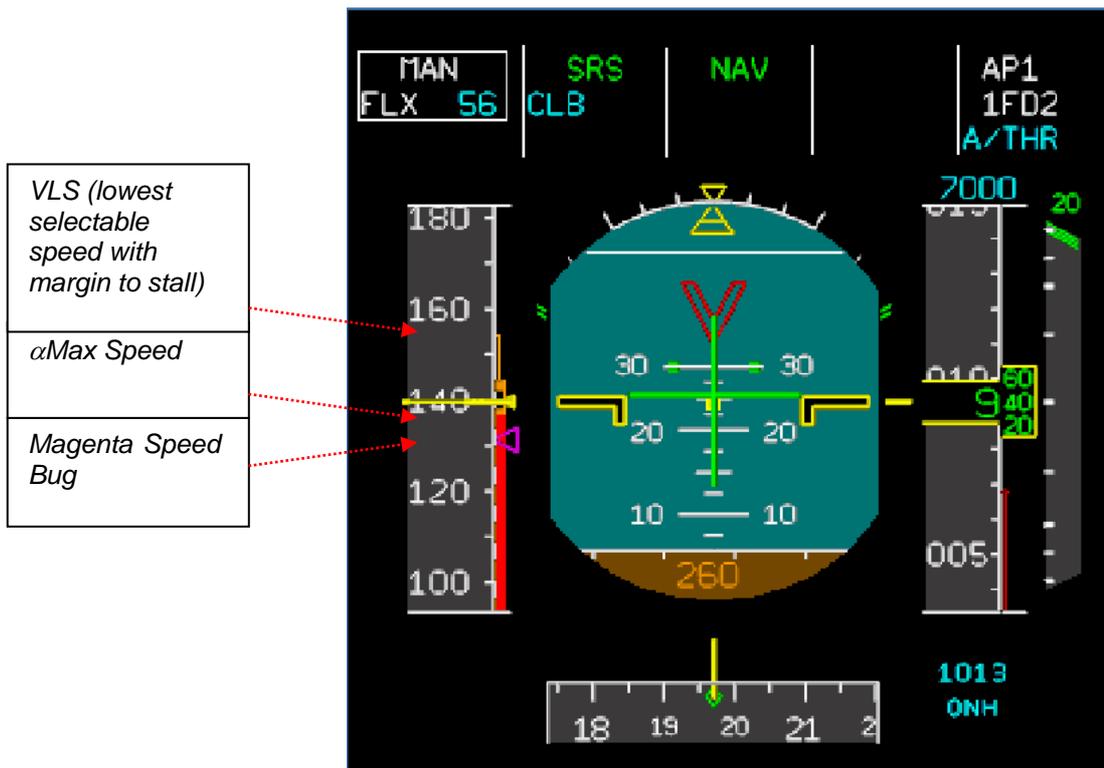
Fig. 1 Illustration of the Flight Management Guidance Envelope Computer (FMGC)

The First Officer was flying the aircraft during take-off. He noticed that the aircraft’s response during rotation was sluggish. (‘sloppy’). As soon as they were airborne, they were able to see that the selected speed for V_2 (Magenta speed bug) was lower than it should have been, since it was within the red area on the ‘speed tape’ (see fig. 1).
