REPORT

Submitted date: 10.07.2008
SL Report: 2008/10

Aircraft:	<i>OY-SEL</i>	<i>D-IRUP</i>
- Type and reg.:	Boeing 737-800, OY-SEL	Cessna 551 Citation, D-IRUP
- Manufacturing year:	Not reported	Not reported
Operator:	Sterling Airlines	Triple Alpha Luftfahrtgesellschaft mbH
Radio call sign:	SNB611T	CLU8000
Date and time:	Torsdag 7. September 2006, at 0748 hrs	
Location:	Oslo airport Gardermoen (ENGM), runway 01L	
Type of occurrence:	Runway incursion	
Degree of seriousness:	Serious air traffic incident	
Type of flight:	Commercial, scheduled	Commercial, non-scheduled
Weather conditions:	METAR ENGM at 0750 hrs: Wind: 020 ° 5 kt. Visibility: 7 000 m Clouds: Few at 300 ft, scattered at 600 ft, broken at 1 500 ft Temperature/Dewpoint: 10 °C/10 °C, QNH: 1003 hPa. NOSIG	
Light conditions:	Daylight	
Flight conditions:	VMC	
Flight plan:	IFR	IFR
Persons on board:	6 crew members 172 passengers	2 crew members Passengers not reported
Injuries to persons:	None	None
Damages to aircraft:	None	None

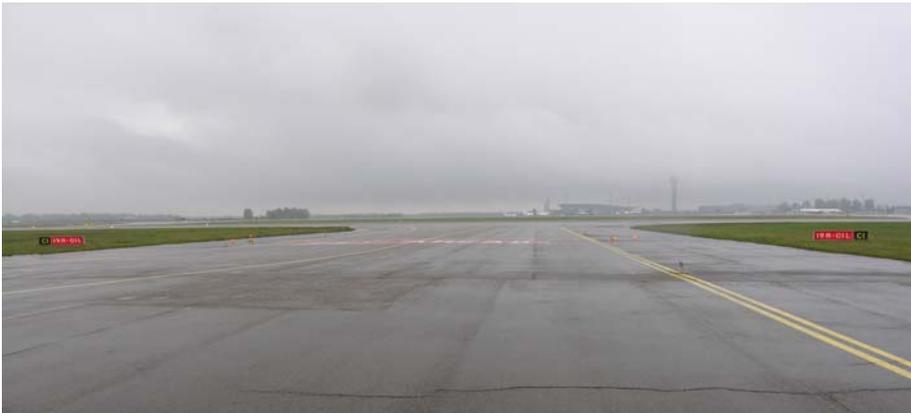
Holding position C1 is clearly marked with stop bars and signs, as well as surface markings which include the words “RWY AHEAD” (see figure 2).

Figure 2: Holding position C1 as seen from the GA area.

The C1 holding position is marked in accordance with regulations, and the probability of an aircraft passing the position due to poor or inadequate marking is considered unlikely.

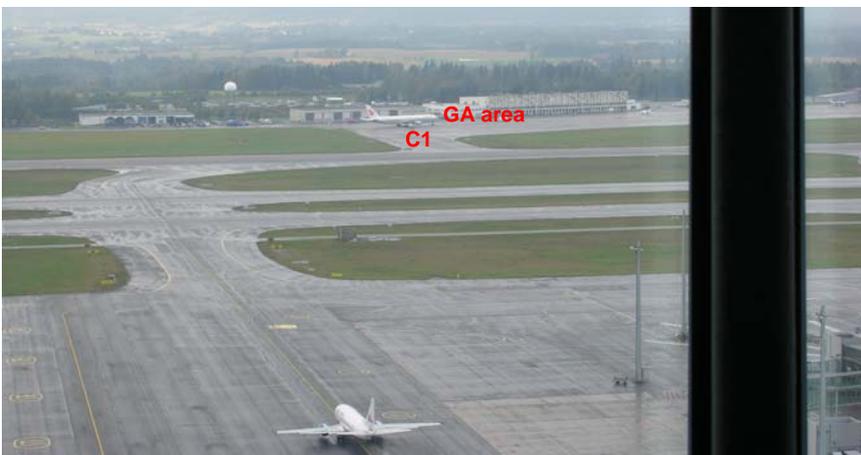
Holding position C1 is clearly visible from the TWR/W working position (see figure 3).

Figure 3: GA area and taxiway/holding position C1 as seen from working position TWR/W in the control tower.
