## REPORT

REP: 41/2000

-type & reg.: Ilyushin Il-76TD, RA 76750

Type of occurrence: Serious aircraft incident, the aircraft made a low final approach and collided with ILS localizer (LLZ) antenna at the approach end of the runway (localizer for approach RWY 09)

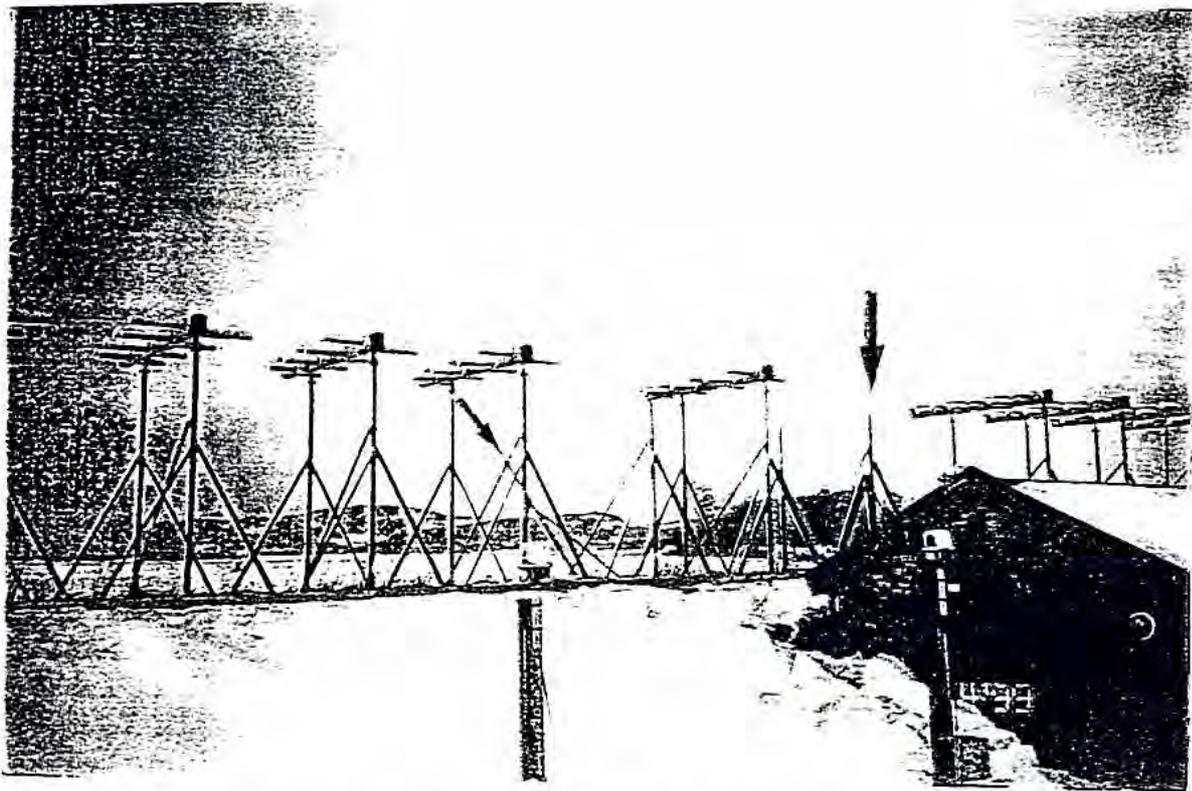
Other damage: 8 of the 12 elements of the ILS LLZ-09 antenna array were more or less damaged, 3 of them totally. Profiles belonging to the array damaged and out of position. Antenna masts were broken and cables and cable-connectors damaged as well. The antenna situated on top of the communication equipment building, of 1.40 m height over the roof, were put down. Some minor damages made on the top of the roof of the same building, and the obstruction light on the north side of the antenna array was moved out of alignment. The estimated cost of the repair is NOK 744.000,-.

LLZ-09 ANTENNA ARRAY AND THE EQUIPMENT BUILDING
