ROAD 2009/03

REPORT ON BUSINCIDENT ON RV3, NEVERDAL IN RENNEBU 7. NOVEMBER 2006

Submitted
date: 12.10.2009
ROAD Report: 2009/03

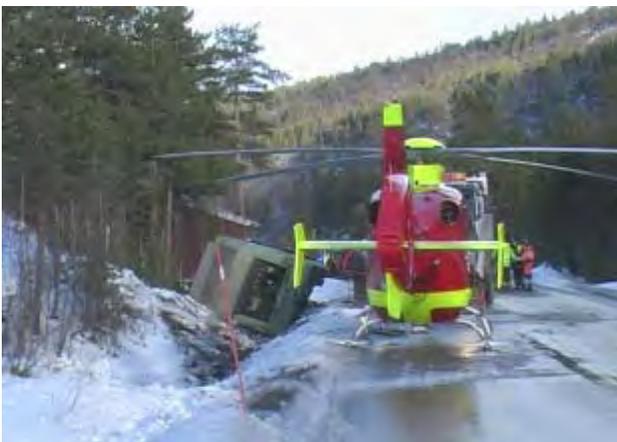
The bus left the road approx. 18 m after passing the border into Sør-Trøndelag County. After exiting the road, the bus drove into the left-side ditch and turned over to the left against the side of the ditch embankment before stopping approx. 50 metres after leaving the road. The bus sustained damage to the front and along the left side.

Figure 2: The bus where it ended up against the ditch embankment. Tracks from the bus's left rear wheels can be seen in the middle bottom of the picture. (Photo: The 330 Squadron, Ørland airbase)

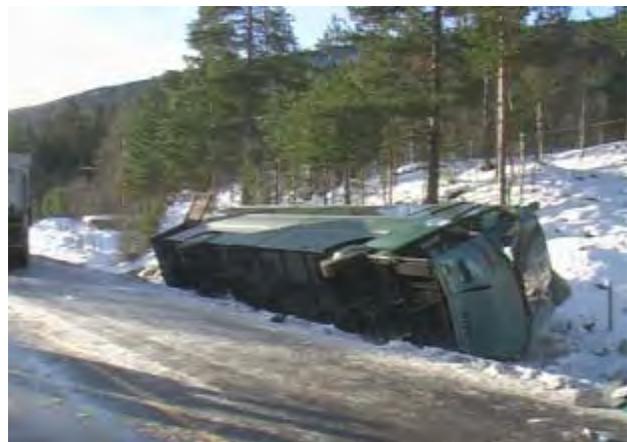
Figure 3: The bus where it ended up in the ditch embankment. (Photo: The 330 Squadron, Ørland airbase)

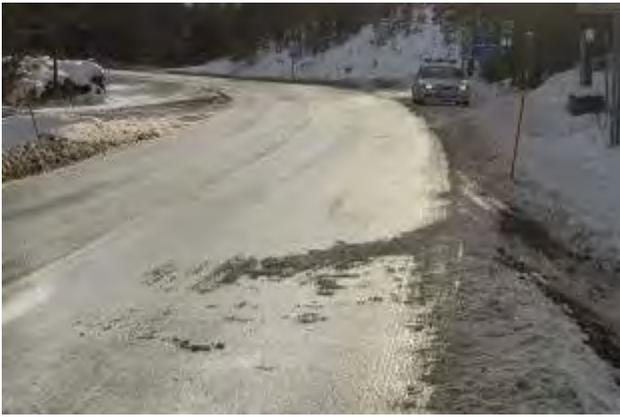
Figure 4: Tracks on the edge of the road after the bus drove off the road, looking southwards into Hedmark County. The border stone can be seen to the right, in front of the police car. (Photo: Norwegian Public Roads Administration)

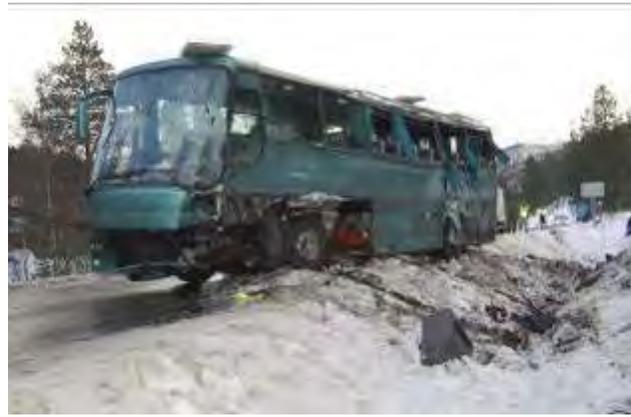
- Damage to vehicle:	Extensive damage to the left of the front and along the entire left side.

Figure 5: Damage to the bus after driving off the road. (Photo: Norwegian Public Roads Administration)
