PRELIMINARY REPORT 28 JUNE 2016

ACCIDENT AT TURØY, NEAR BERGEN, NORWAY ON 29 APRIL 2016, INVOLVING AIRBUS HELICOPTERS H225, LN-OJF OPERATED BY CHC HELIKOPTER SERVICE AS

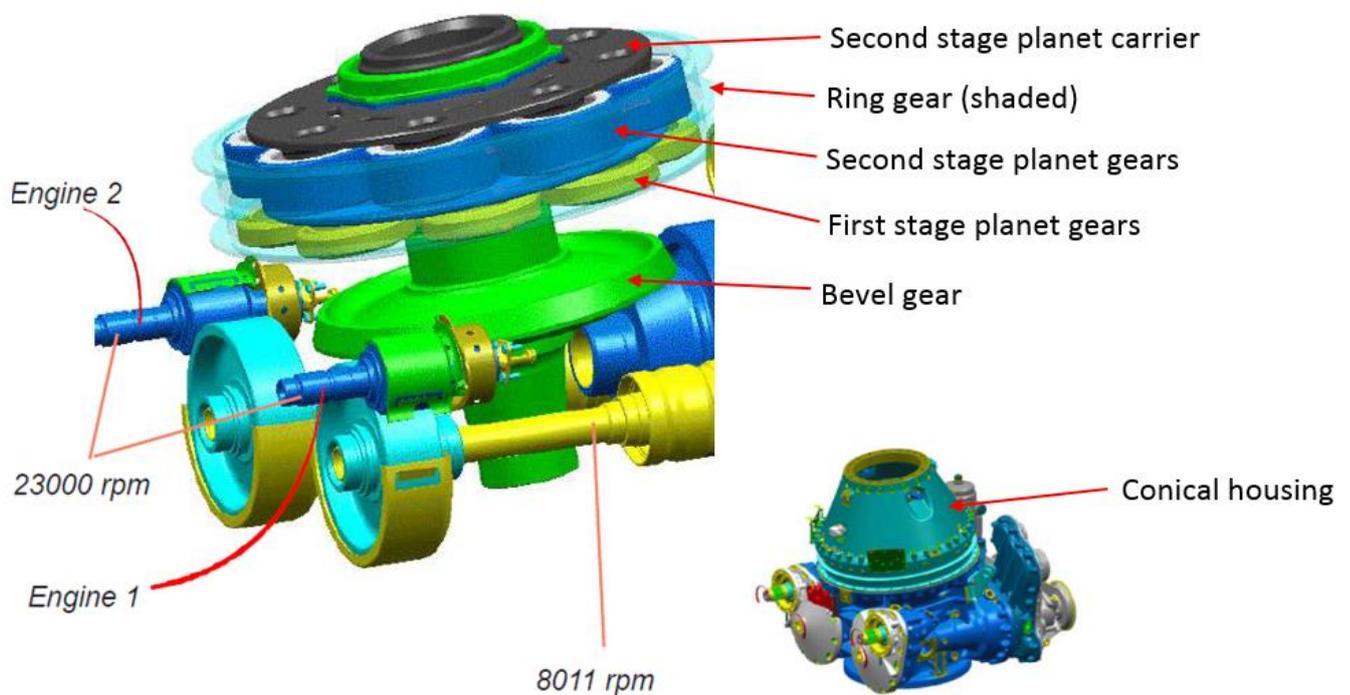
Figure 1: Main power transmission layout with main module (bottom) and epicyclic module with ring gear and two stages of planet gears (top). Conical housing shown in figure to the right. Source: Airbus Helicopters
