# REPORT

SL 2013/16

## REPORT ON AIR ACCIDENT NEAR SØVATNET LAKE IN BJUGN IN SØR-TRØNDELAG COUNTY, NORWAY ON 10 AUGUST 2012 - CESSNA 172RG, D-EIYL

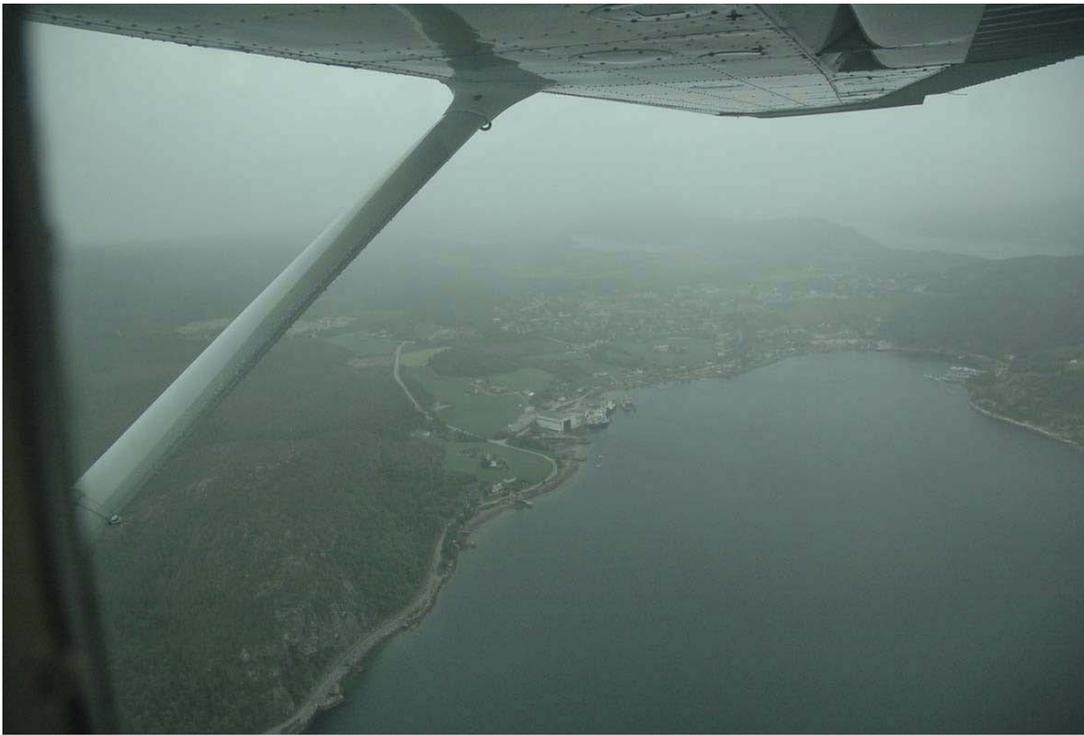
- 1.1.2.9 A camera found inside the aircraft contained a number of photos from the flight. The photo below is of Kolvereid, the administrative centre in Nærøy municipality, seen from the south-east. Kolvereid lies south of Leka, approximately 14 NM east of Rørvik and 23 NM north of Namsos (see Figure 1). Radar records show that the aircraft passed that area at about 1122 hrs.

Figure 2: Photo taken from D-EIYL when passing Kolvereid at approximately 1122 hrs. (Photo private)

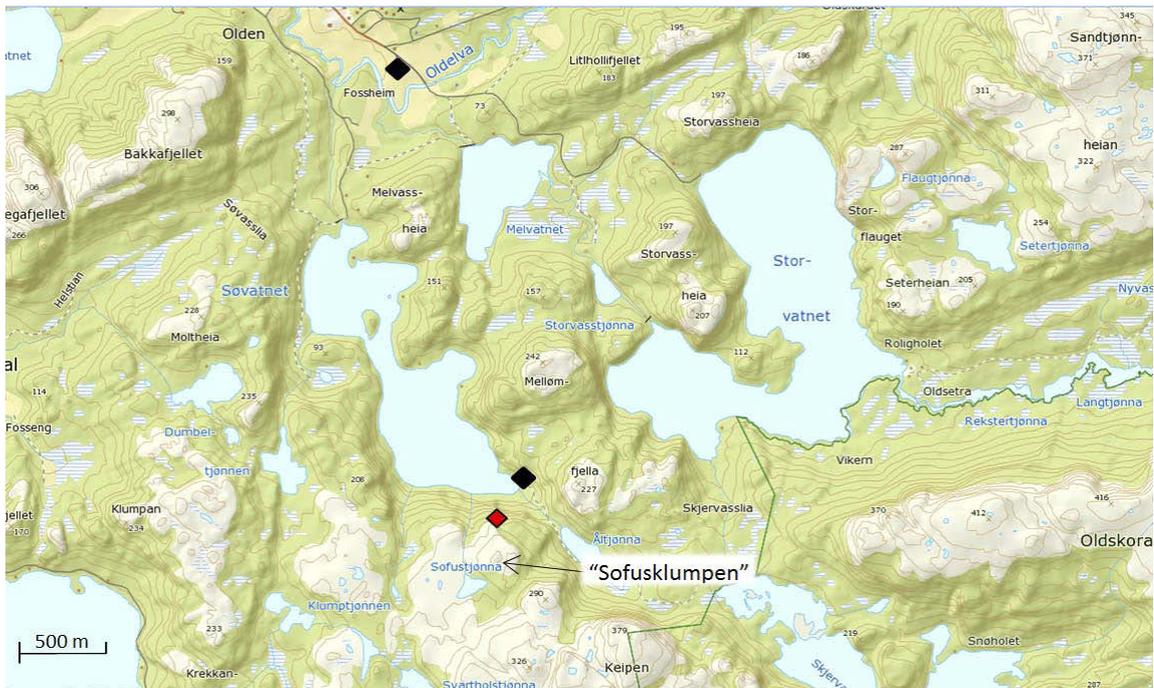
Figure 4: Map section showing the area where the aircraft crashed, the positions of witnesses and the accident site (red marking). (Map: UT.no)

- 1.1.3.1 A witness who was outside on Fossheim farm in Olden (marked by the topmost black diamond in Figure 4) stated that, at about 1223 hrs, he saw the aircraft approaching from the north and flying slowly southwards in the direction of Søvatnet lake approximately 70-90 metres above the farm. He was under the impression that it *'hardly had flying speed'*. The aircraft held a straight course and passed at a very low altitude over the crest of an approximately 100-metre high hill that could just be glimpsed through the cloud cover. It then disappeared from sight. The witness had remarked to someone else on the farm that this could not end well. Ten minutes later, a neighbour called and said that the aircraft had crashed.

- 1.1.3.2 A married couple was staying in the cabin by the bay at the south-eastern end of Søvatnet (see Figure 4). They heard the sound of an approaching aircraft and an unusual noise, and the wife went to the window. She saw the aircraft flying almost straight over the cabin from the north-east, at a very low height above the terrain. She could see the right-hand side of the aircraft from where she was standing. She described the unusual noise as an increase in the engine's rpm – *'a terrible droning sound'* – and she saw the aircraft climb as it was nearing the higher and steeper terrain at the southern end of the lake, with the peak called 'Sofusklumpen'. She expected the aircraft to turn right to move out across the lake, but that did not happen. Instead, it continued to climb while holding a straight course, apparently at a constant speed. She thought it looked as if it was about to rock its wings in greeting. But a slight waver was all she saw before they heard a terrible bang as the aircraft appeared to her to crash straight into the cliff. She did not register any movement, sound or smoke after the crash.

approx. 85 metres (280 ft) above the lake. The terrain where the wreckage came to rest slopes approx. 30° in the north-south direction. There are several peaks of more than 200 metres in the area, see the photo in Figure 8 and the map in Figure 4.

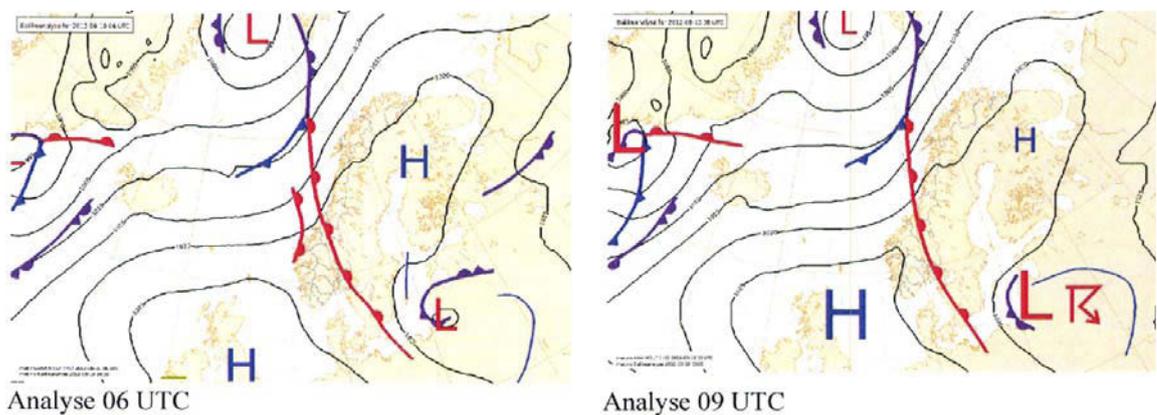
1.7.1.1 On the day of the accident, the Trøndelag region experienced southerly and south-westerly winds as a result of a low-pressure front over the Norwegian Sea combined with a high-pressure front over England. A relatively weak warm front over Sør-Trøndelag county was moving slowly eastwards (see Figure 6). At ground level there was a south to south-westerly strong breeze (around 20 – 30 kt) along the coast. At altitudes up to 5 000 ft, there was a south-westerly wind of around 20 – 30 kt.

Figure 6: The weather situation at 0800 and 1100 hrs.

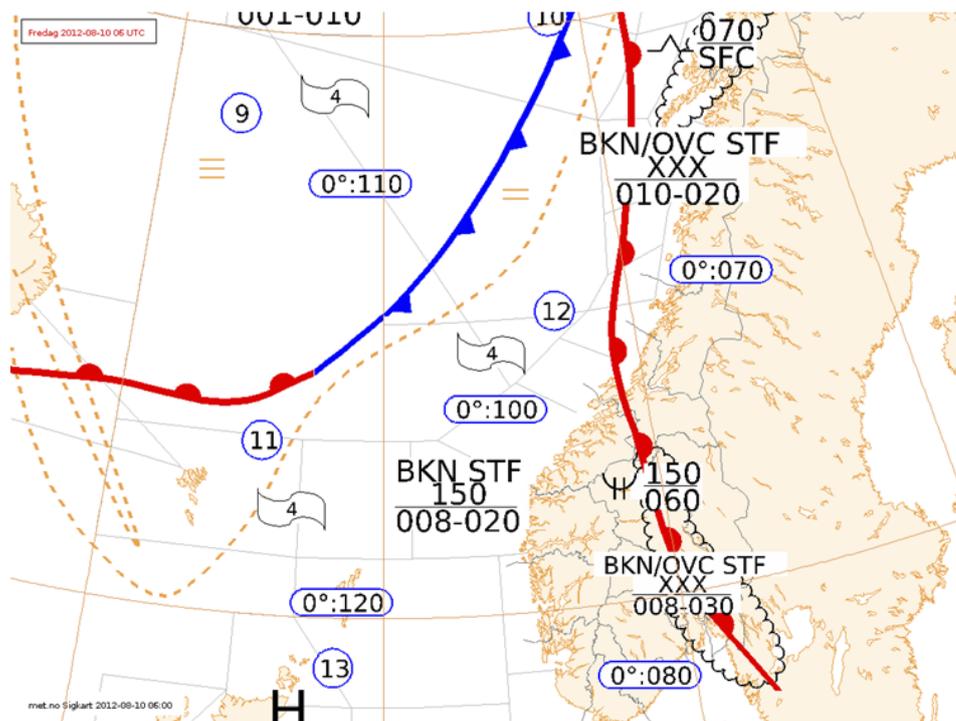
Figure 7: Significant weather map at 0800 hrs.
