REPORT

SL 2010/18

REPORT ON SERIOUS AIRCRAFT INCIDENT AT OSLO AIRPORT GARDERMOEN 25 FEBRUARY 2010 INVOLVING AIRBUS A320-214 VP-BWM, OPERATED BY AEROFLOT RUSSIAN AIRLINES

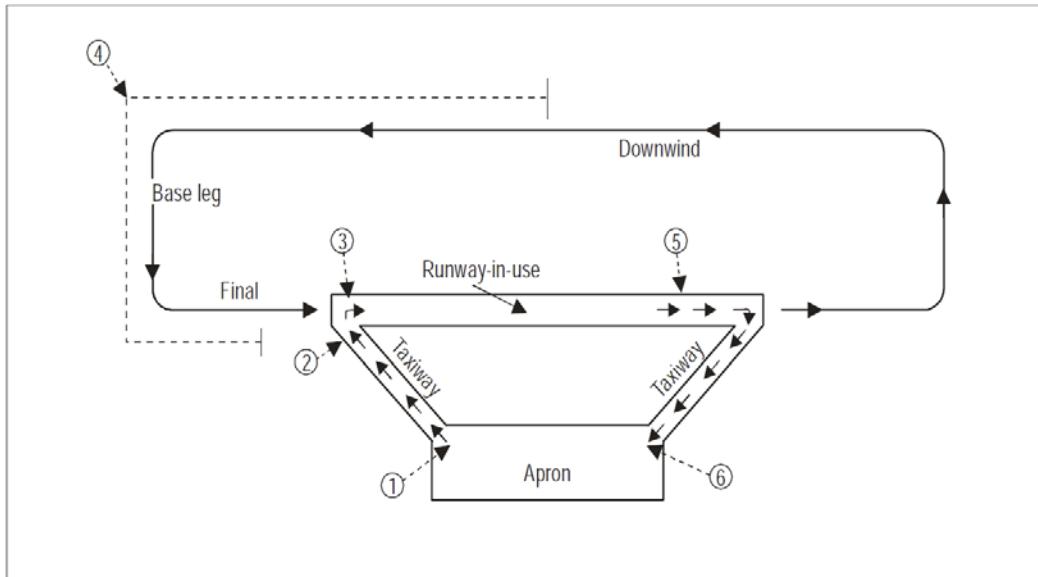
Figure 2: RFL 1 Chapter 7, Item. & Fig. 5.2.1 (from ICAO doc 4444 (PANS-ATM))

In Figure 5.2.1 mentioned above (see Figure 2 in Chapter 1.10.13.1 of this report), a taxiway has been drawn leading in to the runway. Other parallel taxiways adjacent to each other are not indicated in the figure. The Accident Investigation Board is of the opinion that this generic figure is not unambiguous in its explanation of when a take-off clearance will be given in a more complex runway system, such as at Oslo Airport, where there are parallel taxiways.

Position 2 in Figure 5.2.1 is described as follows in the text: "*If there is conflicting traffic, the departing aircraft will be held at this point.*" The Accident Investigation Board therefore considers that position 2 is the holding position for runway, or near this. The preconditions for holding an aircraft are, according to the text, "*if there is conflicting traffic*". Accordingly, the guidelines in ICAO doc 4444/RFL I can be interpreted to mean that the principle "line-up and wait before take-off clearance" must not necessarily be complied with if there is no other conflicting traffic.

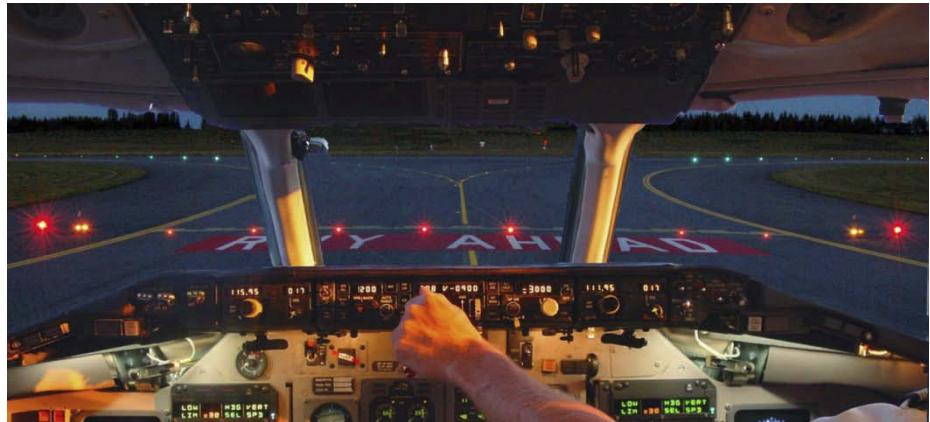
The picture was not taken in connection with the incident, but illustrates how the stop bars, "RWY AHEAD" marking and runway guardlights look from a cockpit.

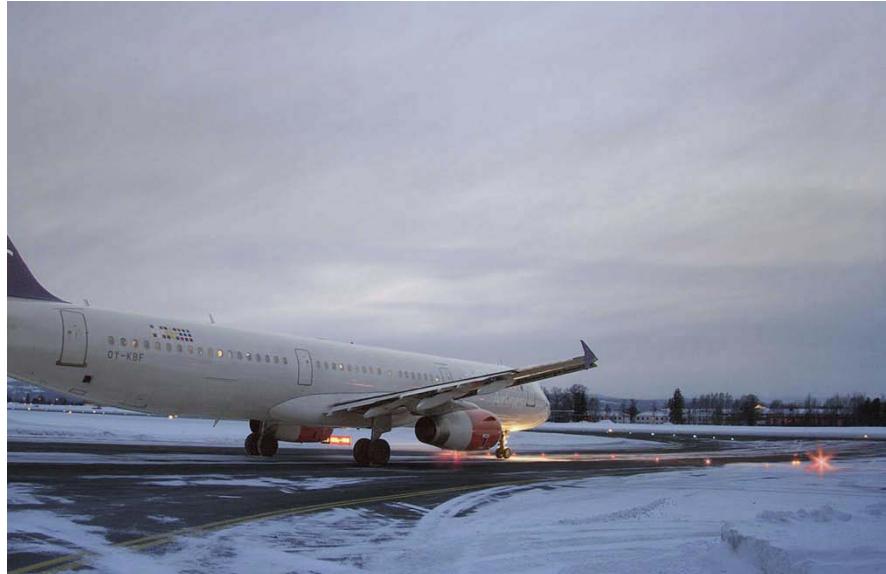
Picture 7

The picture was not taken in connection with the incident, but illustrates how stop bars and runway guardlights look when it is darker than it was at the time of the incident.
