SL 2013/03

REPORT ON SERIOUS INCIDENT AT BERGEN AIRPORT 9 NOVEMBER 2007 WITH ATR-42-300, OY-JRY

Issued date: 23.01.2013
SL Report: 2013/03

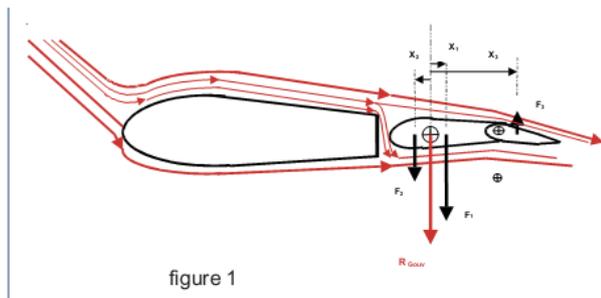
To move or balance the elevator, the pilot or the autopilot needs to create a force which will be applied through the kinetic system to oppose the aerodynamic forces applied onto the elevator and the trim tab. This force is contrary to the elevator hinge moment.

If ice forms on the upper part of the horizontal stabiliser and the elevator, the boundary layer in the aft part of the profile is modified with the result that the elevator tends to pull up.

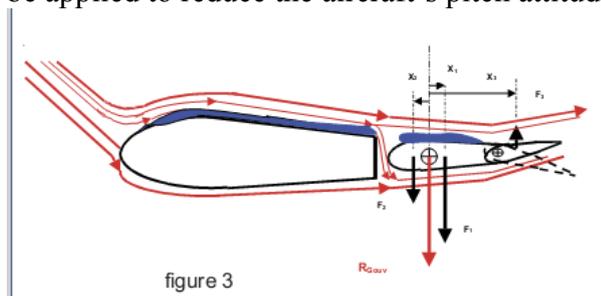
Therefore, to restore equilibrium, the nose-down trim has to be increased which reduces the capacity of the trim to stabilise the aircraft when the speed increases. When the "down" trim stop is reached, the elevator hinge moment can no longer be compensated for, which increases the forces to be applied to reduce the aircraft's pitch attitude (see Figure 3).

Apart from the difficulties in piloting mentioned in the description of the event, a sudden disappearance of the cause of the elevator mistrim (for example if the ice on the upper part of the tail unit drops off suddenly), this will cause the elevator to pull down, thus increasing the aircraft speed. Recovery forces may be large and this situation can cause loss of control.
