REPORT

ROAD 2014/02

REPORT ON OVERTURNING ACCIDENT INVOLVING A TRUCK ON FV 12 BY ALTEREN WEST OF MO I RANA ON 3 OCTOBER 2013

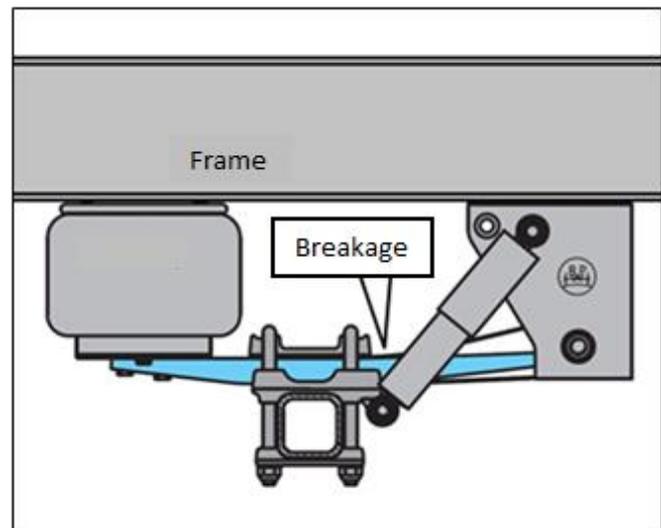
Figure 5: Schematic diagram of the axle's wheel suspension. Source: BPW Bergische Achsen, Ill.: AIBN

1. A draw spring on the left-hand side on the second axle was broken just by the axle's fastening point (see Figures 4 and 5). The picture in Figure 4 was taken during the Norwegian Public Roads Administration's inspection of the semi-trailer after the accident. The photo shows partly corroded sections on the fracture surface. This may indicate that there was previous fracture formation in the draw spring, and that the breakage occurred as the semi-trailer toppled over.
2. The rear axle on the semi-trailer was steerable (friction-controlled⁴). Findings from the investigation indicate that this was in the open position prior to the turnover.
