REPORT

Submitted date: 10.07.2008
SL Report: 2008/10

Aircraft:	<i>OY-SEL</i>	<i>D-IRUP</i>
- Type and reg.:	Boeing 737-800, OY-SEL	Cessna 551 Citation, D-IRUP
- Manufacturing year:	Not reported	Not reported
Operator:	Sterling Airlines	Triple Alpha Luftfahrtgesellschaft mbH
Radio call sign:	SNB611T	CLU8000
Date and time:	Torsdag 7. September 2006, at 0748 hrs	
Location:	Oslo airport Gardermoen (ENGM), runway 01L	
Type of occurrence:	Runway incursion	
Degree of seriousness:	Serious air traffic incident	
Type of flight:	Commercial, scheduled	Commercial, non-scheduled
Weather conditions:	METAR ENGM at 0750 hrs: Wind: 020 ° 5 kt. Visibility: 7 000 m Clouds: Few at 300 ft, scattered at 600 ft, broken at 1 500 ft Temperature/Dewpoint: 10 °C/10 °C, QNH: 1003 hPa. NOSIG	
Light conditions:	Daylight	
Flight conditions:	VMC	
Flight plan:	IFR	IFR
Persons on board:	6 crew members 172 passengers	2 crew members Passengers not reported
Injuries to persons:	None	None
Damages to aircraft:	None	None

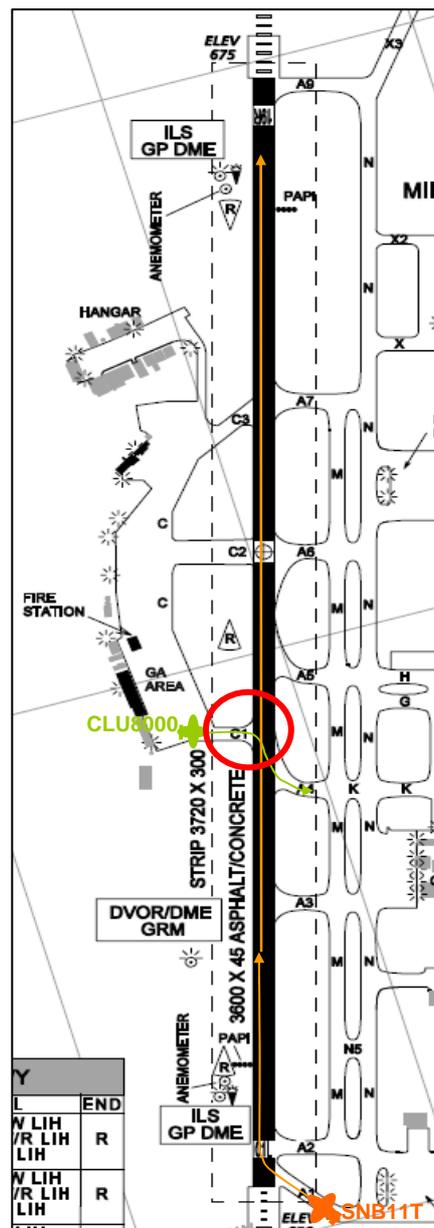
The flight crew of CLU8000, which was parked on the General Aviation (GA) area, contacted TWR/W at 07:46:39, requesting taxi clearance. The GA area is situated to the west of RWY 01L, (see figure 1). CLU8000 was cleared to holding position C1 for RWY 01L.

Figure 1: Map of the western runway at Oslo airport Gardermoen. The movements of SNB611T are marked with orange, and the movements of CLU8000 are marked with green color.
